YMCA POND DAM  
CT 00385

PHASE I INSPECTION REPORT  
NATIONAL DAM INSPECTION PROGRAM

Identification No.: CT 00385  
Name of Dam: YMCA Pond Dam  
Town: Durham  
County and State: Middlesex, Connecticut  
Stream: Tributary To Hersig Brook  
Date of Inspection: 6 November, 1979

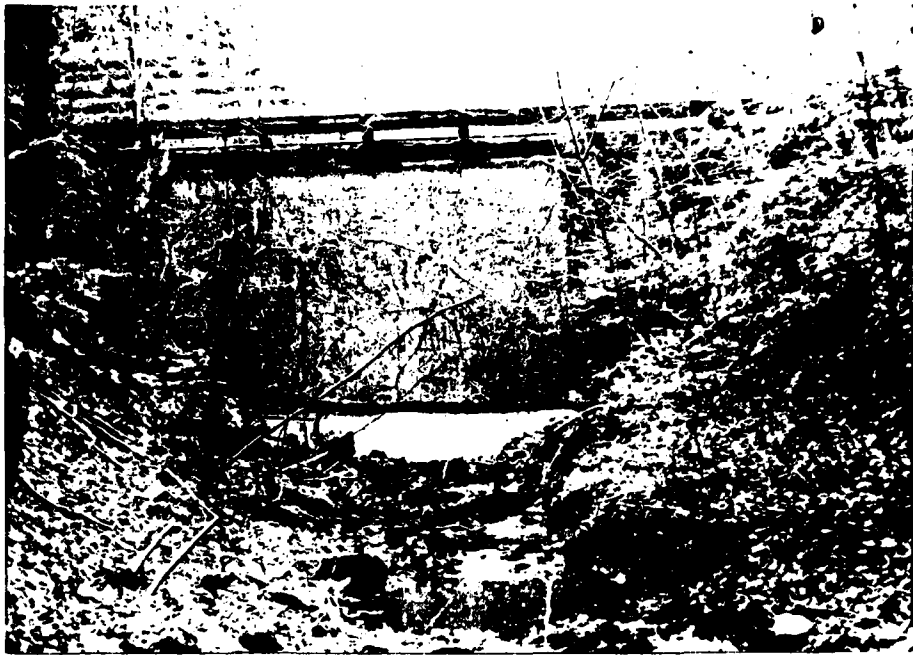
4) Spillway - The spillway is located within the central portion of the concrete gravity dam. (Photo No. 1) The concrete forming the spillway section is in fair condition evidenced by concrete erosion and spalling on the downstream face. (Photo No. 8) Wood flashboards are in place within the spillway section (1' high by 2" wide). The flashboards are in good condition.

PHOTO #1: Downstream face of dam

3. Repair all spalled and deteriorated concrete on the downstream face of the dam.

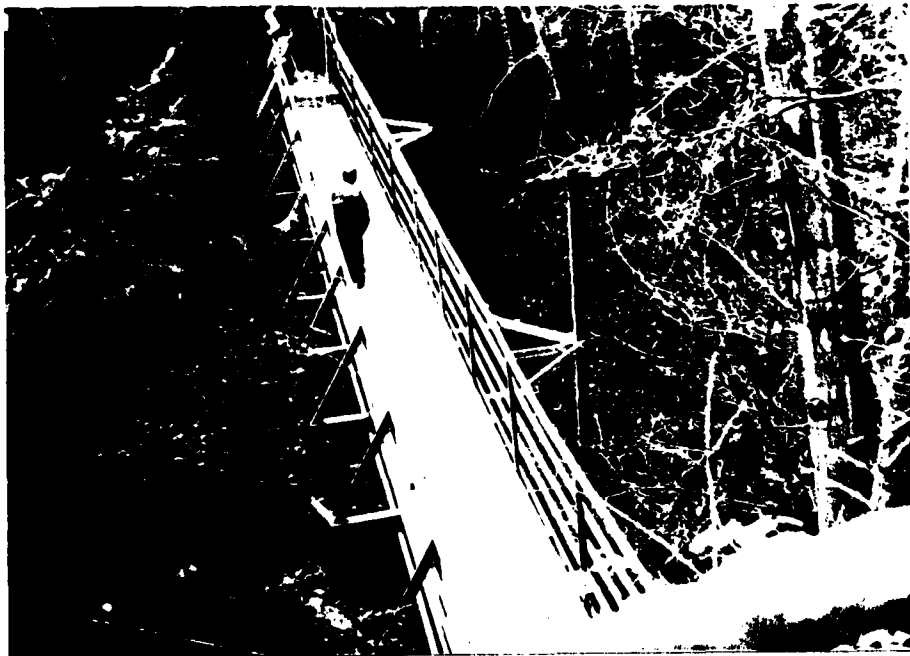
f. Footbridge. A wood footbridge spans the crest of the dam as shown in Photos No. 2 and No. 3. The footbridge is supported by wood blocks attached to the concrete crest by metal angle sections. There is one foot clearance from the crest of the dam to the bottom of the footbridge. The footbridge is in fair condition. Most wooden members of the structure are sound with the exception of several wood supports near the right abutment.

PHOTO #2: Top of dam from left abutment

The footbridge causes a potential for collecting debris and restricting flow. Consideration should be given to raising the bridge to provide adequate clearance over the crest of the dam.

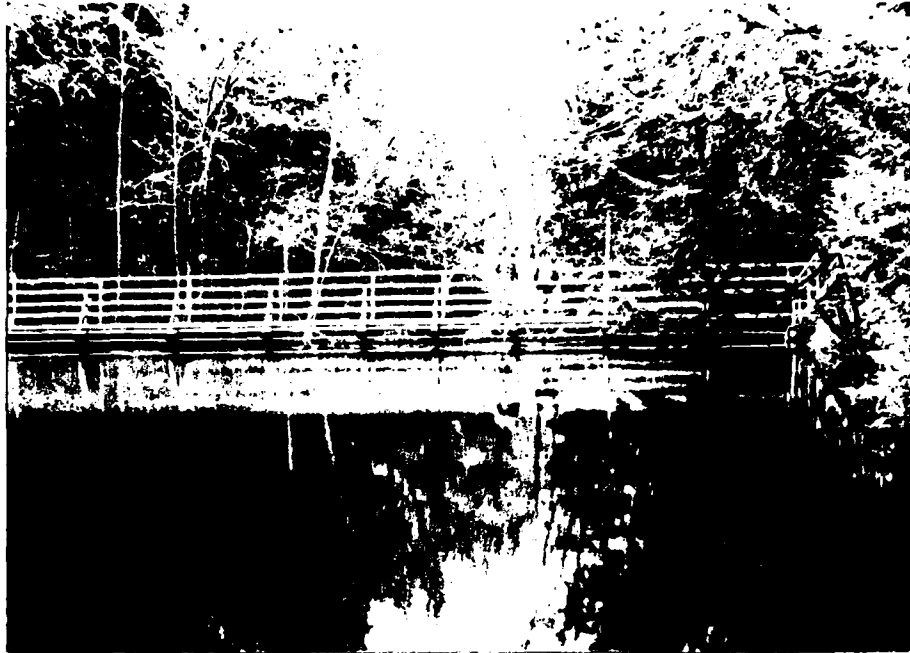
PHOTO #3: Upstream face of dam

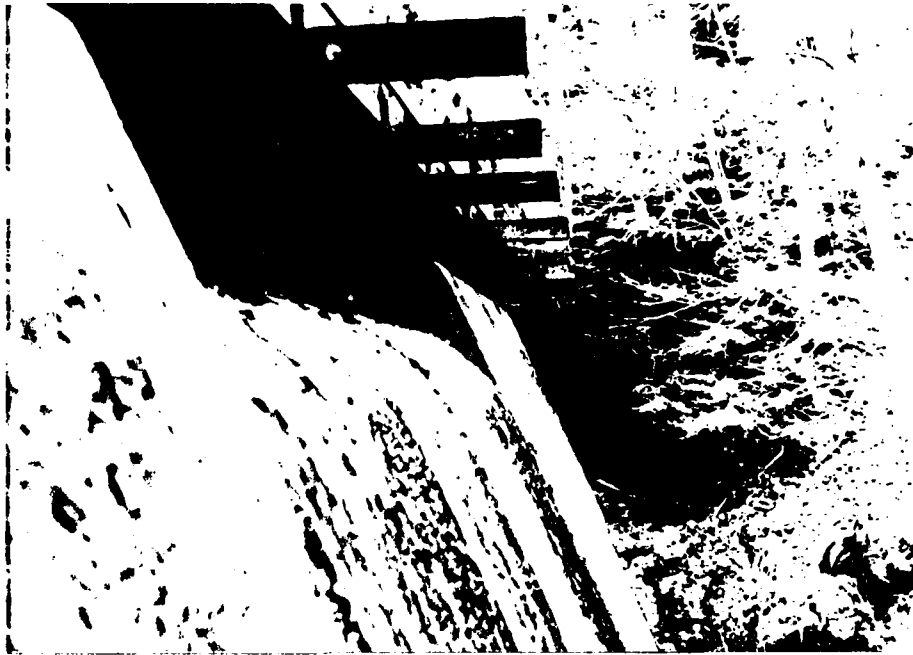
PHOTO #5: Downstream face looking toward left abutment
