HAMDEN, CONNECTICUT

FARM BROOK DAM (SITE I)  
CT 00657

PHASE I INSPECTION REPORT  
NATIONAL DAM INSPECTION PROGRAM

MAY 1981

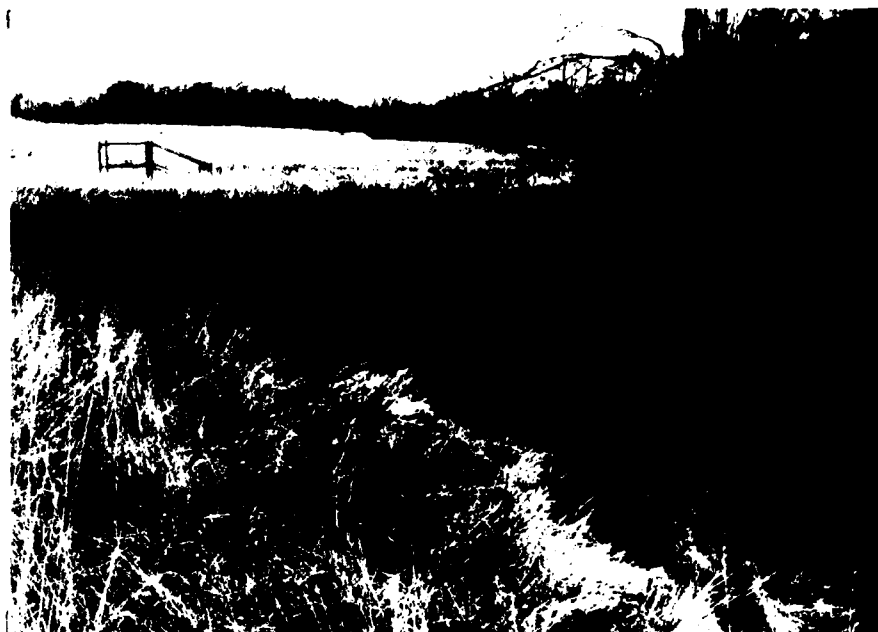
Photo 3 Drainage ditch on toe embankment No 2.

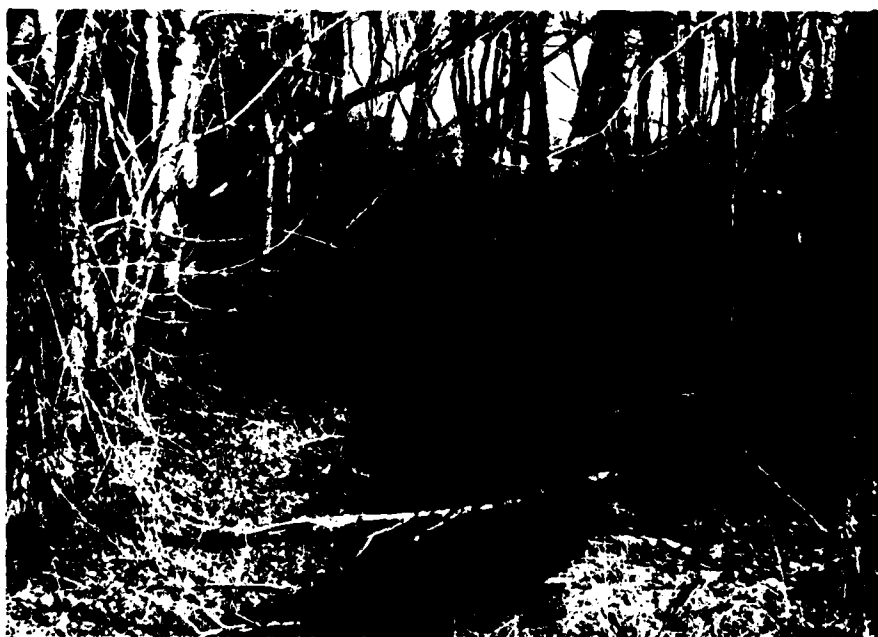
Large quantities of debris were found in and around the stream-bed. Numerous trees and bushes were observed to be both growing in and hanging over the channel (Photo 10).

Photo 10 Downstream channel beyond dam.
