**WILLIAMS POND DAM
CT 00900**

**PHASE I INSPECTION REPORT
NATIONAL DAM INSPECTION PROGRAM**

Identification Number:	CT 00900
Name:	Williams Pond Dam
Town:	Glastonbury
County and State:	Hartford County, Connecticut
Stream:	Hubbard Brook
Date of Inspection:	May 18, 1981

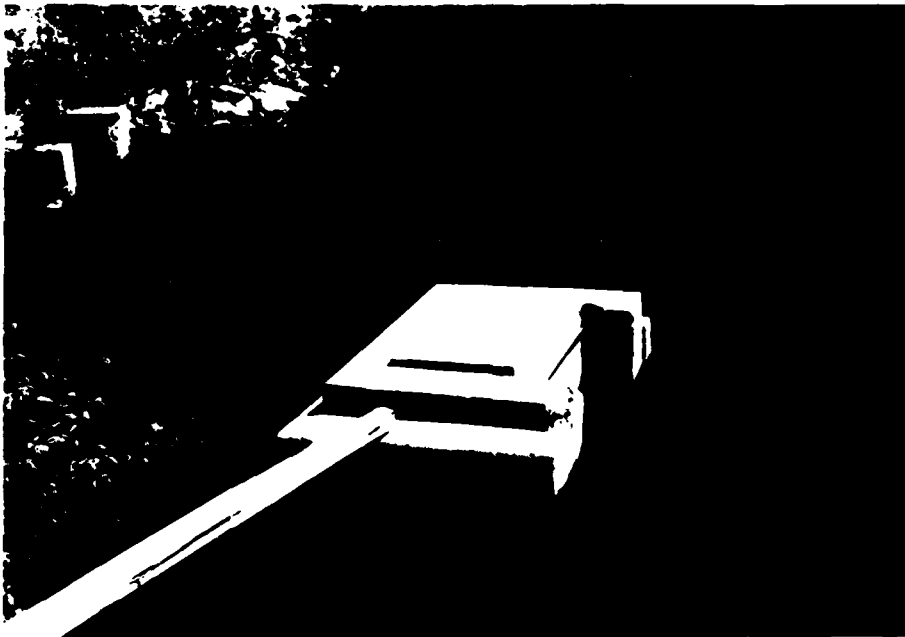
PHOTO 4
INTAKE STRUCTURES

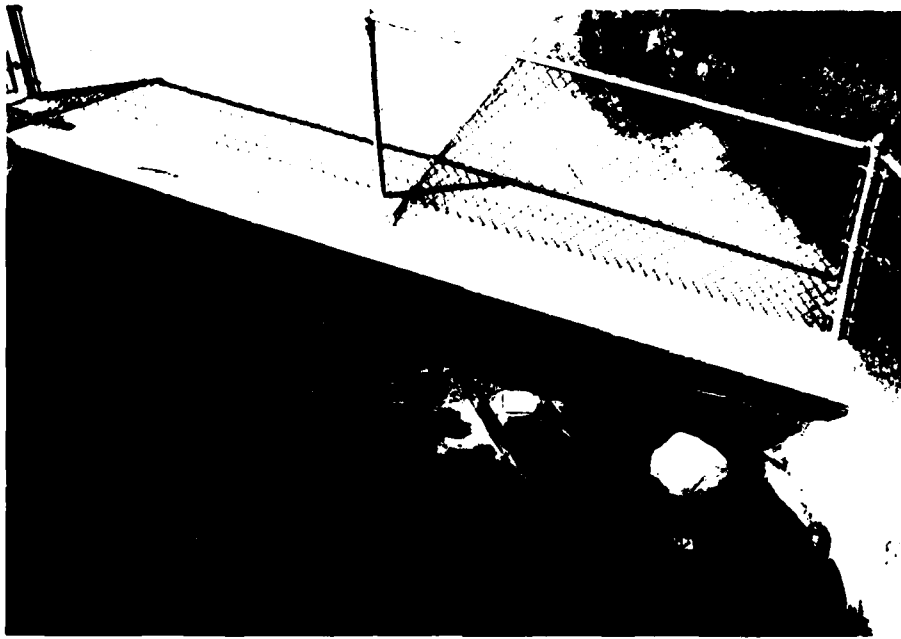
PHOTO 7
DOWNSTREAM CHANNEL
