QUINNIPIAC RIVER BASIN  
MERIDEN CONNECTICUT

# HANOVER POND DAM CT 00134

## PHASE I INSPECTION REPORT NATIONAL DAM INSPECTION PROGRAM

FEBRUARY 1979

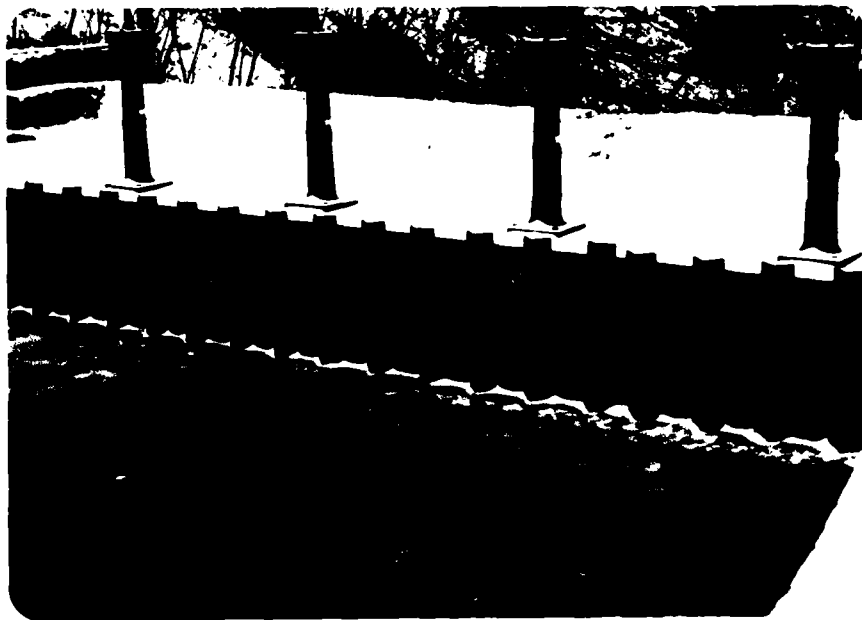
PHOTO NO.3 - Upstream view of gate valves and trash racks at left abutment.
