HOPEVILLE POND DAM
CT. 00438

PHASE 1 INSPECTION REPORT
NATIONAL DAM INSPECTION PROGRAM

DEPARTMENT OF THE ARMY
NEW ENGLAND DIVISION, CORPS OF ENGINEERS
WALTHAM, MASS.

AUGUST, 1980

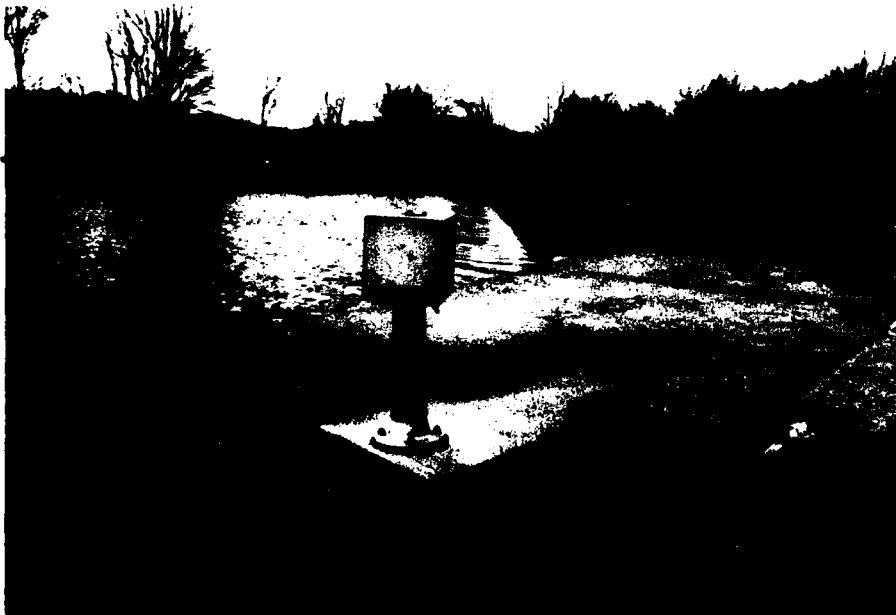
PHOTO C-10 Right outlet works manually controlled sluice gate with lockable hood.

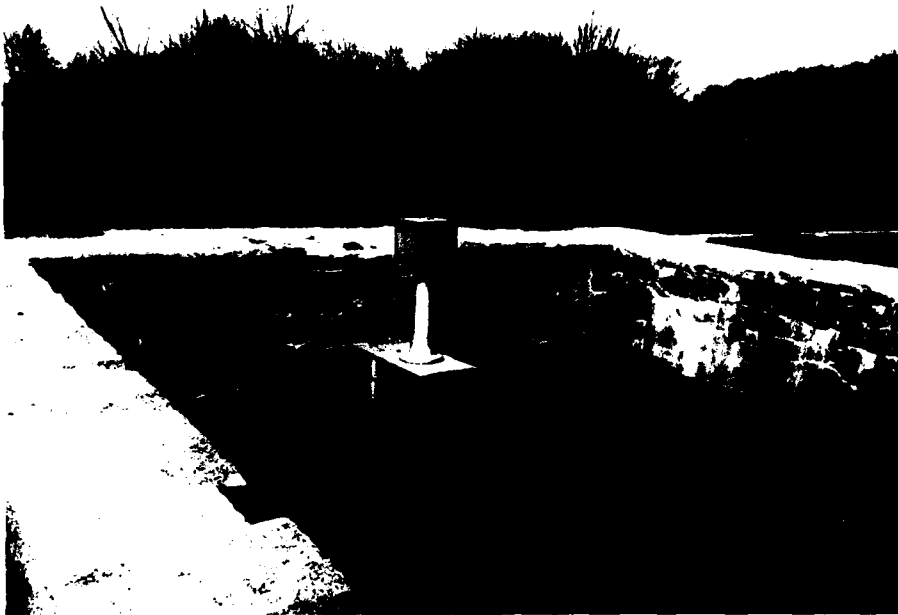
PHOTO C-11 Left outlet works manually controlled sluice gate with lockable hood.

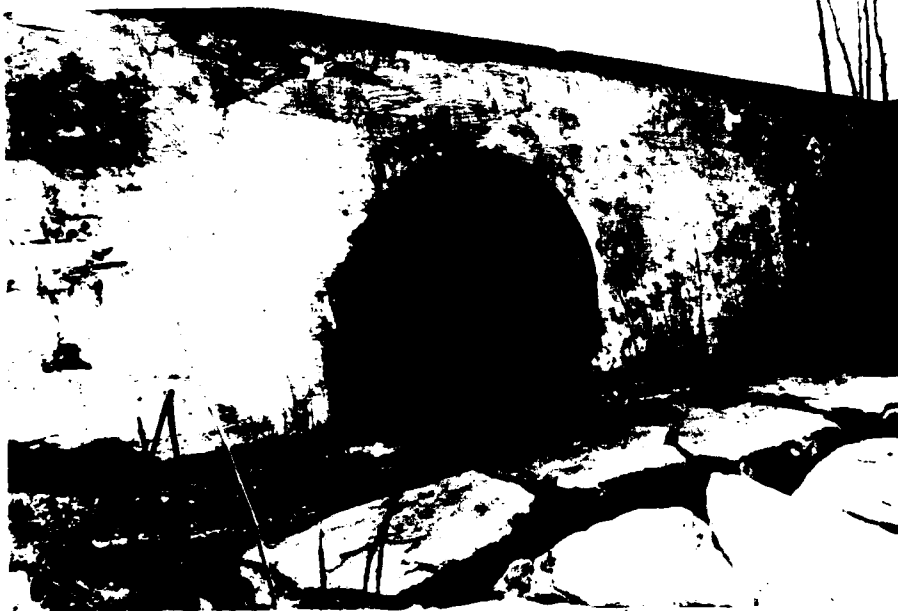
PHOTO C-12 Left outlet works conduit and stone masonry foundation ruins at downstream toe of dam.

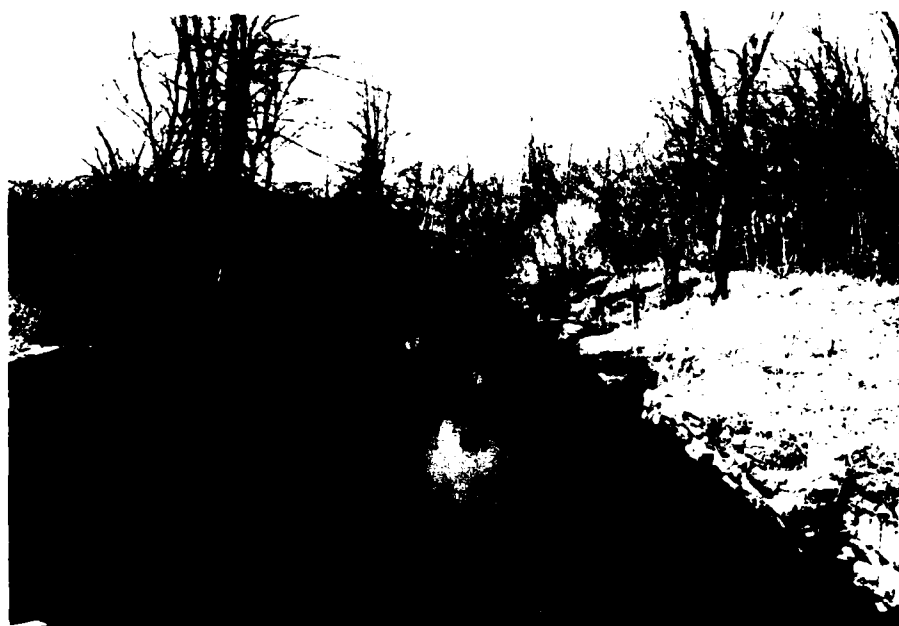
PHOTO C-14 Tailrace looking from invert of 96-inch diameter outlet conduit left dam embankment.

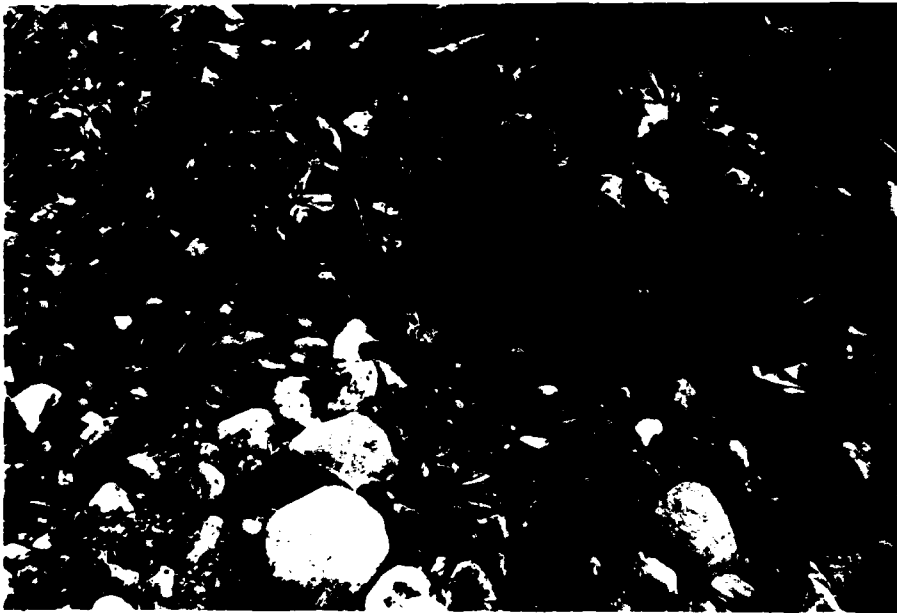
PHOTO C-18 Animal hole on downstream slope dam embankment.
