ENSIGN BICKFORD DAM  
CT 00567

FARMINGTON RIVER BASIN  
SIMSBURY, CONNECTICUT

PHASE I INSPECTION REPORT  
NATIONAL DAM INSPECTION PROGRAM

Re: Ensign Bickford Dam  
Simsbury, Connecticut

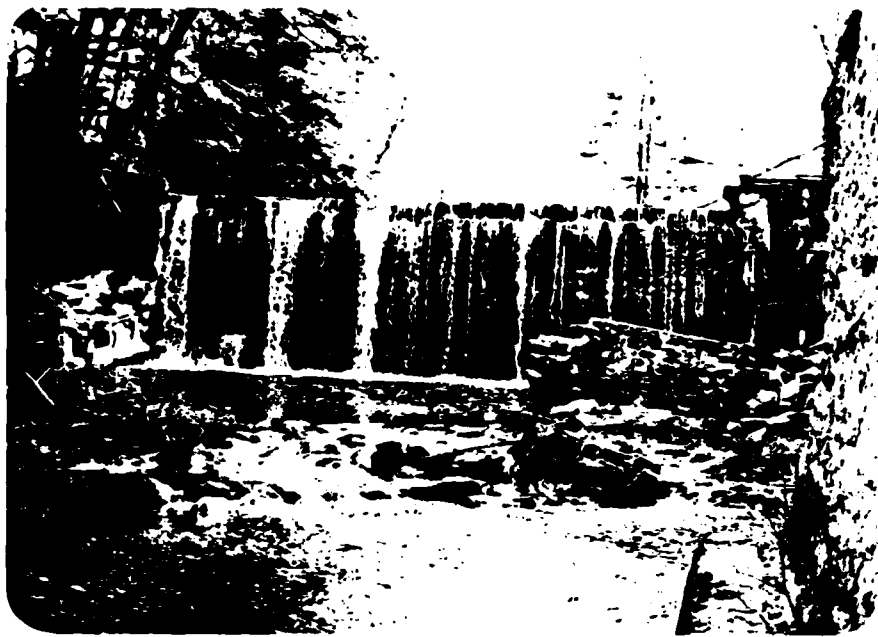
PHOTO NO. 1

SPILLWAY

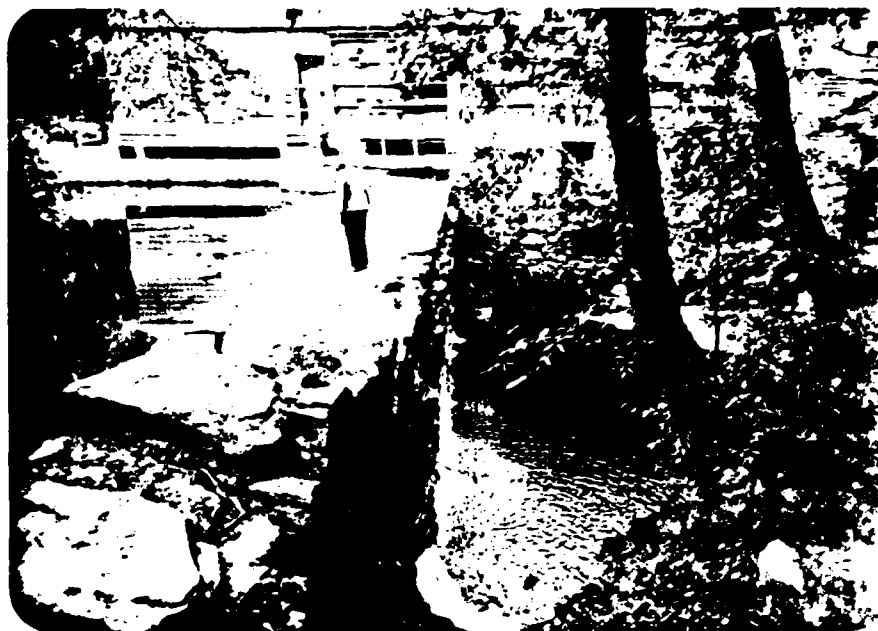
PHOTO NO. 5\*

MILL BUILDING AT LEFT ABUTMENT. NOTE AUXILIARY  
SPILLWAY UPSTREAM OF DAM AND DETERIORATED  
CONCRETE CAP ON MAIN SPILLWAY

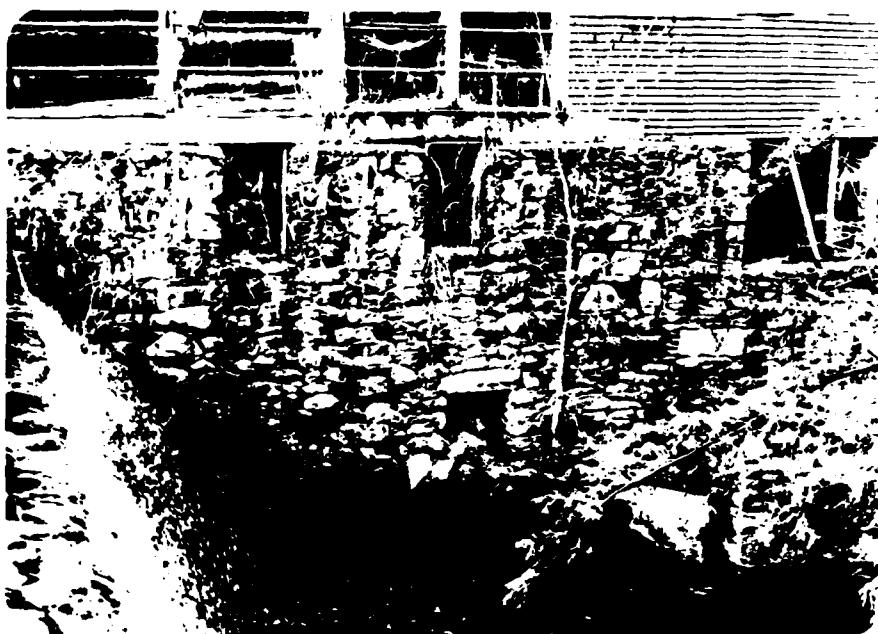
PHOTO NO. 6

FOUNDATION OF OLD MILL DOWNSTREAM OF DAM.  
ARCHED CONDUIT DISCHARGES FLOW FROM NEW SLUICE GATE  
AND AUXILIARY SPILLWAY

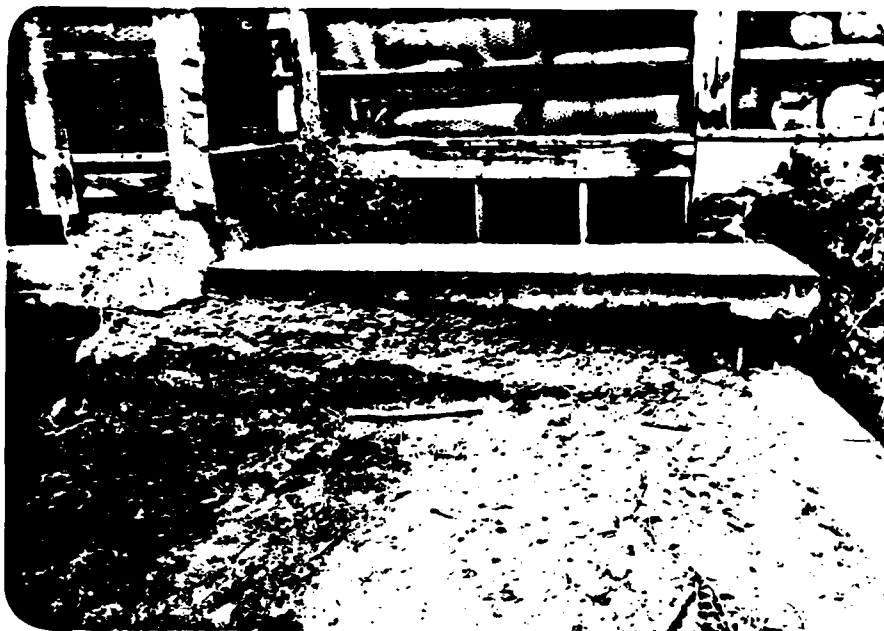
PHOTO NO. 7\*

DETERIORATION OF  
CONCRETE AT LEFT  
SPILLWAY  
TRAINING WALL

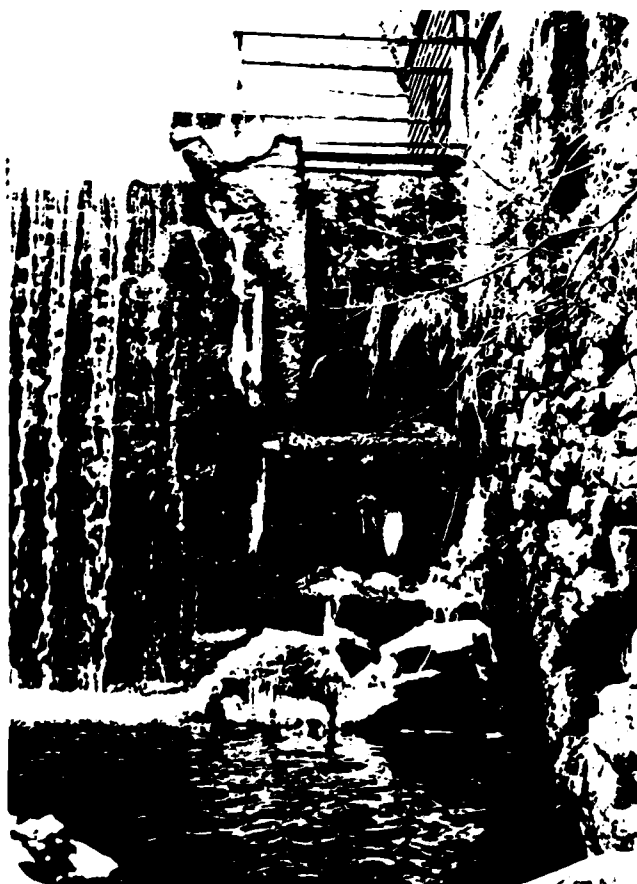
PHOTO NO. 8

DETERIORATED TRAINING WALL  
AND 30-INCH OUTLET AT  
LEFT END OF SPILLWAY

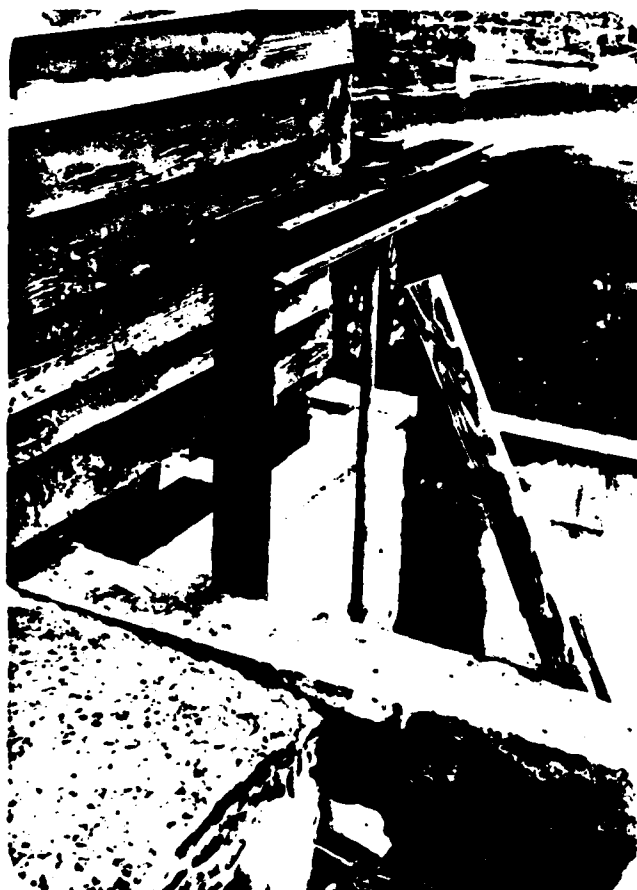
PHOTO NO. 10  
NEW 4'X4' SLUICE GATE AND  
CONCRETE SLUICWAY AT LEFT  
END OF DAM

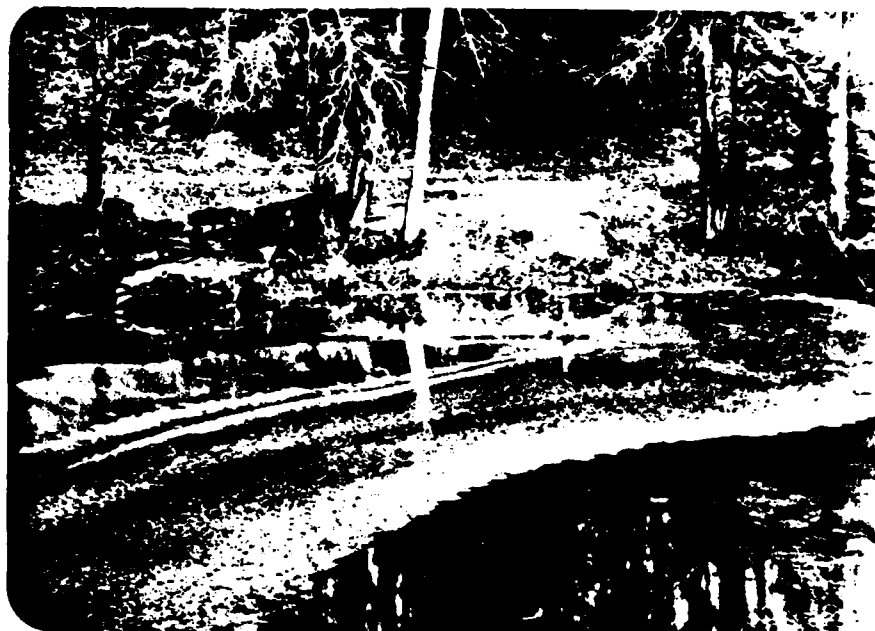
PHOTO NO. 11

RIGHT ABUTMENT. NOTE OPERATOR  
IN POND FOR STONE MASONRY SLUICEWAY
