ASPINOOK DAM

CT. 00539

PHASE I INSPECTION REPORT
NATIONAL DAM INSPECTION PROGRAM

NOVEMBER 1979

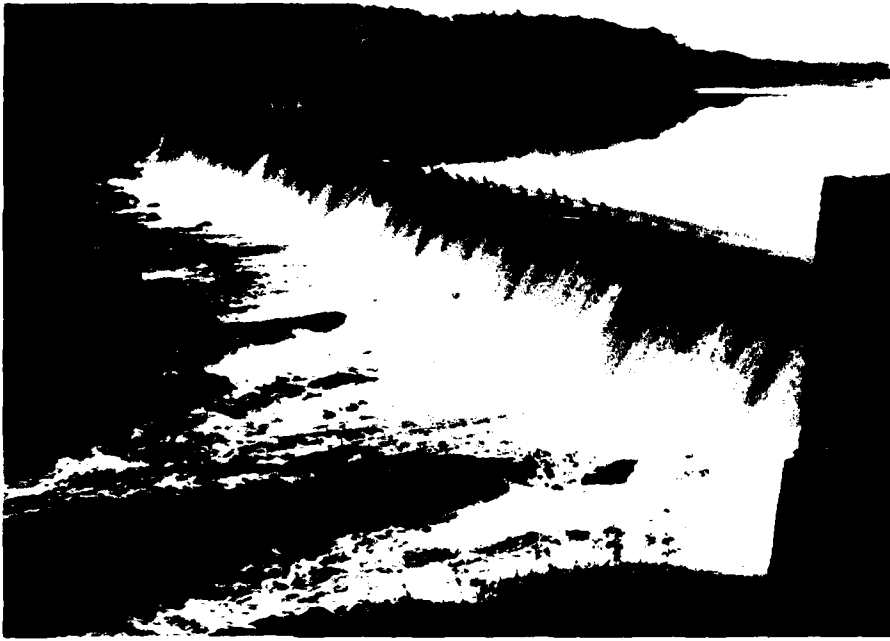
Overview from left abutment.

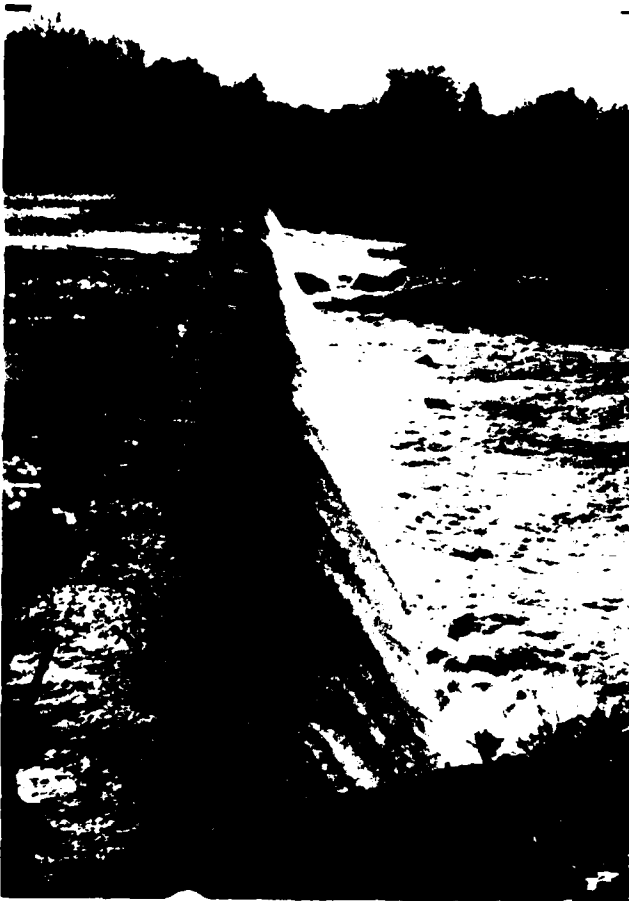
Overview from
right abutment.

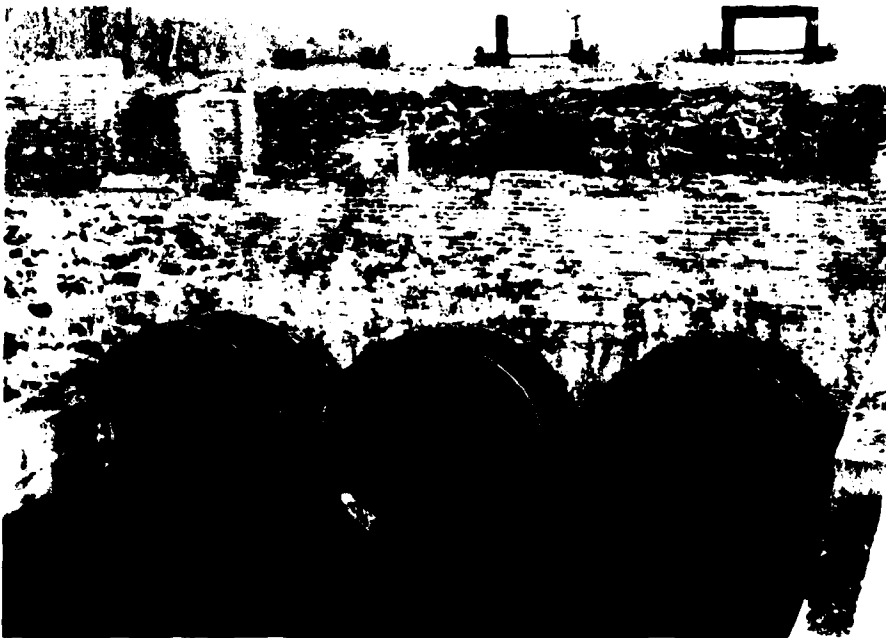
6. 3 abandoned penstocks cut off at downstream end of forebay.

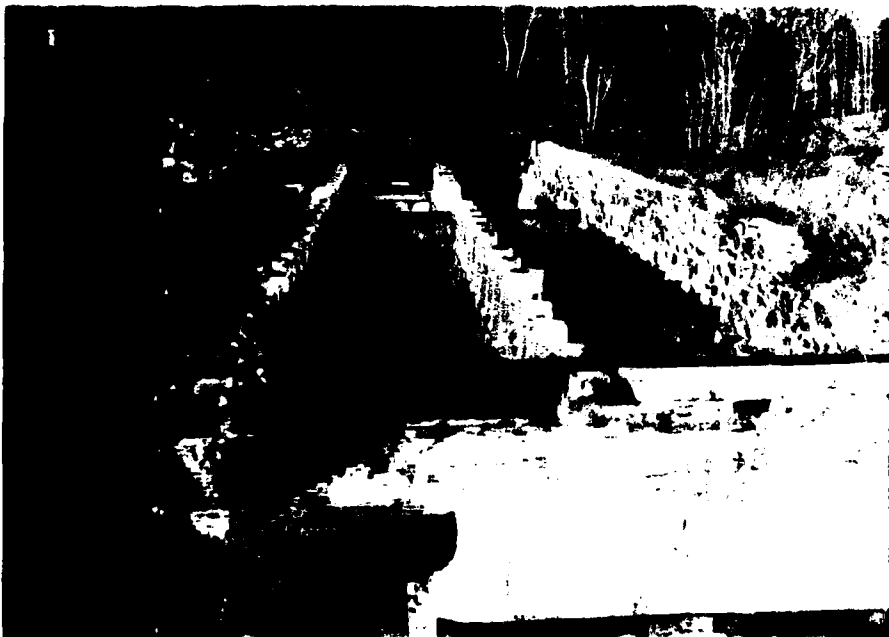
7. 36 in. dia. water pipe from forebay to plant (upper)
and 24 in. dia. pipe cut off (lower).
