QUINNIPIAC RIVER BASIN  
WALLINGFORD, CONNECTICUT

# SIMPSON POND DAM CT 00630

## PHASE I INSPECTION REPORT NATIONAL DAM INSPECTION PROGRAM

FEBRUARY, 1981

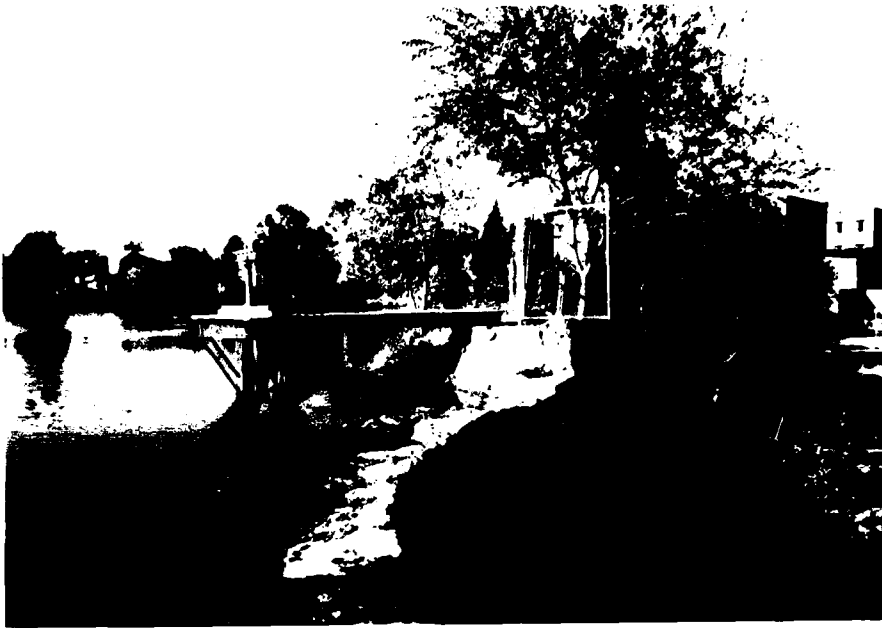
A service bridge extends about 20 feet from the south abutment to a low level discharge gate (Photo 3). The bridge, consisting of wooden boards on steel beams and columns, is in good condition. The gate is kept locked to inhibit vandalism. The gate is operable and controls a 27-inch metal low-level discharge pipe that passes through the base of the dam (Photo 6).

PHOTO 3  
SPILLWAY - SOUTH ABUTMENT - CONTROL GATE
