**CONNECTICUT COASTAL BASIN  
STONINGTON, CONNECTICUT**

**MYSTIC RESERVOIR-SOUTH DAM  
CT. 00613**

**PHASE I INSPECTION REPORT  
NATIONAL DAM INSPECTION PROGRAM**

**FEBRUARY 1981**

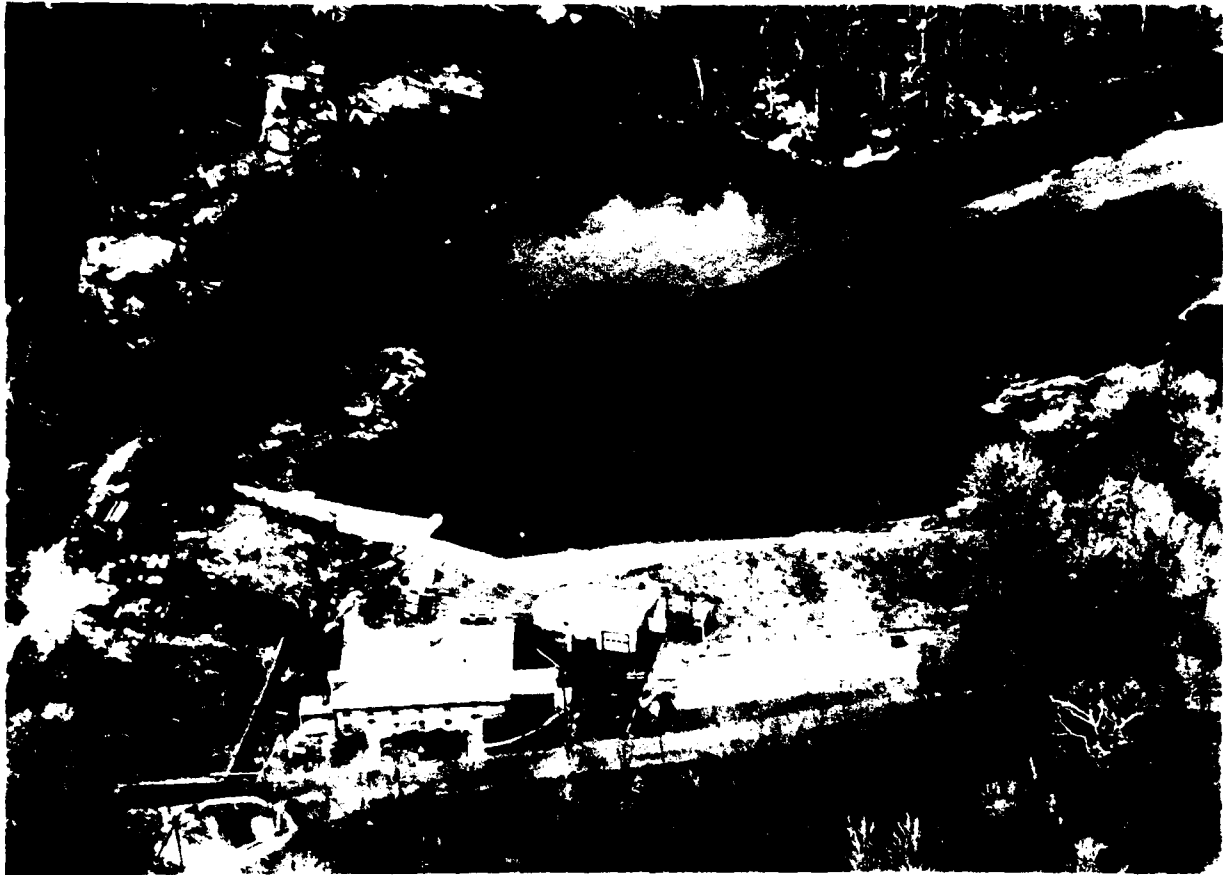
December 12, 1980

OVERVIEW PHOTO - Mystic Reservoir South Dam

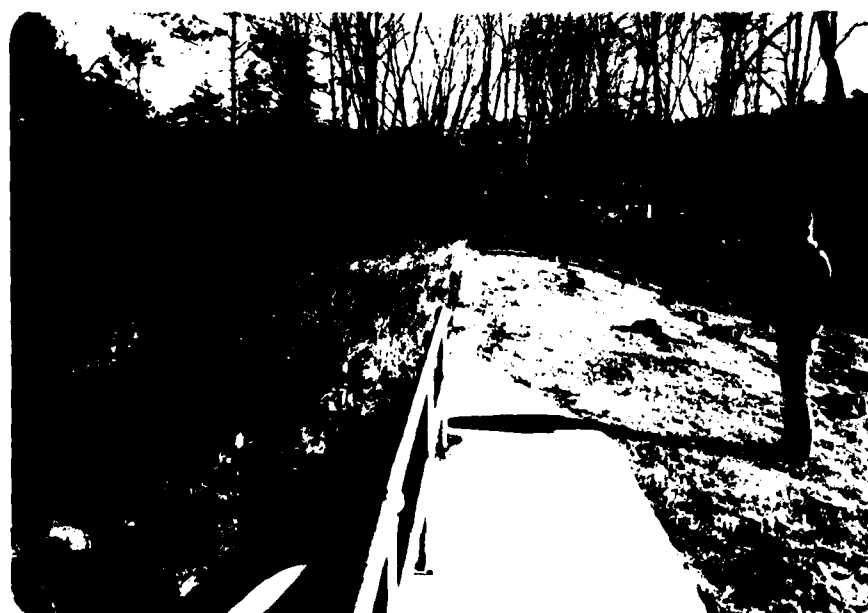
2. Crest. The crest of the dam is shown on Photos C-1, C-2, and C-3. The crest of the earth embankment section is 7 feet wide with the concrete core wall extending to the surface. The crest of the concrete gravity section has transverse hairline cracks spaced regularly 10-15 feet apart and at all construction key joints. Larger transverse cracks 1/32 to 1/16 inch were observed at Stations 2+50 and 2+95 (Photo C-9). Some spalling of a thin slush coat of concrete was observed on the crest

PHOTO C-2: Left abutment and dam crest.

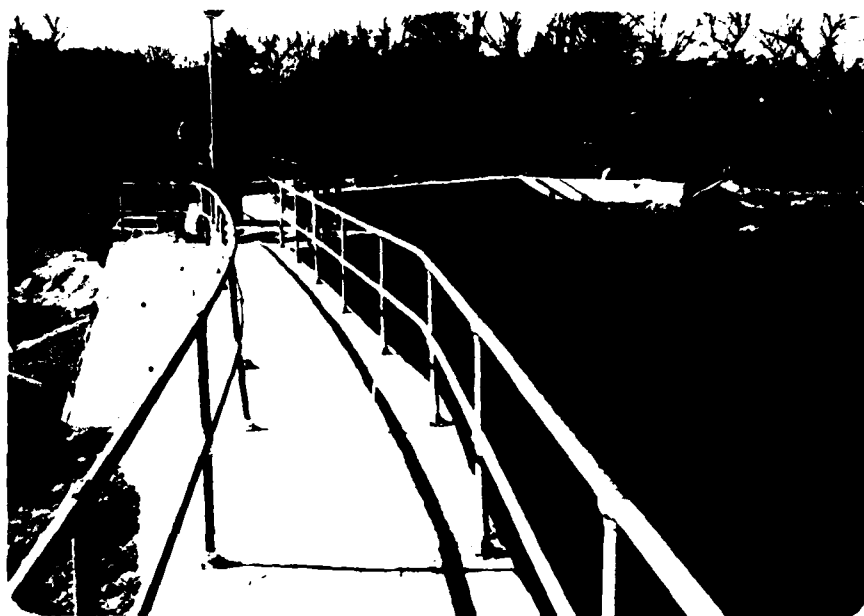
1. Upstream Face. The upstream face of the earth embankment section has 10-20 pound stone riprap protection to within 3 feet of the crest (Photo C-4). Small trees and brush cover the upstream slope from the riprap to the crest of the dam. The upstream face of the gravity section of the dam is vertical and spalling of the concrete in several places in vicinity of the normal pool level was observed (Photo C-3).

PHOTO C-3: Upstream face, crest and intake structure looking towards right abutment.

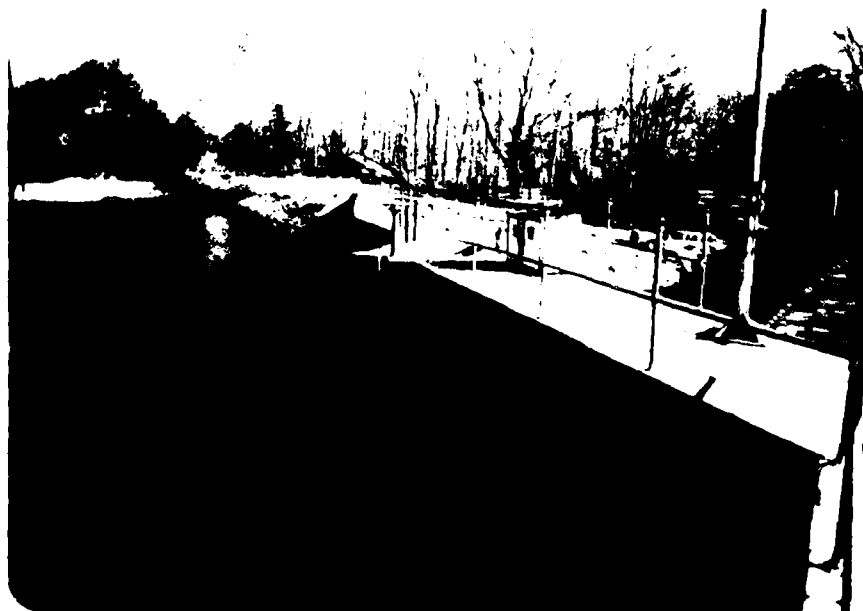
PHOTO C-4: Upstream face and left abutment.

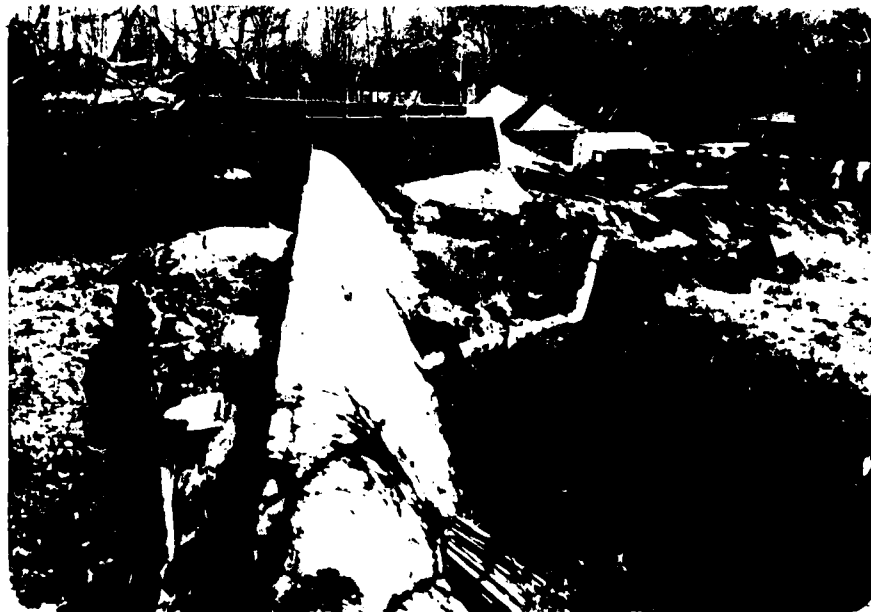
PHOTO C-8: Spillway crest from the right abutment showing constriction of spillway discharge channel by natural ground.

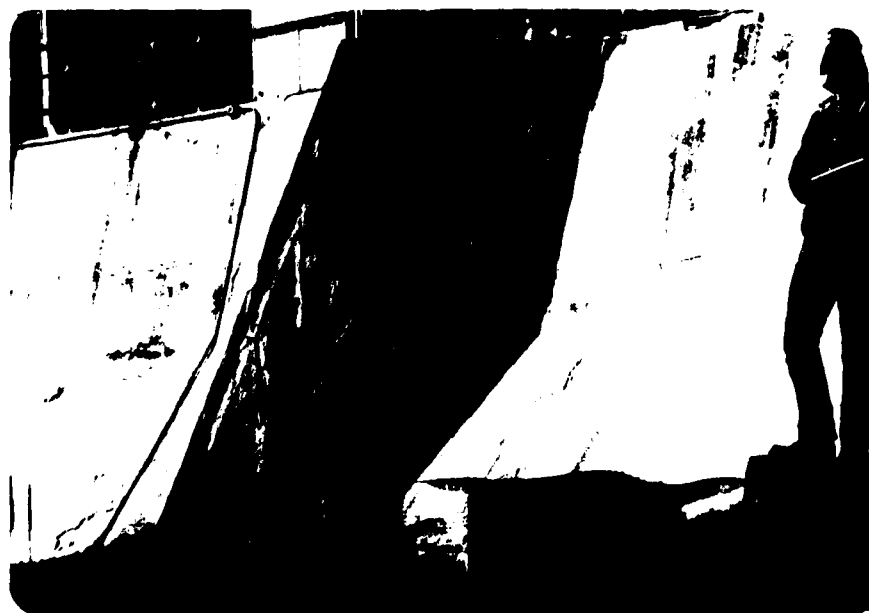
PHOTO C-10: Downstream face of gravity section. Note cracking and efflorescence of concrete.

- d. Investigate and recommend methods to repair cracking and spalling of the concrete along the crest and at the downstream toe of the spillway, at the left spillway abutment on the downstream face of the gravity section of the dam, and at the intake/outlet structure. Investigate and recommend methods to control seepage through and beneath the spillway.
- e. Evaluate the need for increasing the capacity of the spillway discharge channel.
- f. Design and supervise the placement of riprap on the upstream face of the embankment between the normal pool elevation and the crest.
- g. Replace the trash rack.

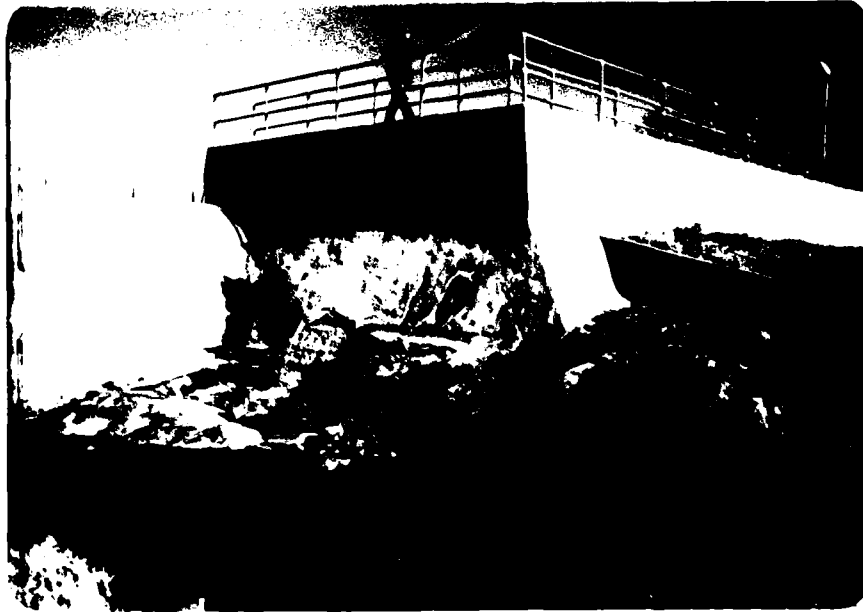
PHOTO C-11: Downstream face of gravity section at the left spillway abutment. Note the seepage and cracking and spalling of concrete near the left spillway abutment.

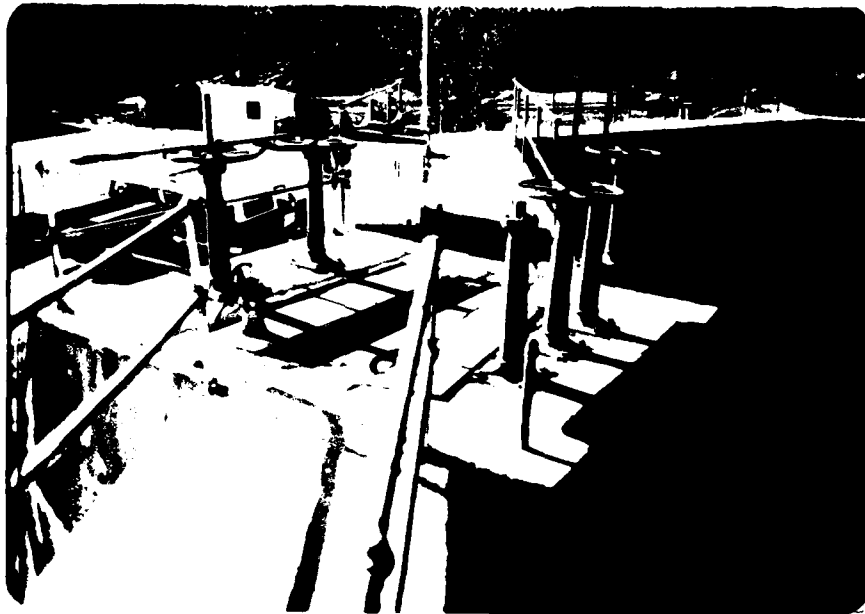
PHOTO C-14: Intake structure and gate mechanisms near the centerline of the dam.
