LYME, CONNECTICUT

MOULSONS POND DAM

CT 00420

PHASE I INSPECTION REPORT

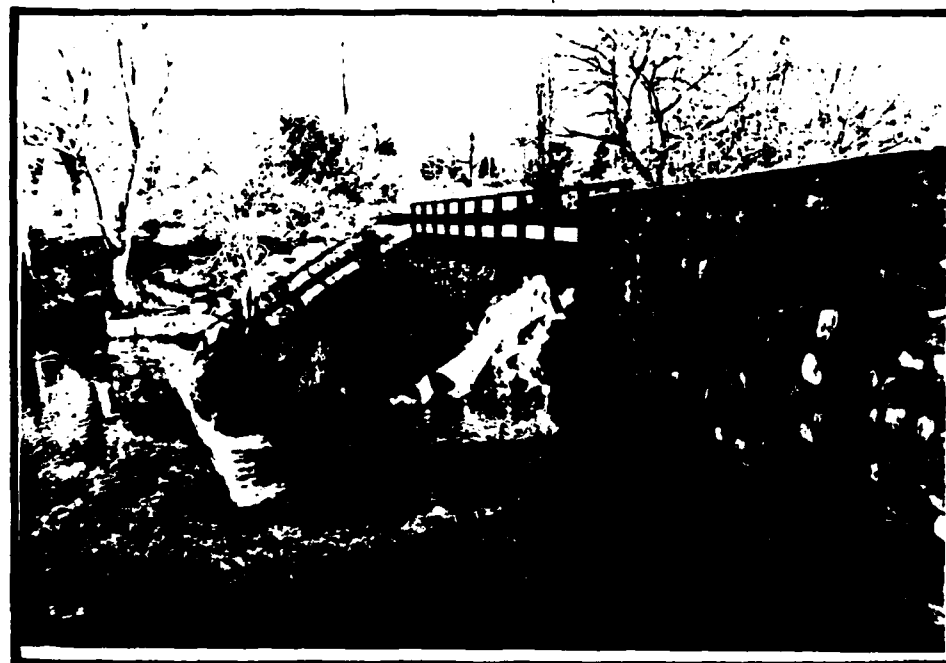
SPILLWAY - DOWNSTREAM BRIDGE
