REPORT DOCUMENTATION PAGE		READ INSTRUCTIONS BEFORE COMPLETING FORM
1. REPORT NUMBER CT 00484	2. GOVT ACCESSION NO.	3. RECIPIENT'S CATALOG NUMBER
4. TITLE (and Subtitle) West Side Dam NATIONAL PROGRAM FOR INSPECTION OF NON-FEDERAL DAMS		5. TYPE OF REPORT & PERIOD COVERED INSPECTION REPORT

Inclosed is a copy of the West Side Dam (CT-00484) Phase I Inspection Report, prepared under the National Program for Inspection of Non-Federal Dams. This report is based upon a visual inspection, a review of the past performance and a brief hydrological study of the dam. I approve the report and support the findings and recommendations described in Section 7 and ask that you keep me informed of the actions taken to implement them. This follow-up action is vitally important.

WEST SIDE DAM
BLACKBERRY RIVER
NORFOLK, CONNECTICUT
CT 00484
17 NOVEMBER '80

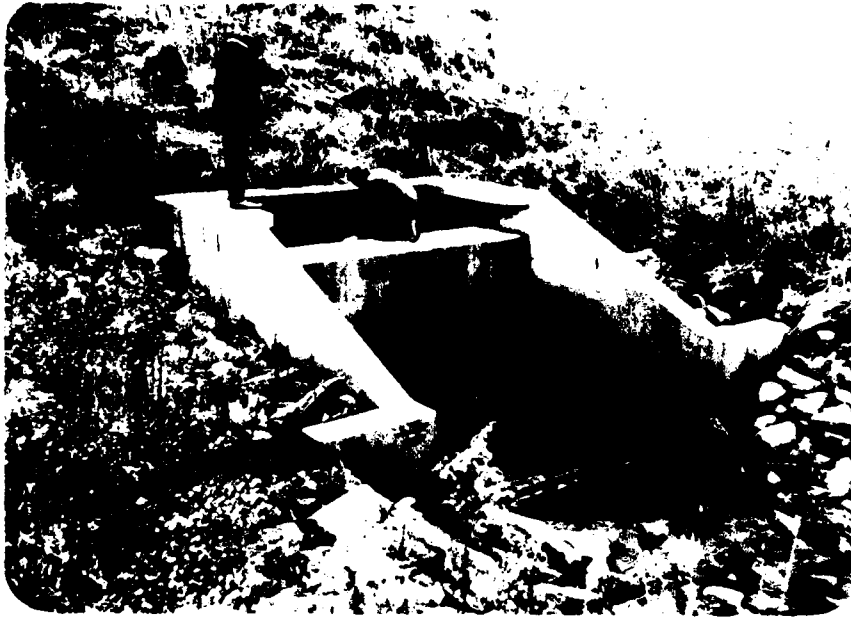
PHOTO NO. 7

ENERGY DISSIPATOR. NOTE TOE DRAIN DISCHARGE,
ROCKS IN THE DISSIPATOR AND UNMOWED GRASS ON EMBANKMENT.
