**CONNECTICUT RIVER BASIN  
WEST HARTFORD, CONNECTICUT**

**BURNT HILL RESERVOIR DAM  
CT 00488**

**PHASE 1 INSPECTION REPORT  
NATIONAL DAM INSPECTION PROGRAM**

**DEPARTMENT OF THE ARMY  
NEW ENGLAND DIVISION, CORPS OF ENGINEERS  
WALTHAM, MASS  
MAY, 1981**

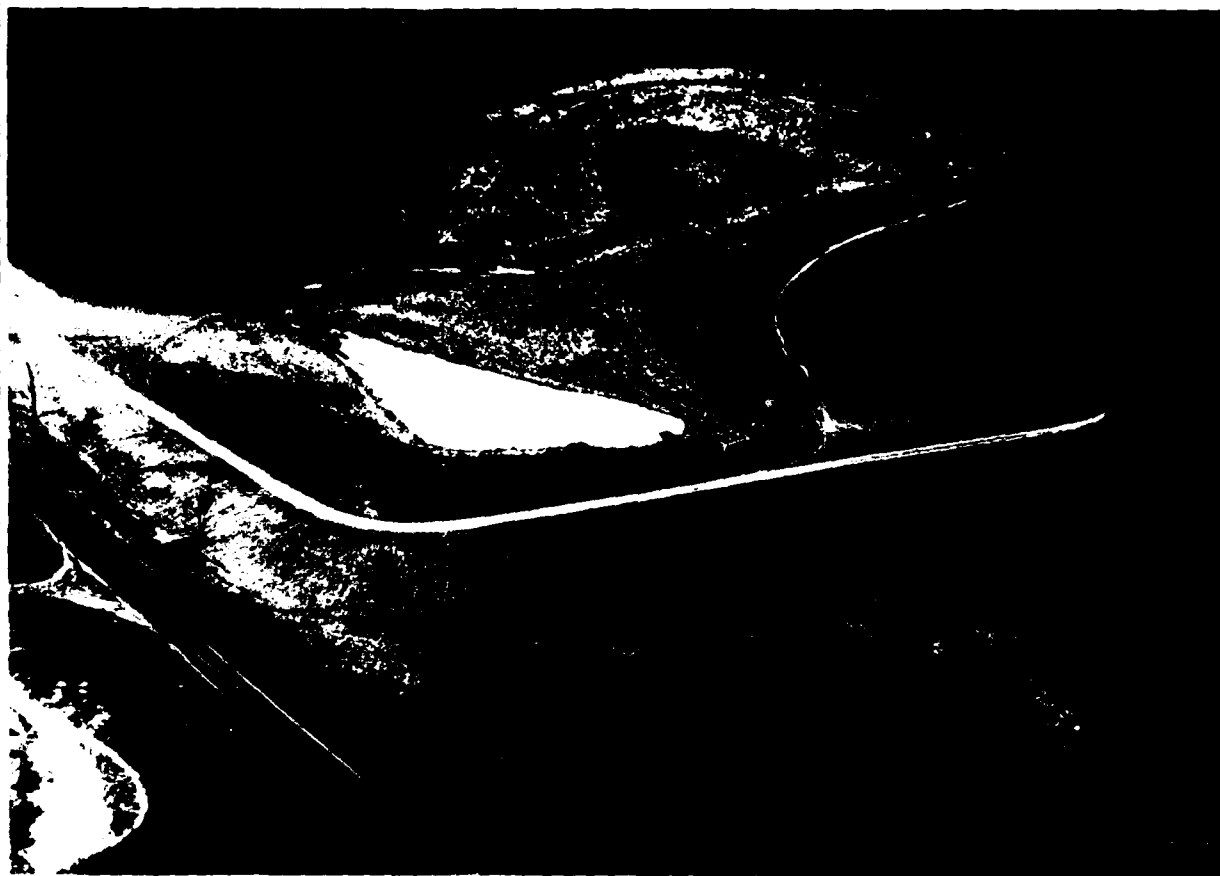
OVERVIEW PHOTO - BURNT HILL RESERVOIR DAM

There is no permanent reservoir except for a small sediment pool (Photo C-6). The immediate reservoir area is grassed with woodland beyond (Overview Photo). No unusual geologic features were noted that could be expected to adversely affect the dam or its appurtenant structures.
