THAMES RIVER BASIN  
STAFFORD, CONNECTICUT

ELLITHORPE DAM  
CT 00481

**PHASE I INSPECTION REPORT**  
**NATIONAL DAM INSPECTION REPORT**

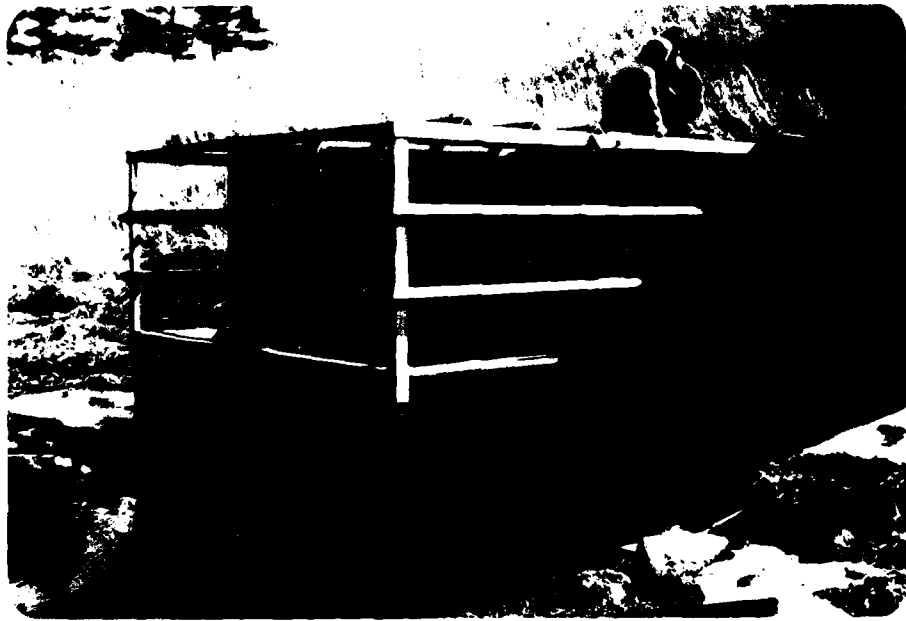
1. Principal Spillway - Photo No. C-5 shows the inlet to the principal spillway. The inlet is a reinforced concrete riser with splitter wall and hooded inlet. An 8-foot by 1-foot slot opening is set at the elevation of the approach channel to carry low flows. Condition of the concrete and appurtenances is good.

C-5 INLET STRUCTURE

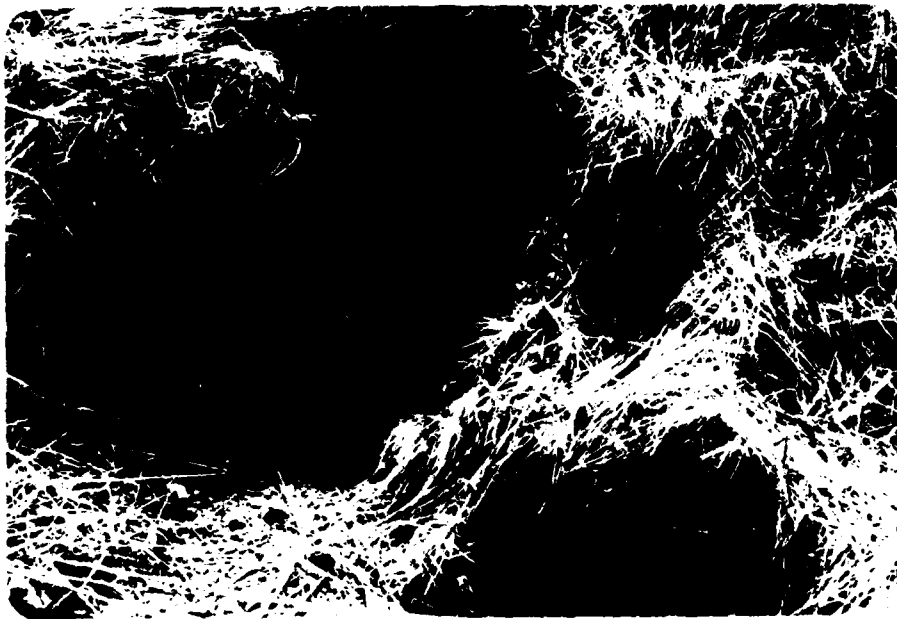
1. Upstream Face - The upstream face is grass covered with a very dense mat on most of the surface. There are no trees growing on this slope which is shown in Photo No. C-3. There are numerous rodent burrows in the upstream face. The burrows are about 8 inches in diameter and are located mainly from just east of the principal spillway to about 200 feet east of the spillway. Six burrows were found, but more may be evident during seasons when the animals are more active. Also, there are two recreational vehicles trails causing minor erosion on the slope. A typical rodent burrow is shown in Photo No. C-7.

C-7 RODENT BURROW

1. Repair erosion caused by recreational vehicles running on the slopes.
2. Exterminate rodents invading the upstream face of the embankment and fill the burrows with suitable compacted material.
3. Emergency procedures consisting of an operation plan and warning system for downstream residents should be developed and implemented.
4. Maintain a record of maximum water levels during flood events for future evaluation studies.
5. During flood events, check dam for evidence of seepage.
6. Institute a biennial inspection of the dam by technical personnel.
