THAMES RIVER BASIN  
STAFFORD, CONNECTICUT

POMEROY DAM  
CT 00479

**PHASE I INSPECTION REPORT**  
**NATIONAL DAM INSPECTION REPORT**

DEPARTMENT OF THE ARMY  
NEW ENGLAND DIVISION, CORPS OF ENGINEERS  
WALTHAM, MASS. 02154

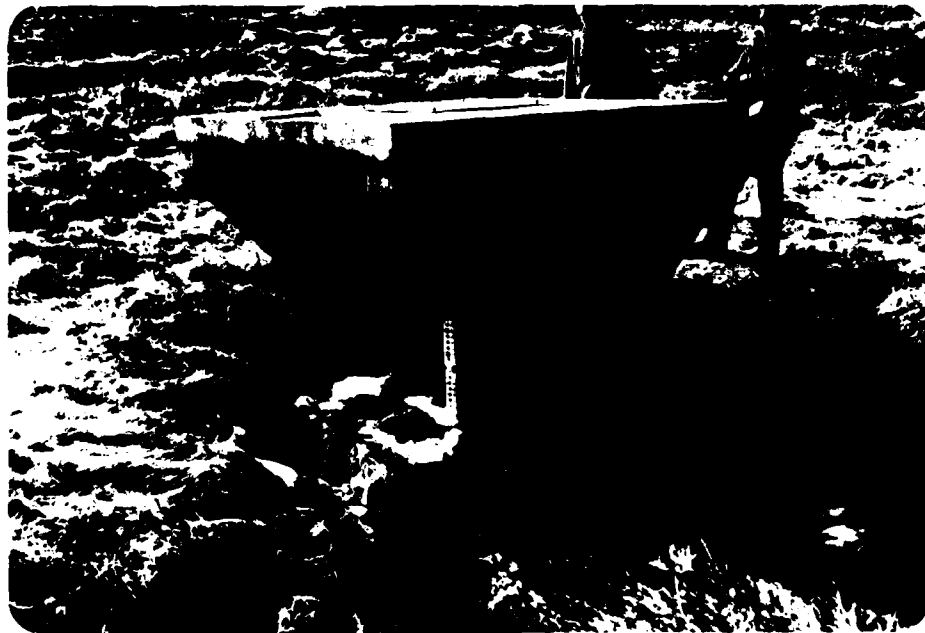
C-4 PRINCIPAL SPILLWAY INLET STRUCTURE

1. Principal Spillway - The inlet to the principal spillway is shown in Photo No. C-4. Although the plans show an 18-inch slide gate at invert of the approach channel, only the frame is presently attached as shown in Photo No. C-4. The concrete and appurtenances appear in good condition.

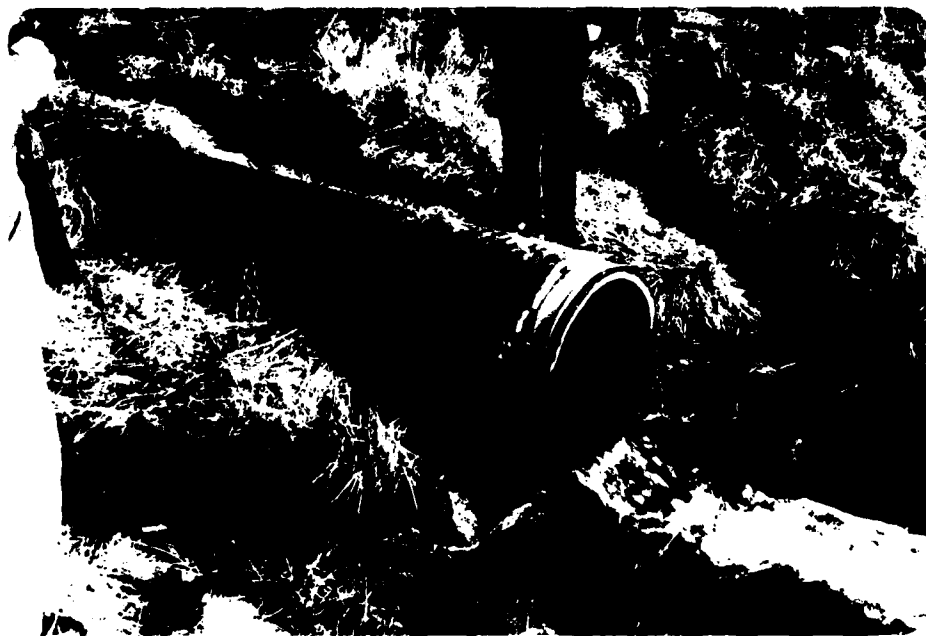
C-6 PRINCIPAL SPILLWAY OUTLET

There is a 24 inch concrete water pipe from the riser through the embankment to the outlet. The portion of the pipe that is visible is in good condition and is shown in Photo No. C-6. There is no evidence of channel erosion at the outlet. The last pipe at the outlet is 16 feet in length and is supported
