**WYASSUP LAKE DAM  
CT. 00570**

**PHASE 1 INSPECTION REPORT  
NATIONAL DAM INSPECTION PROGRAM**

**DEPARTMENT OF THE ARMY  
NEW ENGLAND DIVISION, CORPS OF ENGINEERS  
WALTHAM, MASS.**

**AUGUST, 1980**

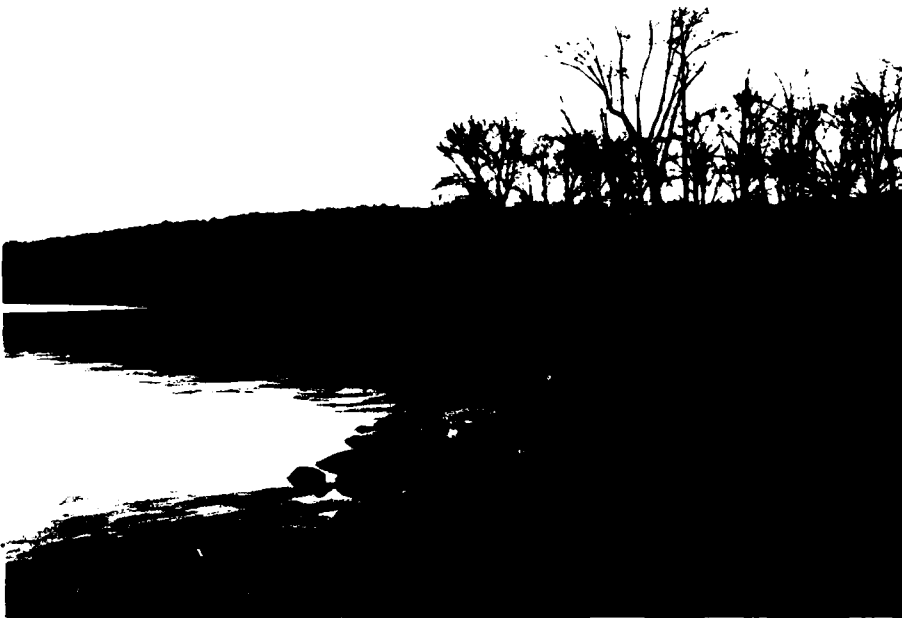
The upstream slope of the right embankment had riprap slope protection extending to within 2 to 3 feet of the crest (Photos C-1 and 2). Small brush was observed to be growing between the riprap. The water level at the time of inspection was about 1 foot below the top of the riprap. The left and right abutments had no riprap protection, and extensive erosion by wave action was observed to have cut significantly into the slope (Photo C-15). The upstream slope above the riprap was grass covered and very uneven with considerable sloughing near the crest (Photo C-2).

PHOTO C-2 Crest and upstream face of dam looking toward left abutment,

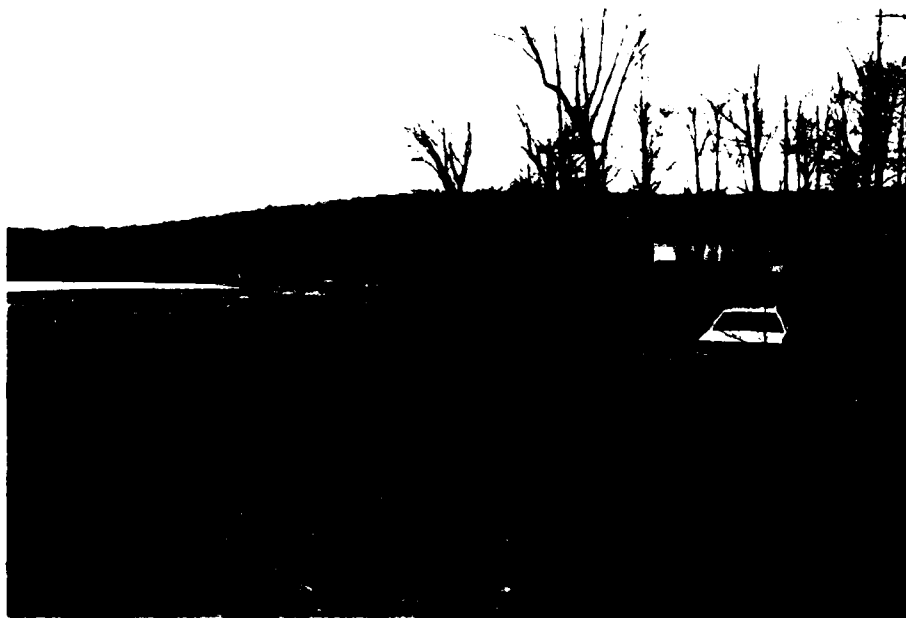
The downstream slope of the right abutment is grass covered and has a slope of 1V on 2H (Photo C-4). A 10-inch diameter tree stump is located at the toe of the right embankment approximately 15 feet from the right abutment (Photo 9). A wet area surrounding a smaller area of brush was observed on the downstream slope and toe at the right abutment contact (Photo C-17).

PHOTO C-4 Downstream slope looking from right abutment.

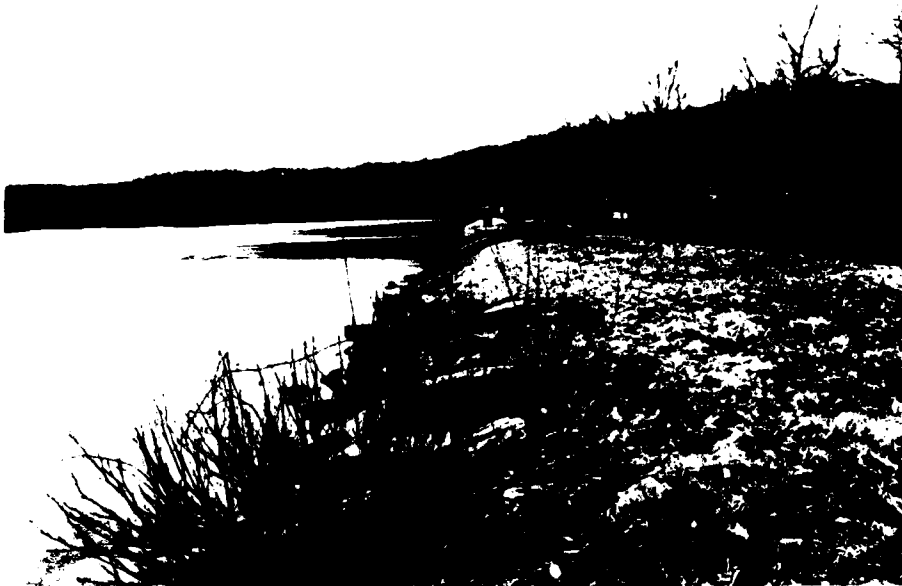
The upstream slope of the left embankment has riprap slope protection extending to within 2 ft of the crest of the embankment (Photos C-5 and 6). Small brush was observed to be growing between the riprap (Photo C-6). The upstream slope at the right abutment contact had no slope protection and was eroded by wave action. Note that the stone wall in Photo C-1 corresponds to the natural ground that separates the two sections of the dam. The water level at the time of inspection was 2.74 feet below the elevation of the crest. The upstream slope above the riprap was grass covered and irregular. (Photos C-1, 2, 5, 6, 15 and 16).

PHOTO C-6 Upstream slope of dam,

1. Perform detailed hydrologic and hydraulic studies to further assess the need for and means to increase the project discharge capacity.
2. Extend riprap to protect the abutments of the left and right embankments and redress the stone along the upstream slope.
3. Cut brush growing on the upstream slopes of the left and right embankments and at the downstream toe of the left embankment.
4. Periodically monitor the wet areas, observed during the Phase I inspection, that occur at the downstream toe of the left and right embankments.

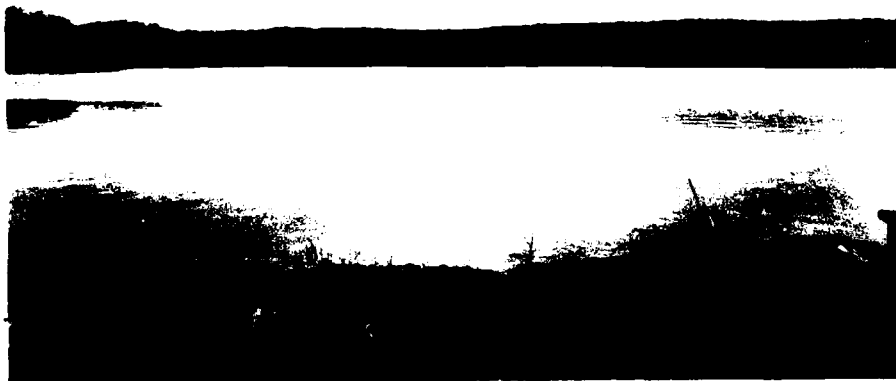
- d. Reservoir Area. The shoreline area of Wyassup Lake is flat to moderately sloped with vegetation and trees covering the banks. Floating debris could obstruct the overflow spillway, or more easily the downstream channel, causing localized flooding. No evidence of shoreline sloughing or severe bank erosion was observed. (See Photo C-14).

PHOTO C-14 Wyassup Lake.
