HOUSATONIC RIVER BASIN
SHARON, CONNECTICUT

HATCH POND DAM
CT 00603

PHASE I INSPECTION REPORT
NATIONAL DAM INSPECTION PROGRAM

SEPTEMBER 1980

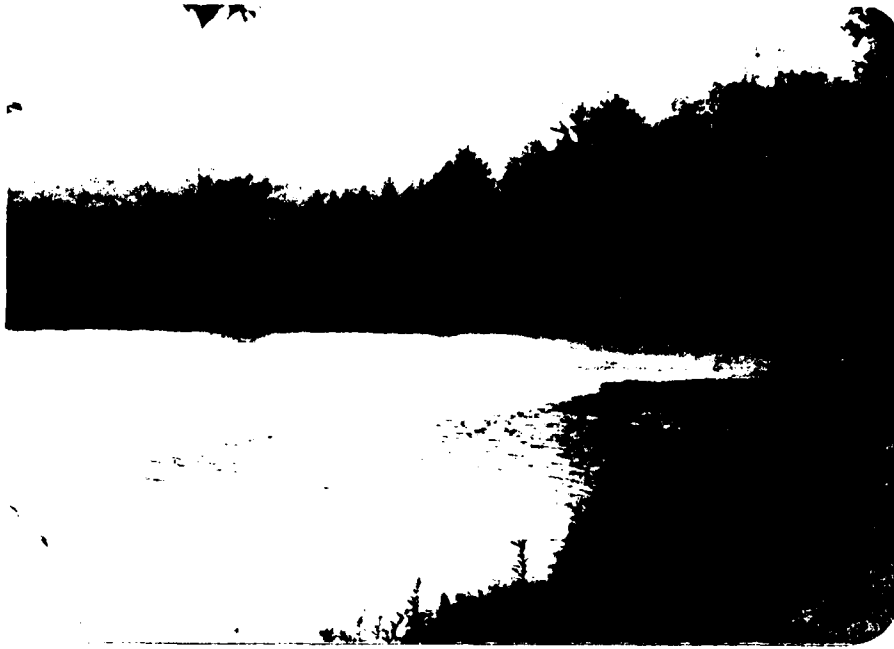
PHOTO NO. 1

The upstream slope of the dam is protected by riprap from below the water level to about 1 foot below the crest. The riprap appears to be in good condition but is heavily overgrown with weeds and brush, Photo 2. Several trees up to 3 inches in diameter are growing on the upstream slope near the center and right end of the dam, Photo 1.

VIEW OF DAM FROM RIGHT SIDE OF POND.
 NOTE SERVICE BRIDGE OVER SPILLWAY AT
 RIGHT AND VEGETATION ON UPSTREAM SLOPE AND CREST.

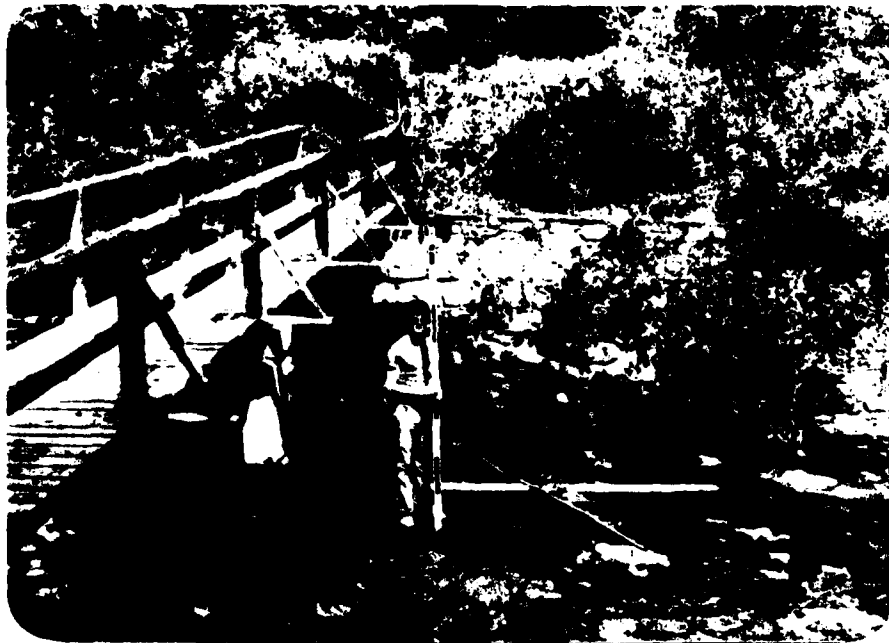
PHOTO NO. 6

The spillway located at the right end of the dam consists of a concrete overflow section with a mortared cut stone cap, Photo 6. The spillway appears to be in good condition. There is a slight amount of leakage under the cap stones. At the left end of the spillway there is an inclined flume approximately 2 feet wide and slightly lower in elevation than the remaining spillway crest, Photo 6. The upstream stone masonry training walls are overgrown with brush and vines and appear to be in good condition.

The service bridge over the spillway consists of a wooden footbridge supported by steel rails and a center stone pier, Photo 6. The bridge appears to be in good condition with the exception of a broken railing and possible tilting of the center pier.

SPILLWAY FROM
RIGHT ABUTMENT.
NOTE FLUME AT LEFT
END OF SPILLWAY
AND SERVICE BRIDGE.

8. Repair footbridge railing and center pier.

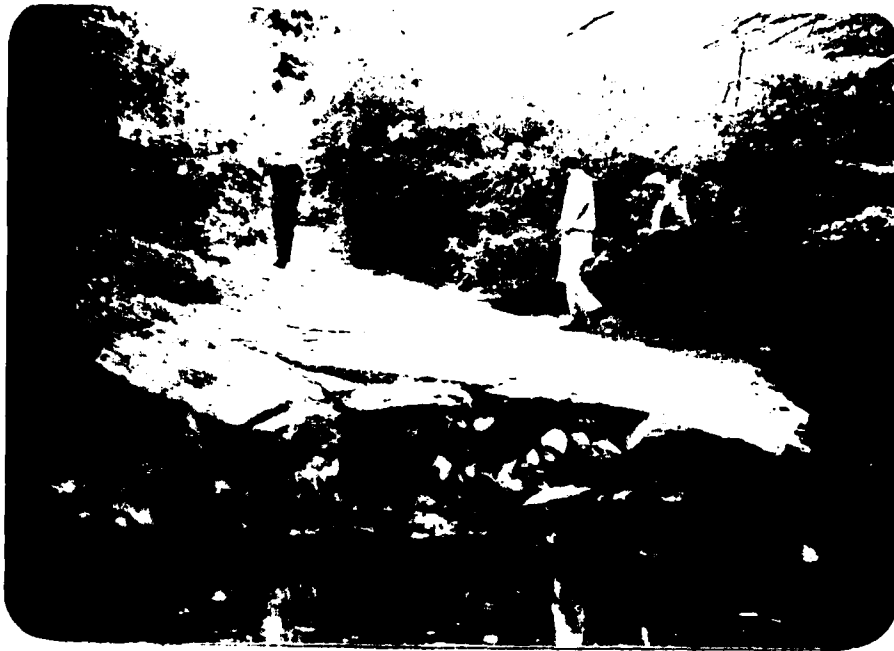
a wood sheet pile cutoff below the bottom of the channel, Photo 8. The end of the channel has been undermined and is badly broken, Photo 9.

PHOTO NO. 9
 UNDERMINING AND
 DETERIORATION AT
 END OF SPILLWAY
 DISCHARGE CHANNEL.

5. Investigate and recommend procedures to prevent further undermining of the lower end of the spillway discharge channel.
