ASHFORD, CONNECTICUT  
**ASHFORD LAKE DAM**  
**CT 00462**

PHASE I INSPECTION REPORT  
NATIONAL DAM INSPECTION PROGRAM

AUGUST 1980

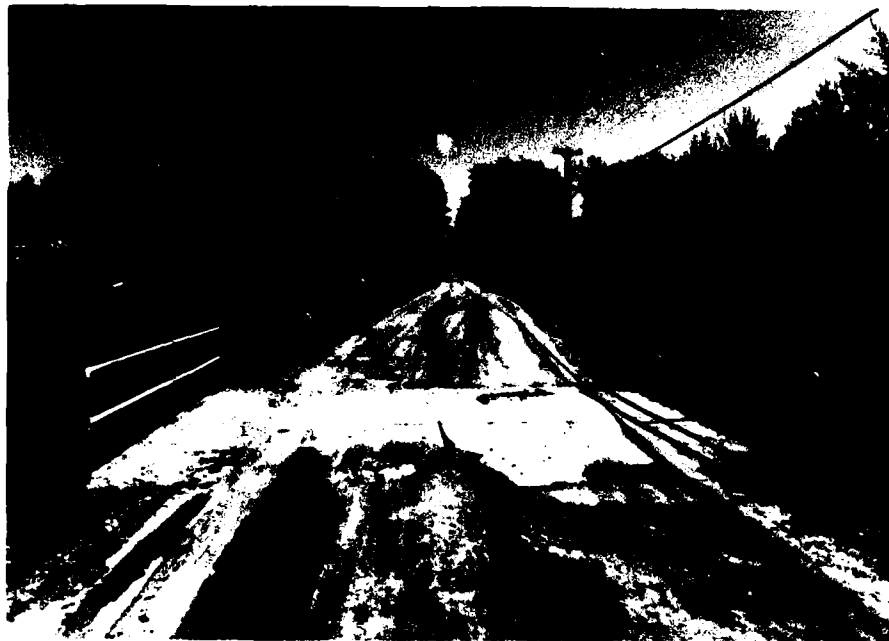
Crest - The top of the dam showed no signs of misalignment or visible cracking. However, there is an unpaved, two lane road which extends the length of the dam. This road had a number of pot holes and ruts (Photo 2).

Photo 2 - Unpaved road and potholes on top of dam taken from right abutment (March 1980).

5. The road on the top of the dam should be regraded and proper protection placed.
6. The spalled concrete of the valve chamber should be repaired.
7. All obstacles, debris, or overhanging trees and brush on the spillway crest, and the floor of the spillway approach, discharge and low-level outlet channels should be removed. The damaged earth dikes along the spillway discharge channel should be restored to prevent spillway discharge along the toe of the dam.

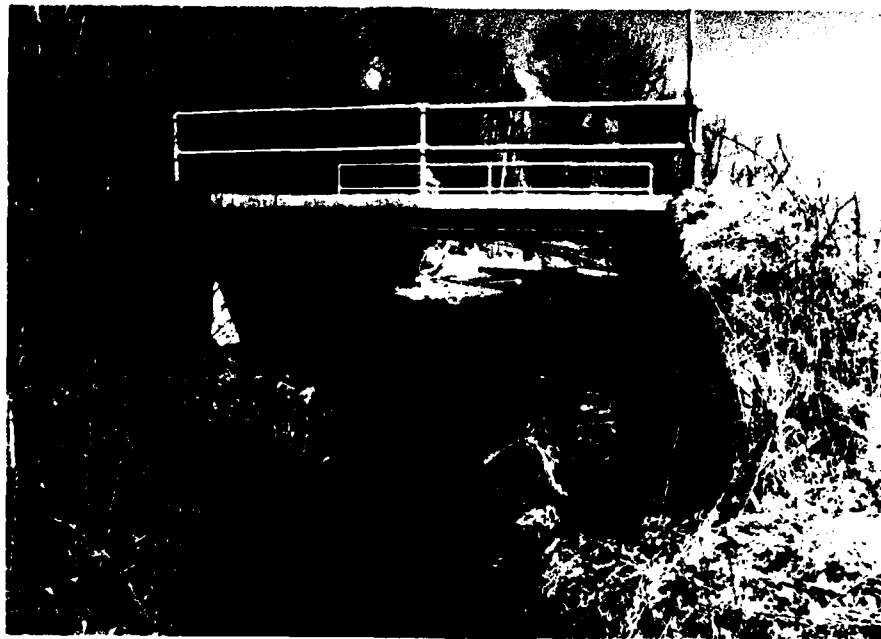
Photo 4 - Spillway channel taken from downstream  
(March 1980).
