THAMES RIVER BASIN  
PLAINFIELD, CONNECTICUT  
**PACKERS POND DAM**  
**CT 00578**

PHASE I INSPECTION REPORT  
NATIONAL DAM INSPECTION PROGRAM

DECEMBER 1980

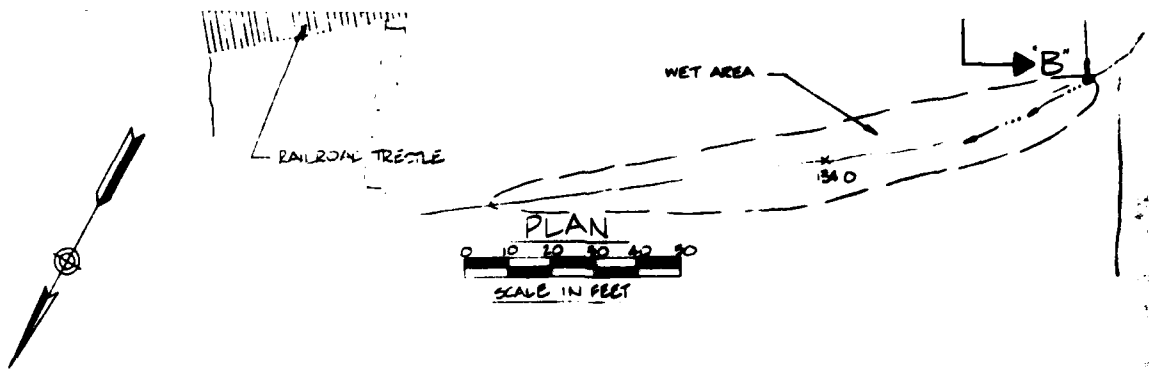
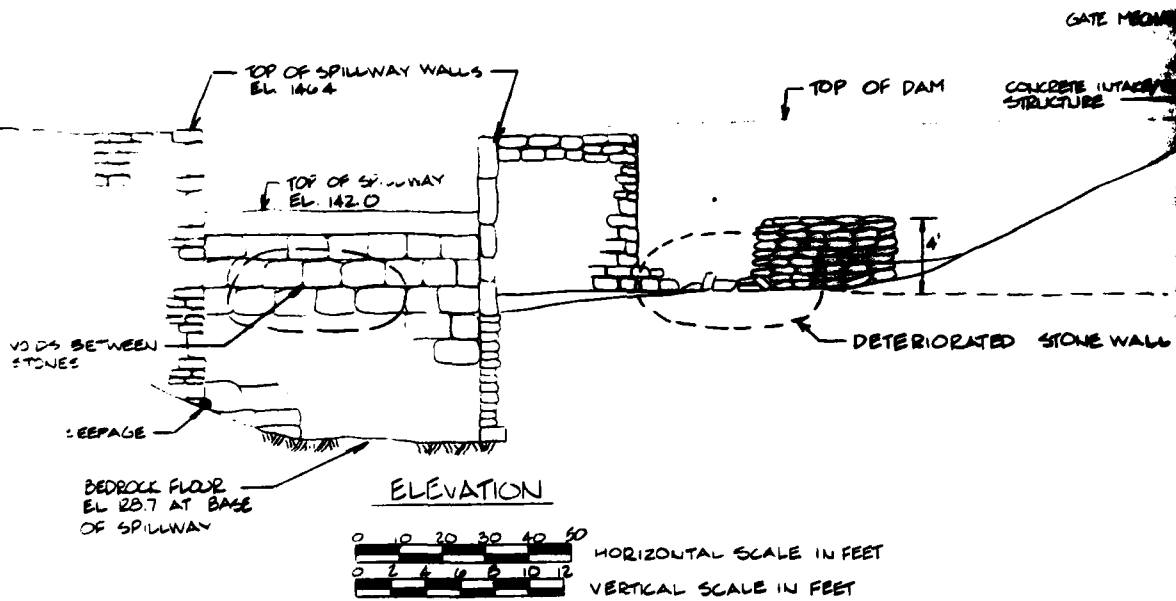
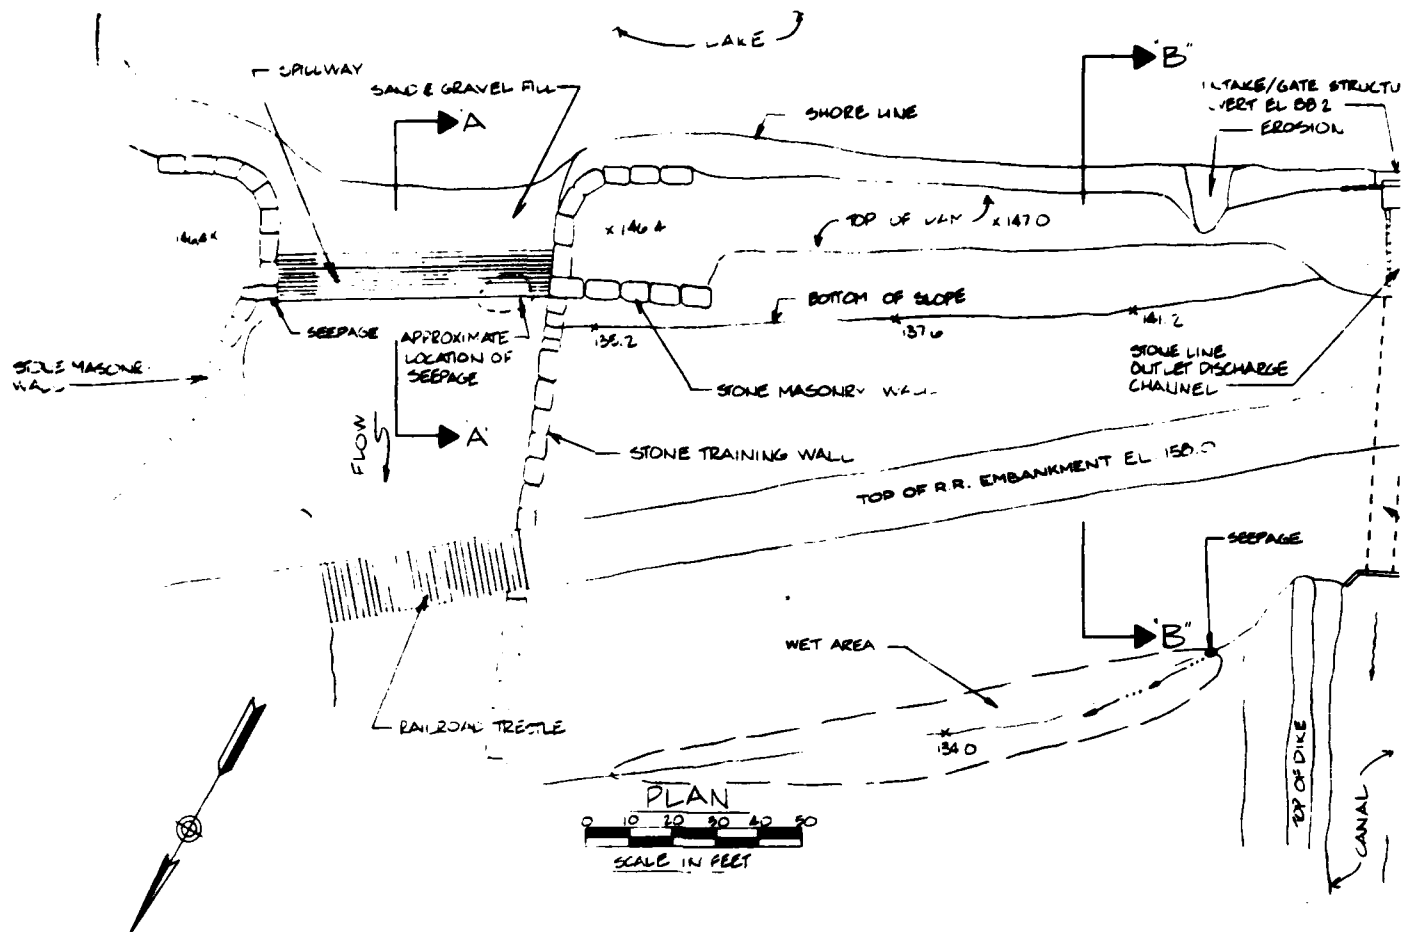
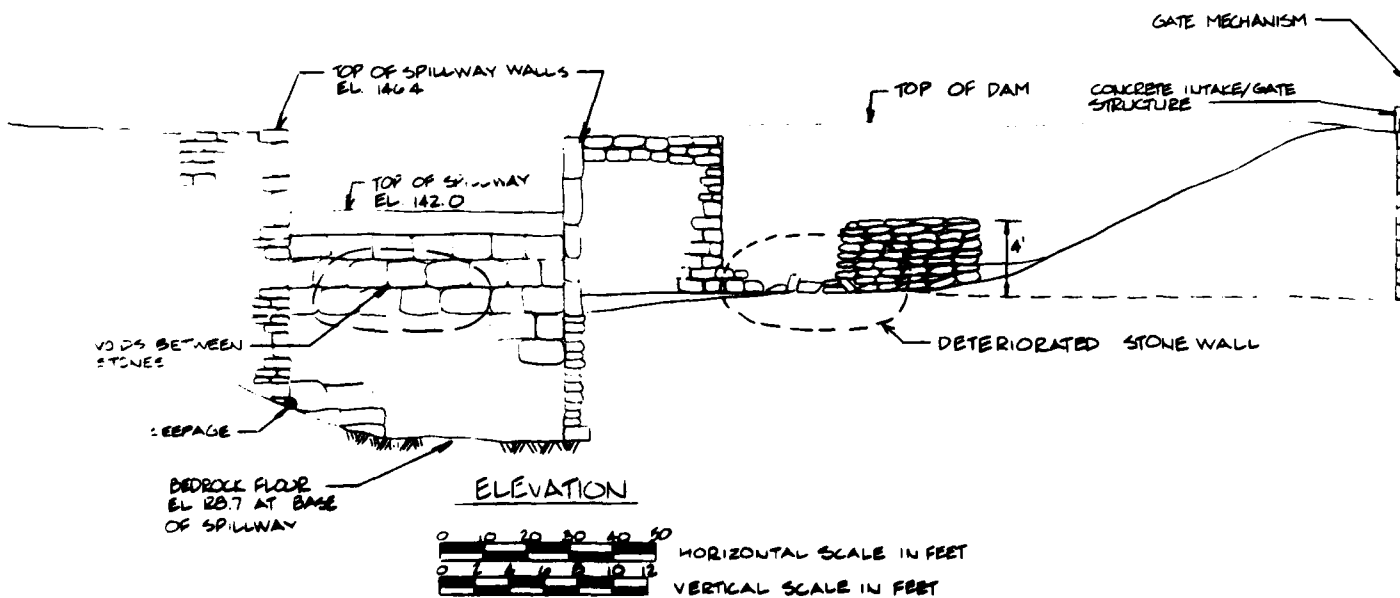
| R.F. | TH | TH | DATE DEC 1980 SHEET B-1 |

seepage of less than 1 gpm was noted at the base of the spillway near the right spillway wall (See Sheet B-1). Some reddish-brown staining was observed in the area around this seep. Although the spillway had no flow over the crest, a flow of 10-15 gpm was noted in the spillway discharge channel. The stone masonry walls at either end of the spillway and along the left side of the spillway discharge channel appear to be in fair condition. The stone work is in good condition, however there is some undermining at the base of the right wall about 15 feet downstream from the base of the spillway and visible at the far left side of Photo 7. The spillway discharge channel is free of debris except for a tree at the right side of the channel.

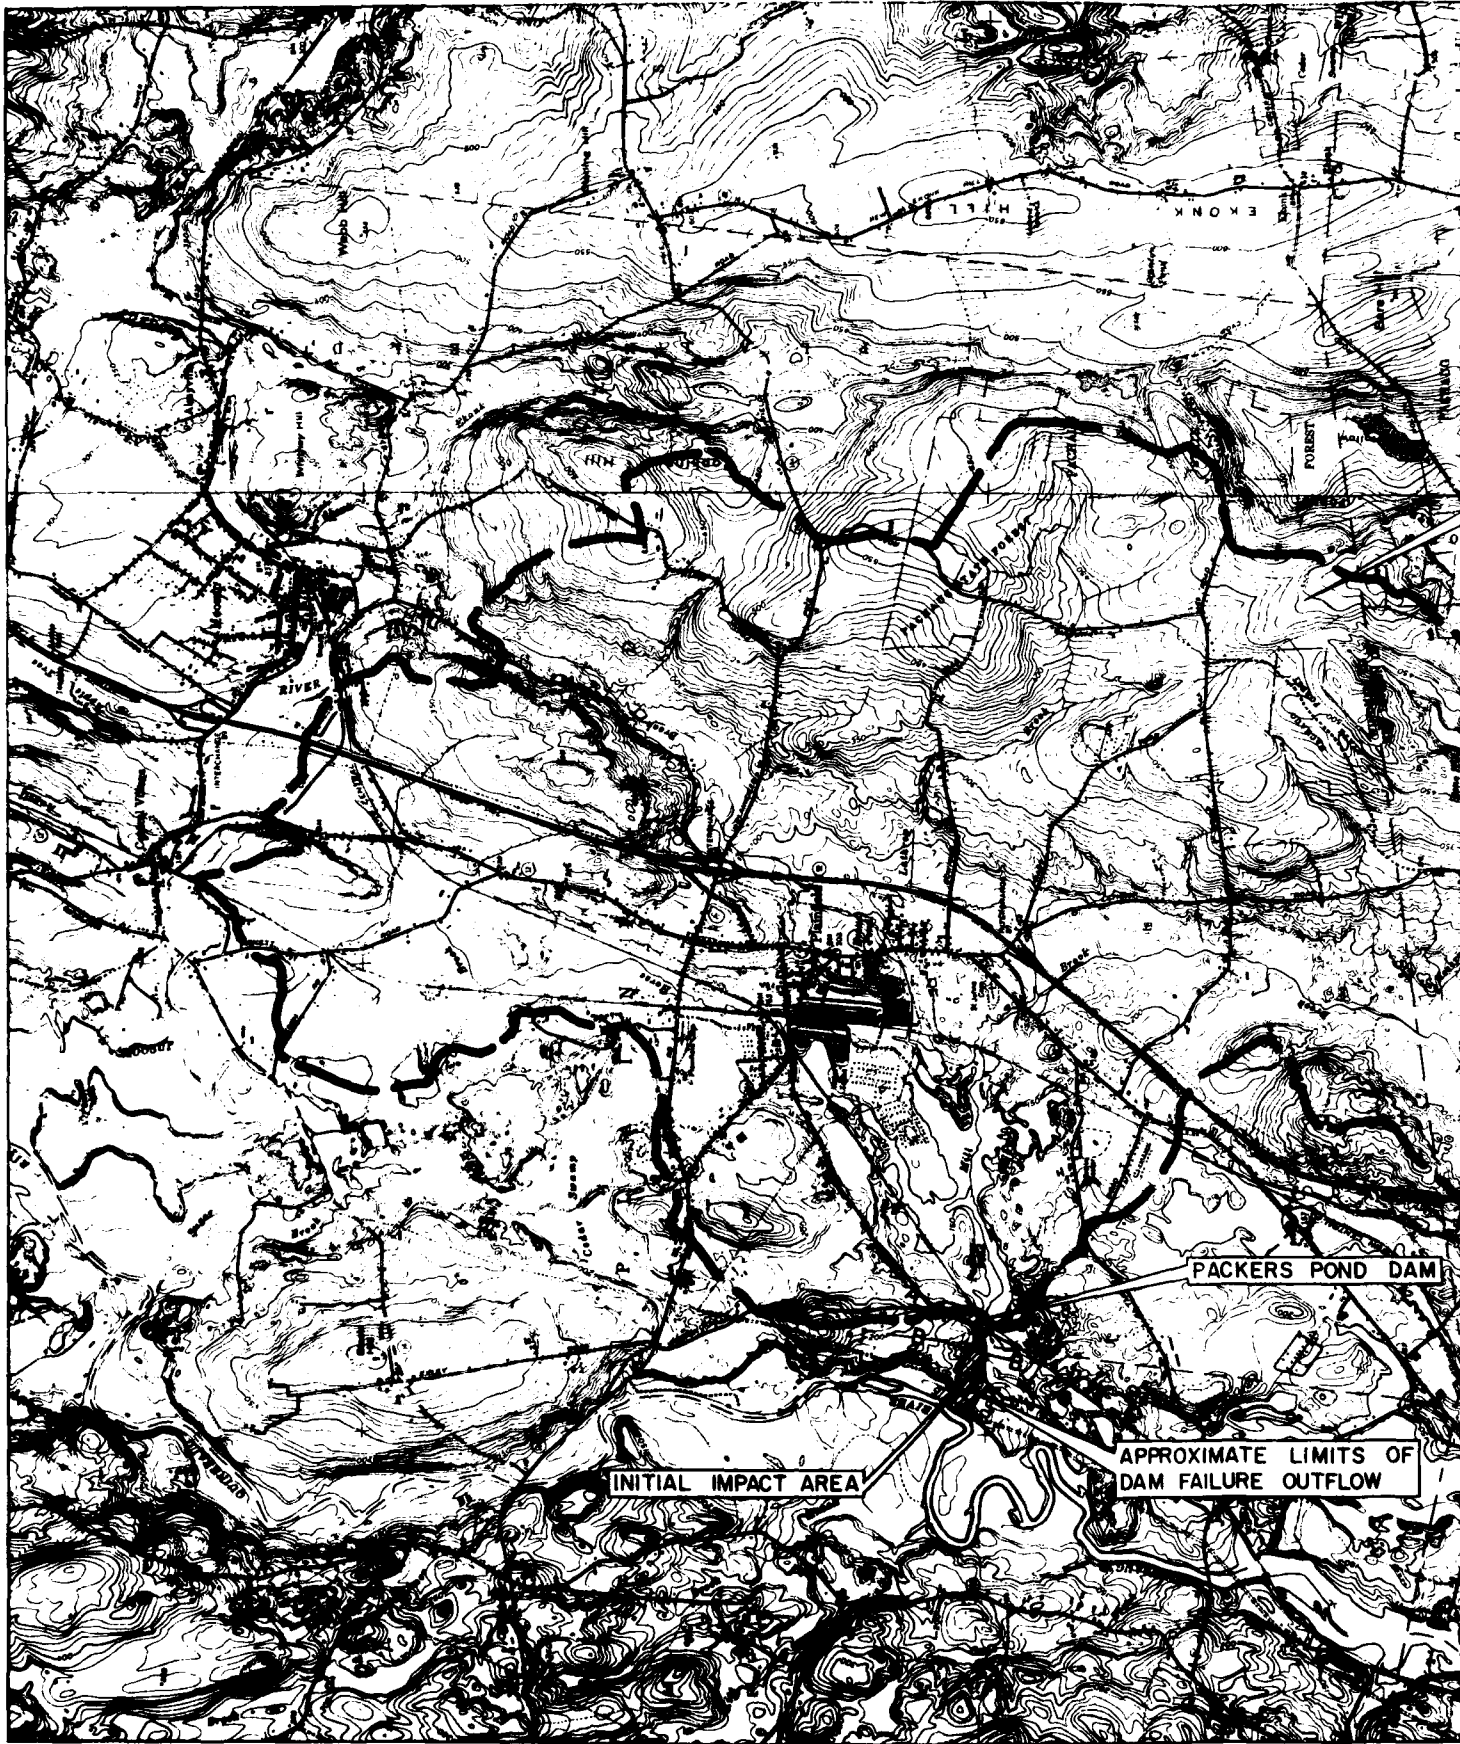
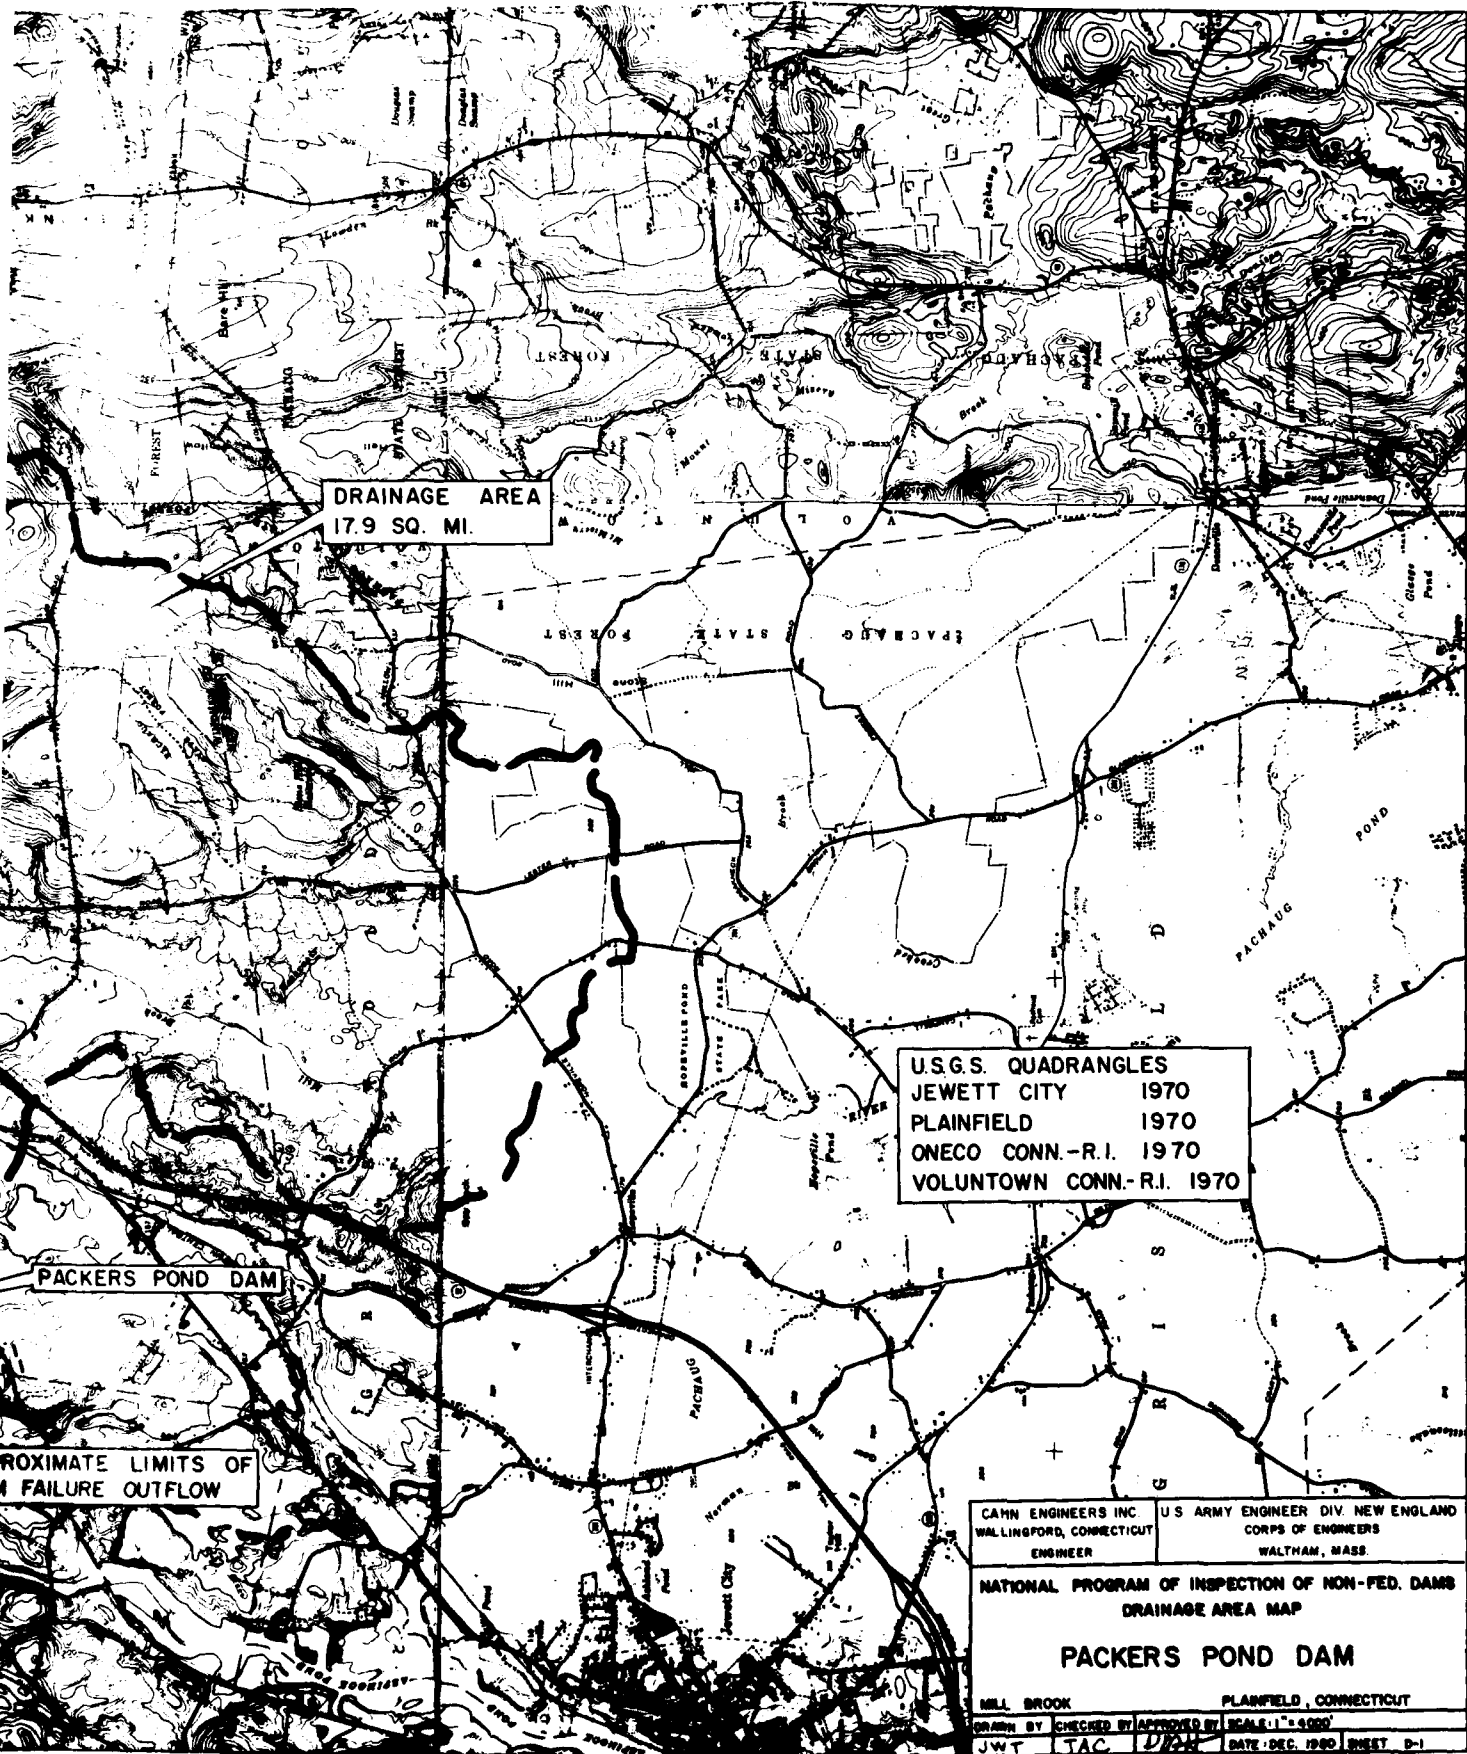
| DATE: DEC. 1990 SHEET: D-1 | |

d. Hazard Classification - (SIGNIFICANT) - If the dam were breached, there would be a potential for the loss of a few lives and some property damage at two houses located 1000 and 1300 feet downstream along Packer Road (See Sheet D-1). The rapid 4.4 foot rise in the water level at this primary impact area upon failure of the dam would result in ground floor flooding of these two homes by more than 1 foot. Due to the rapid rise in water level and the expected velocity, the resulting property damage and possibility for loss of life classifies Packers Pond Dam as a significant hazard.

Two houses, located on Packer Road approximately 1000 and 1300 feet downstream from the dam, have basement floors 9+ feet above the streambed of Mill Brook. This area is designated as the primary impact area and is shown as such on Sheet D-2. In addition to this primary impact area, damage is expected to occur (upon breach of the dam) at the culvert under Packerville Road about 400 feet downstream from the dam.
