THAMES RIVER BASIN
GRISWOLD, CONNECTICUT

STONE HILL RESERVOIR DAM
CT 00436

PHASE 1 INSPECTION REPORT
NATIONAL DAM INSPECTION PROGRAM

MAY 1979

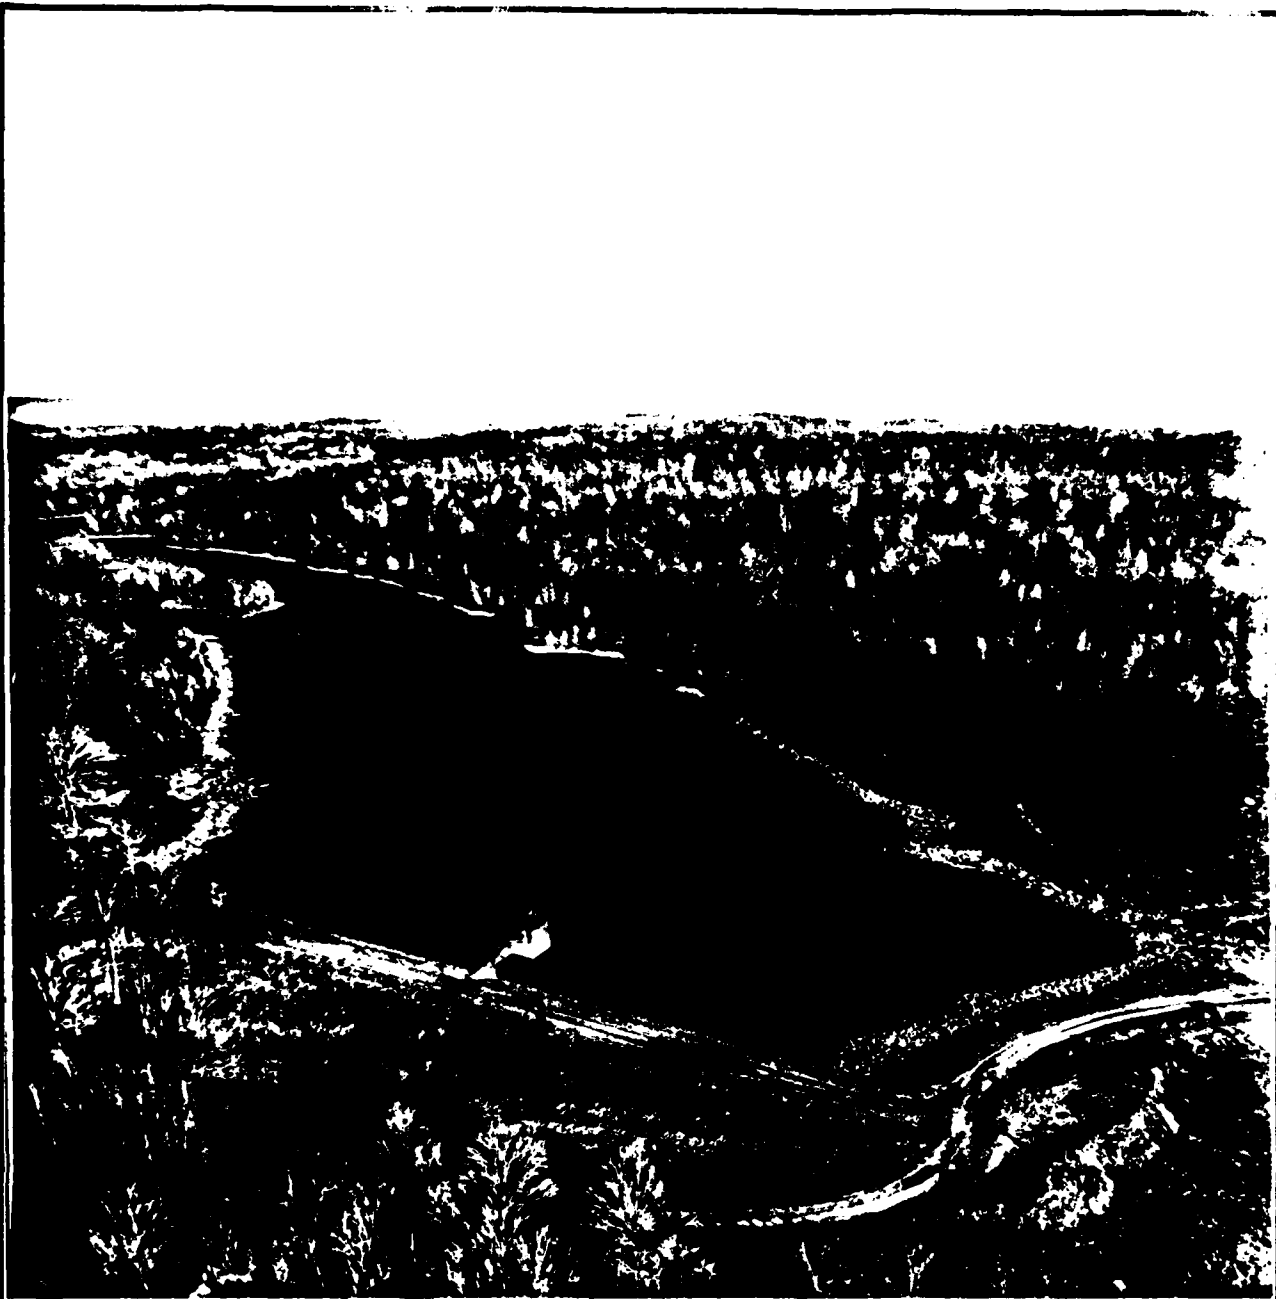
OVERVIEW PHOTO - STONE HILL RESERVOIR DAM

- d. Reservoir Area. No specific detrimental features in the reservoir area were observed during the visual inspection. The slopes of the watershed are well-covered with growth to preclude sloughing of shoreline material (See overview photo).
- e. Downstream Channel. The downstream channel for the Stone Hill Reservoir Dam is a natural stream called Reservoir Brook. Directly below the dam, the channel is in rock and earth. The flow from the spillway discharge channel joins the brook approximately 600 feet downstream of the dam. The downstream channel is steeply sloped below the dam.

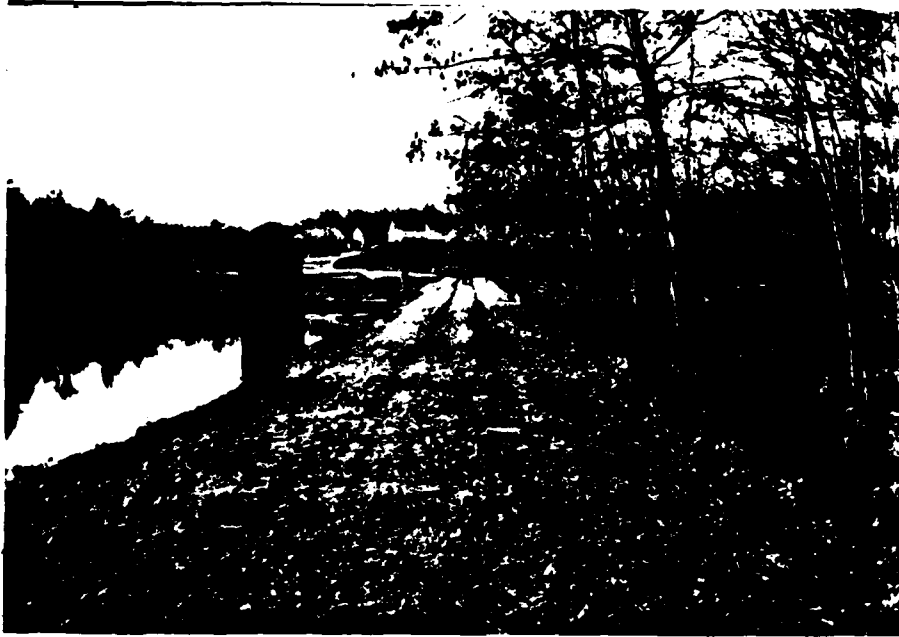
1. Crest. The crest of the dam is covered with grass, as shown in Photo C-3. The upstream edge of the crest lies at an elevation about six inches lower than the downstream edge. There are two five-inch deep ruts along the axis of the dam caused by vehicles trespassing across the crest. Along the downstream edge of the crest, there are two power

line poles. There is a slight settlement of the crest observed in the vicinity of station 3+50. Reference stationing is indicated on the Photo Index Sheet in Appendix C.

C-3 CREST OF MAIN EMBANKMENT.

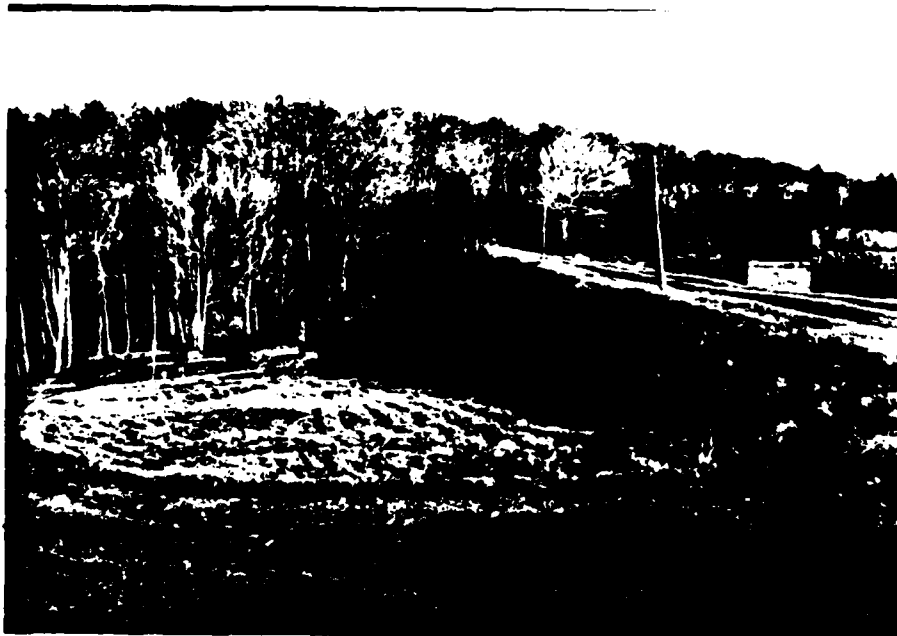
C-4 DOWNSTREAM SLOPE OF MAIN EMBANKMENT.

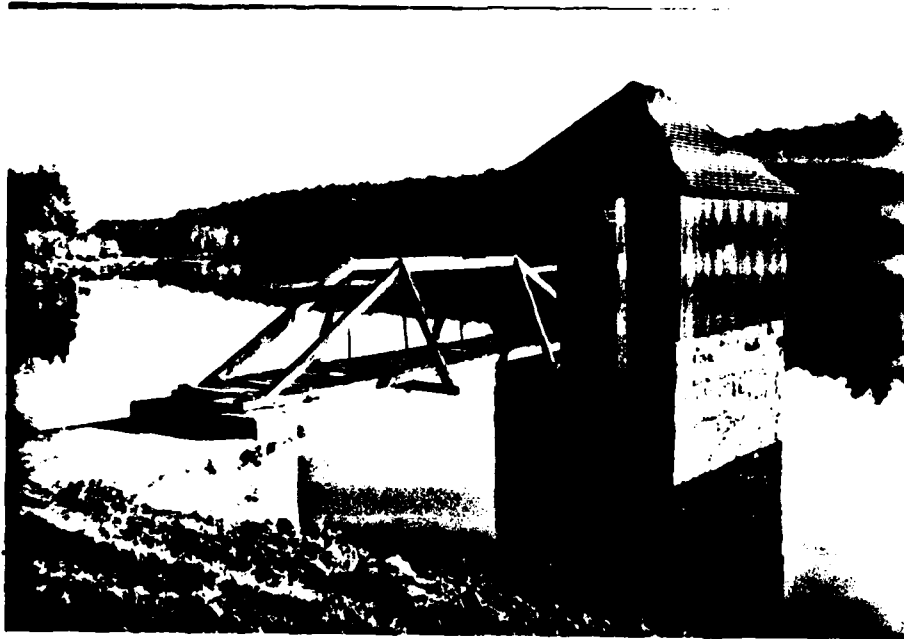
The control mechanism for the inlet gates to the wet well of the gatehouse structure appeared to be in good working order. Flashboards are used to increase storage by raising the effective spillway crest. The service bridge leading to the gate structure needs painting but otherwise appeared to be in good condition.

2. Outlet Works. The outlet works is located on the upstream slope of the dam and is a structure with a stone masonry wet well foundation with a timber superstructure which appears to be in good condition (See Photo C-5). The outlet works consist of two sixteen inch diameter cast iron outlet pipes and one 4 inch diameter outlet pipe which are controlled by manually operated vertical sluice gate mechanisms. One of the 16 inch pipes connects to the water treatment facility downstream of the dam while the other pipeline serves as the outlet works conduit, which discharges into a rock channel at the toe of the dam (See Photo C-6, 12). The 4 inch diameter conduit is used as a by-pass during periods of maintenance on the 16 inch diameter supply pipe. The gate mechanisms appear to be in good condition and the outlet conduit is reportedly operated once or twice a year. An additional gate is located on the outlet conduit. This gate appears to be in poor condition, inoperable and permanently fixed in the open position. (See Photo C-7). Trash screens are located at the outlet works in the control tower wet well and are cleaned periodically. No seepage was observed at the emergency outlet pipe.

C-5 GATEHOUSE AND SERVICE BRIDGE

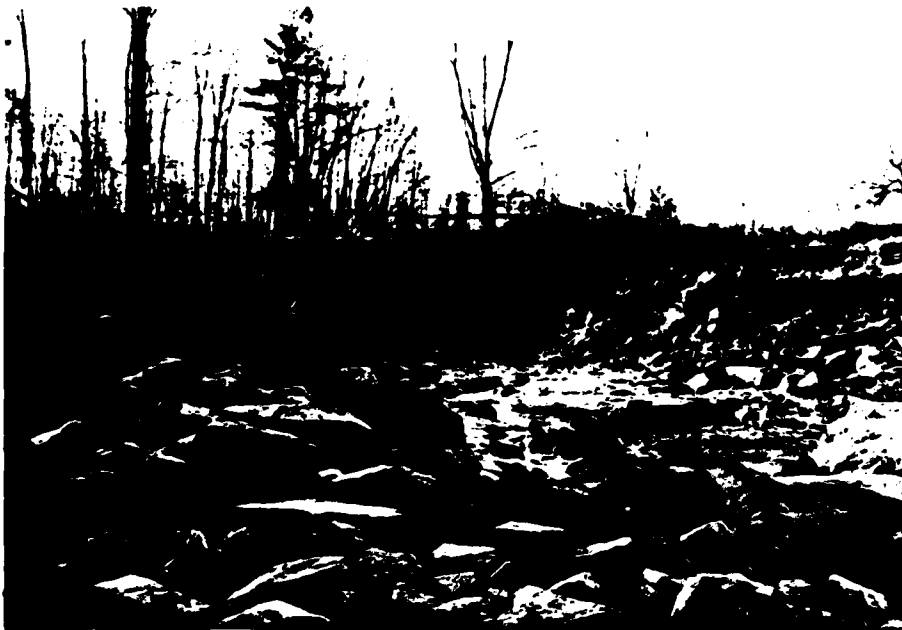
C-8 RESERVOIR BROOK INLET TO RESERVOIR AND APPROACH CHANNEL FOR SPILLWAY.

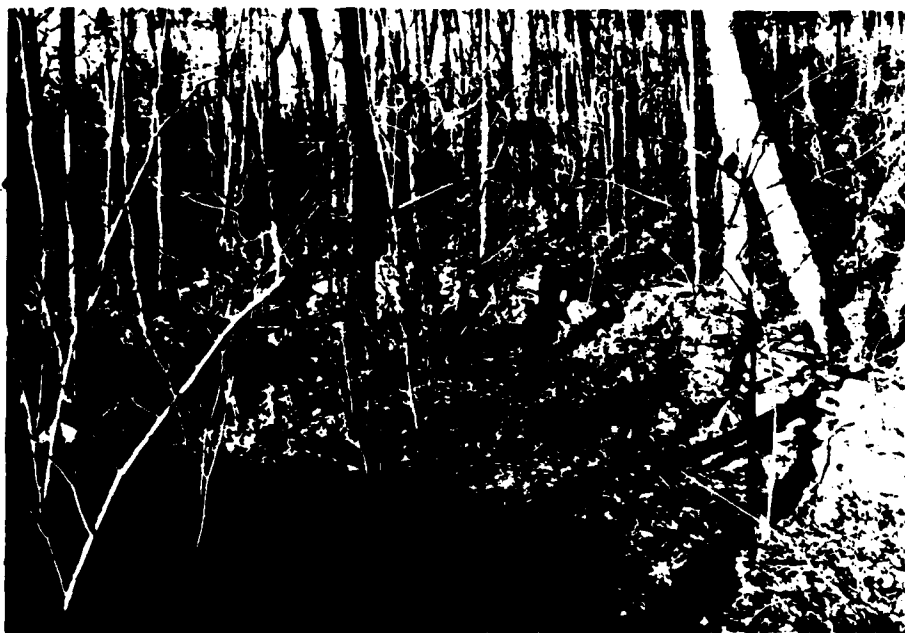
C-12 DOWNSTREAM CHANNEL BELOW OUTLET
