CONNECTICUT RIVER BASIN

# COLLINS COMPANY LOWER DAM CT 00380

PHASE I INSPECTION REPORT  
NATIONAL DAM INSPECTION PROGRAM

JULY 1979

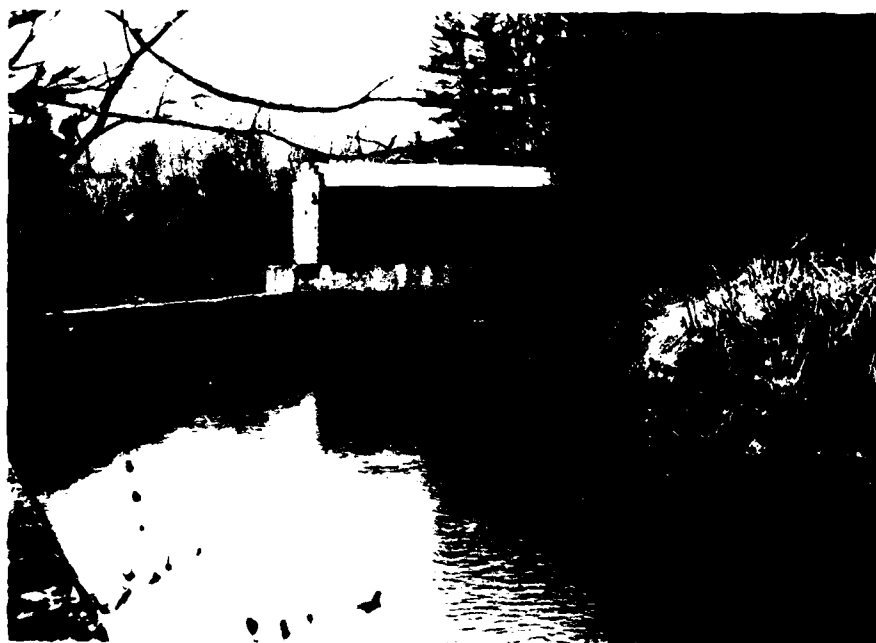
PHOTO 6 - Spalling of downstream face of left abutment at canal inlet. (April, 1979).

4. Deteriorated concrete of the dam abutments, canal walls, canal waste weir, powerhouse bulkhead, and retaining walls upstream of the dam should be repaired. Planking for the steel frame foot bridge over the canal waste weir should be put in place.

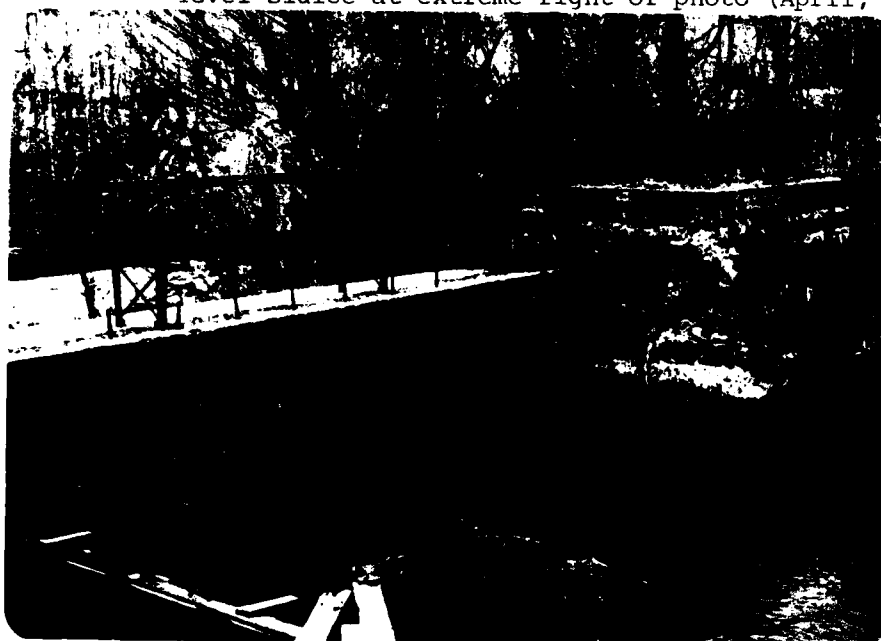
PHOTO 10 - Waste weir at downstream end of canal adjacent to power-  
house. Note spalling of concrete and debris in channel  
(April, 1979).
