CONNECTICUT RIVER BASIN  
WESTBROOK, CONNECTICUT  
**MESSERSCHMIDT POND DAM**  
**CT 00392**

PHASE I INSPECTION REPORT  
NATIONAL DAM INSPECTION PROGRAM

NOVEMBER, 1979

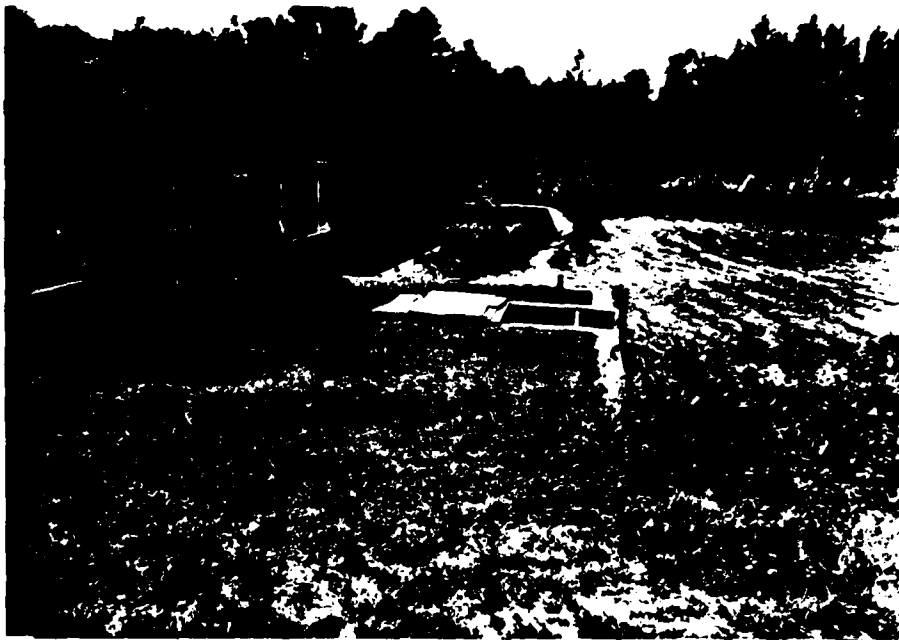
Upstream Slope - The upstream slope, inclined approximately at 2.5 horizontal to 1 vertical is grass covered and partially protected by riprap. Some riprap displacement, brush and trees were noted on the slope. (Photo 1).

Photo 1 - General view of left and central embankments principal spillway, sluice and factory building (Sept 1979)

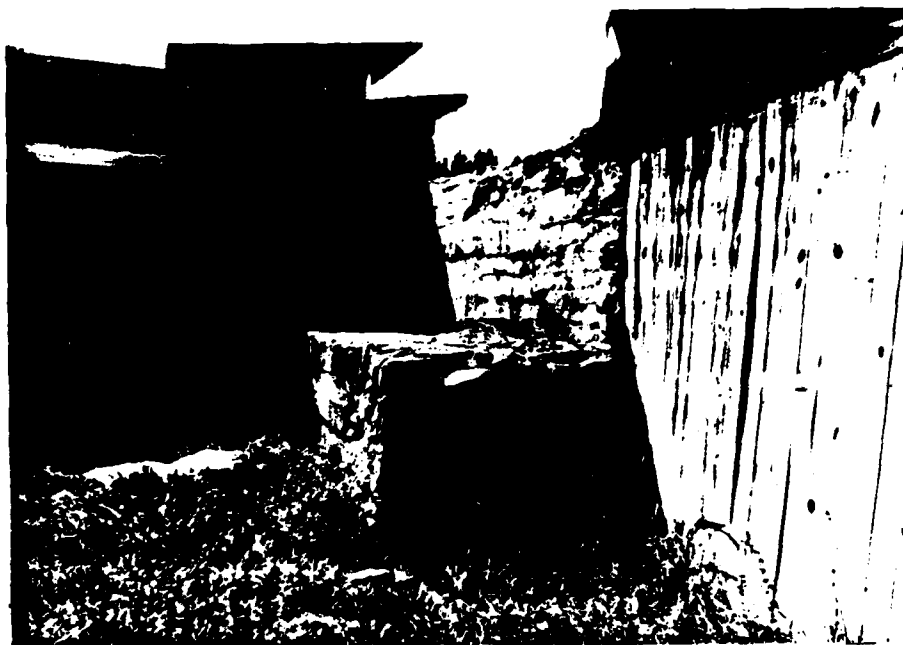
1. Damaged concrete of the left embankment retaining wall, if left without repair, could lead to further deterioration and decrease the stability of this wall.

Photo 5 - Concrete retaining wall of left embankment (Sept 1979)
