KILLINGWORTH RESERVOIR DAM  
CT 00401

PHASE I INSPECTION REPORT  
NATIONAL DAM INSPECTION PROGRAM

DEPARTMENT OF THE ARMY  
NEW ENGLAND DIVISION, CORPS OF ENGINEERS  
WALTHAM, MASS. 02154

MARCH 1979

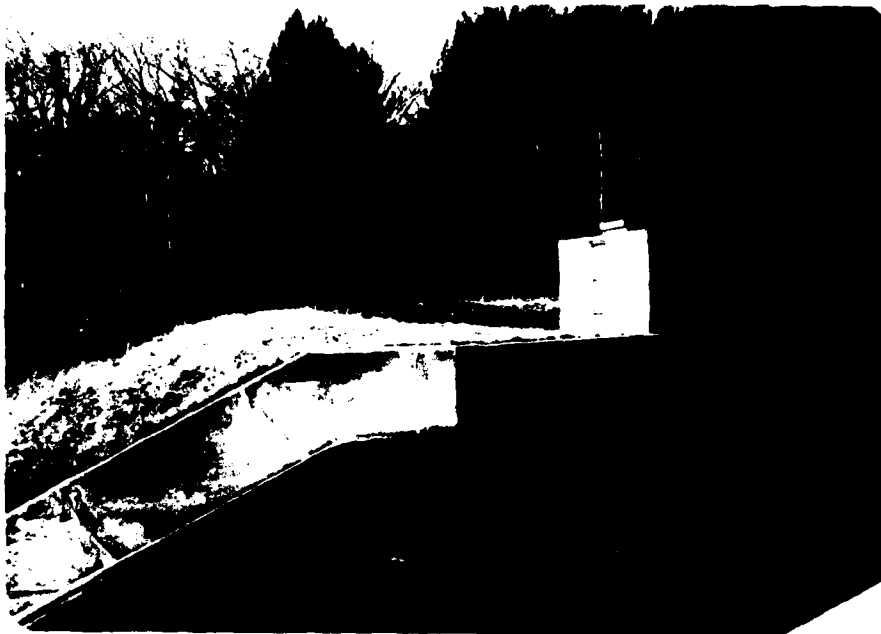
PHOTO 3 - Intake structure and right spillway wingwall. Note cracks which have been sealed.

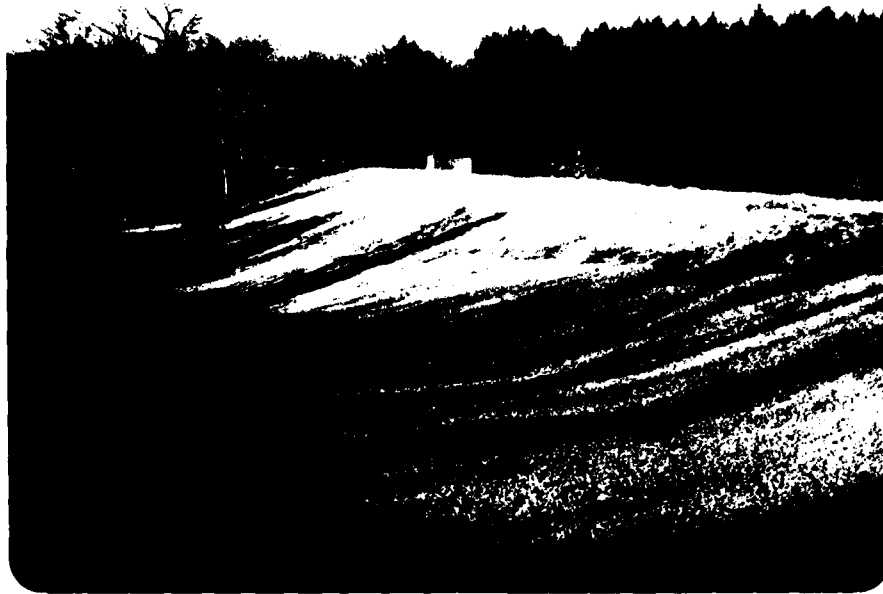
Downstream Slope - The downstream slope is grass covered with a toe drain covered by processed stone running along the length of the dam. There are no signs of sloughing of erosion on the slope, and the toe drain is in good condition and clear of debris and vegetation, as shown in Photo 5. The toe drain outlet pipe exits from the left gabion wall as shown in Photo 6. The owner reported that water has never been observed flowing from the drain pipe.

PHOTO 5 - Downstream face of dam with toe drain.

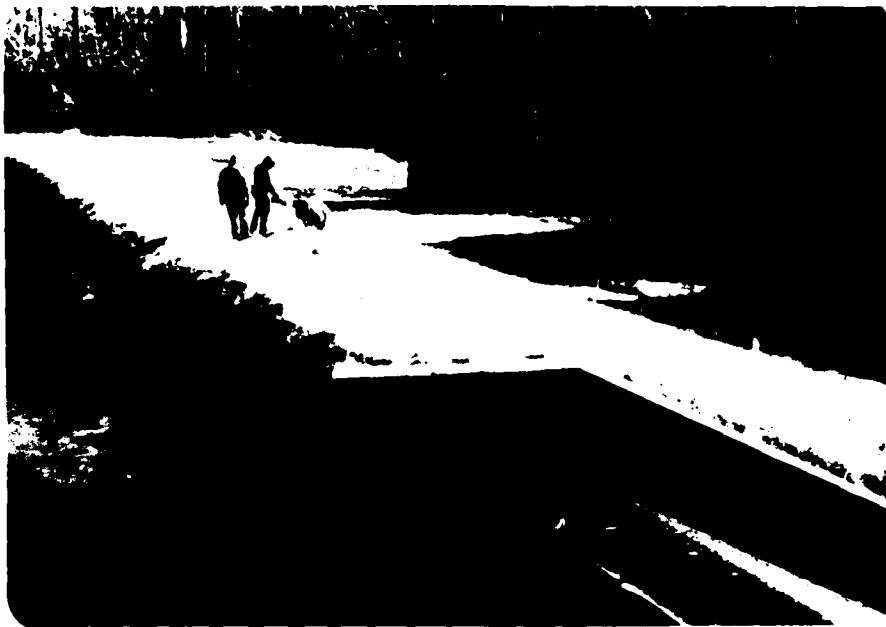
Crest - The crest is grass covered and in good condition with no signs of erosion, as shown in Photo 7.

PHOTO 7 - View of crest and upstream face of dam embankment.
