NATIONAL PROGRAM FOR INSPECTION OF NON-FEDERAL DAMS NEW 1/1  
BRITAIN RESERVOIR. (U) CORPS OF ENGINEERS WALTHAM MA  
NEW ENGLAND DIV AUG 79

## PHASE I INSPECTION REPORT

### NEW BRITAIN RESERVOIR DAM

New Britain Reservoir Dam  
Roaring Brook  
Wolcott, Connecticut  
CE # 27 660 KB  
DATE Aug. '79 PAGE C-3

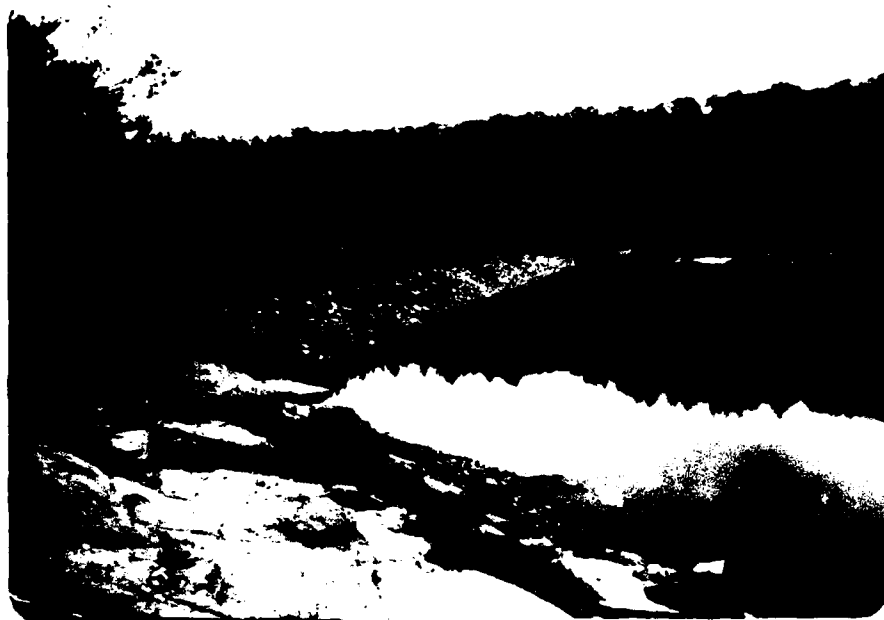
Upstream Slope - The slope inclination is 2 horizontal to 1 vertical and protection is 18 inch thick stone paving to approximately 1 to 2 feet below the top of the dam. The paving does not have any visible displacement or areas needing replacement, although there is some vegetation between the stones (Photo 3). A pine tree of 12 to 15 inches in diameter was noted at the left end of the embankment.

PHOTO 3 - Crest and upstream slope of main embankment. Note brush and grass on riprap (July, 1979).

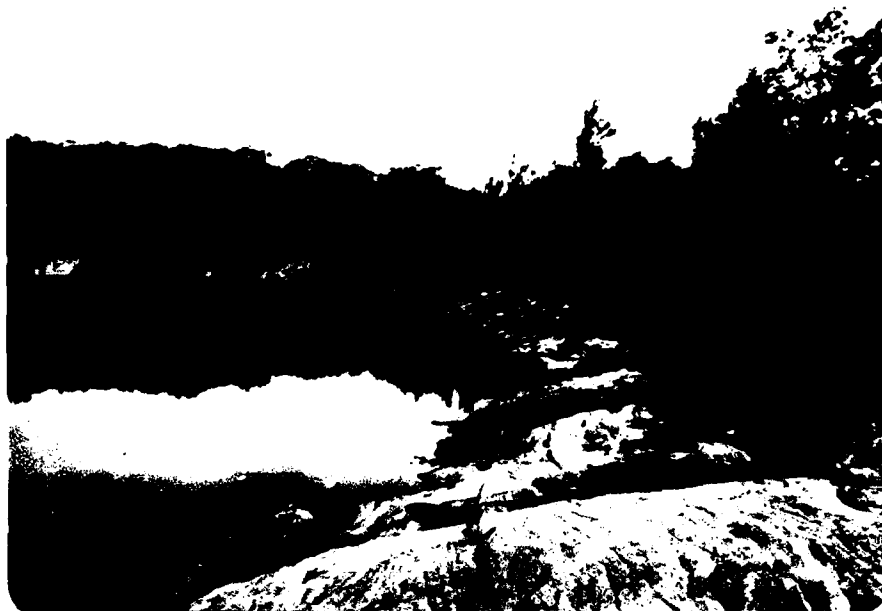
Upstream Slope - The slope inclination is 2 horizontal to 1 vertical with stone paving to approximately 1 to 2 feet below the crest. The stone paving does not have any visible displacement or areas needing replacement, although there is some vegetation between the stones. Also, the top of the slope, just above the paving, is overgrown by trees and brush (Photo 5).

PHOTO 5 - Crest and upstream slope of dike. Note heavy brush and small trees (July, 1979).
