THAMES RIVER BASIN  
BOZRAH, CONNECTICUT

FITCHVILLE POND DAM  
CT 00510

PHASE 1 INSPECTION REPORT  
NATIONAL DAM INSPECTION PROGRAM

JUNE 1979

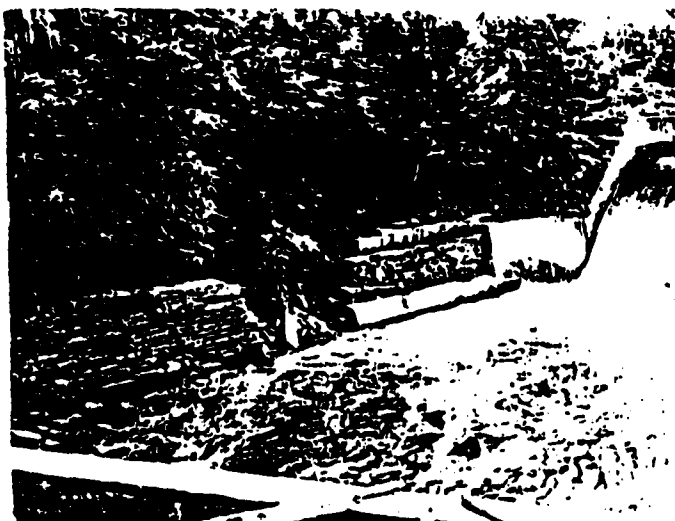
Picture #2 shows the deteriorated condition of the valve house. The doors are open and some of the wooden floor boards are missing and many appear rotting. There are large iron hand wheels connected to timber valve stems which protrude thru the roof when raised. These wooden gates are operable by turning these wheels which are not locked. This structure presents a definite hazard to children and should be repaired to safeguard the curious and to prevent unauthorized tampering with the draw down facilities.

Some leaks were noted coming thru the masonry just below the main draw down controls (3 horizontal wheels in picture #2).  
----- at the safety of the structure.

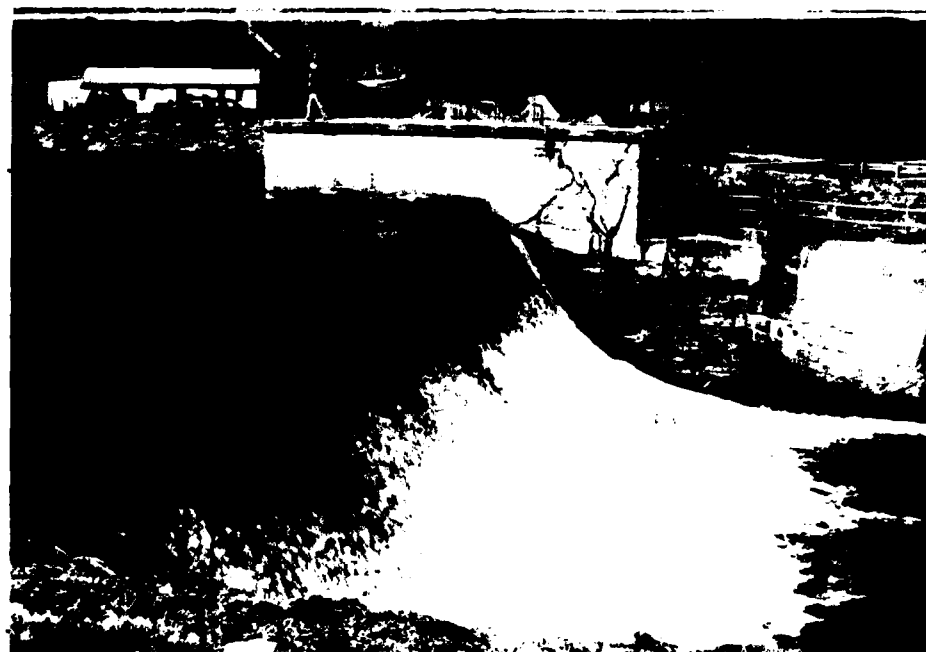
The spillway training walls are in poor condition. As shown in Photo C-2, the concrete facing is missing from the left training wall just downstream from the spillway crest and the underlying open stonework is exposed. Concrete facing is also missing from the left training wall just downstream from the outlet gate raceway and seepage is occurring through the exposed open stonework, as shown in Photo C-10. As shown in Photos C-11 and C-15, the concrete facing on the right training wall is intact, but seepage is occurring through the open stonework in a 25-ft. section starting about 15 ft. downstream from the spillway toe where the concrete facing extends only partway up the training wall. The dry stone masonry wall is damaged with a number of stones missing in a 15-ft. section immediately downstream of the concrete-faced section, as shown in the same photos.

Concrete facing is missing from the left spillway training wall and the underlying open stonework is exposed.

C-2 SPILLWAY - LOOKING FROM RIGHT ABUTMENT (NOTE CRACK IN CONCRETE MONOLITH ON LEFT ABUTMENT)

1. Evaluate the condition of the spillway surfaces and training walls and develop a program for their rehabilitation.
2. Trees and brush on the upstream and downstream slope should be removed. The stumps of the trees should be removed only after a procedure has been developed by a competent engineer for proper backfill and compaction.

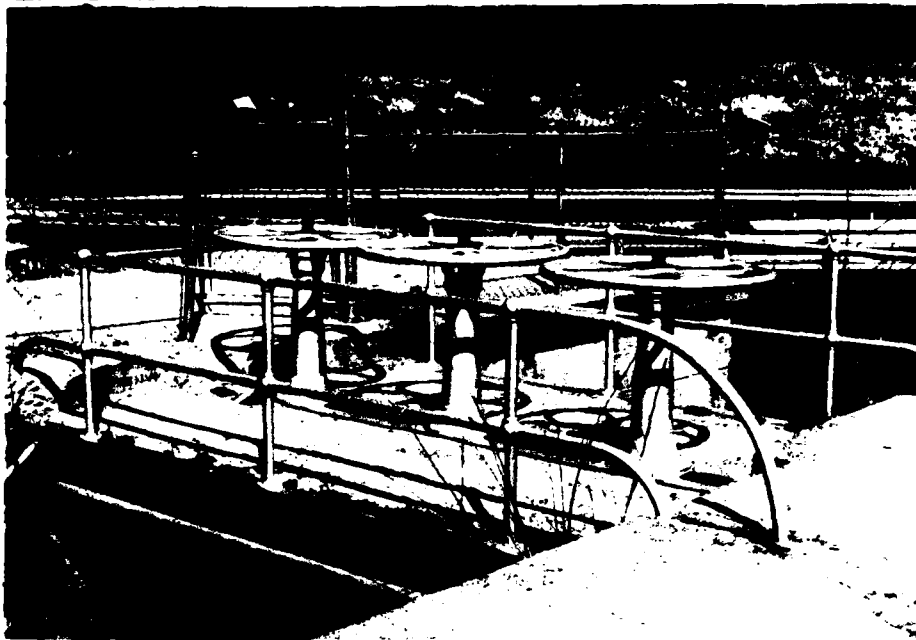
2. Outlet Works. The outlet gate structure is located at the left abutment of the spillway. The general configuration of the outlet gate structure is shown in Photos C-5, C-6 and C-13. Flow from the outlet gate enters the downstream spillway channel through a short raceway section. Large cracks and extensive seepage were noted in the concrete covering of the stone masonry outlet structure, as illustrated in Photo C-5. The outlet works gates were not exercised at the time of the inspection but are reportedly operable according to the Owner of the dam.

C-5 OUTLET WORKS CONTROL GATES

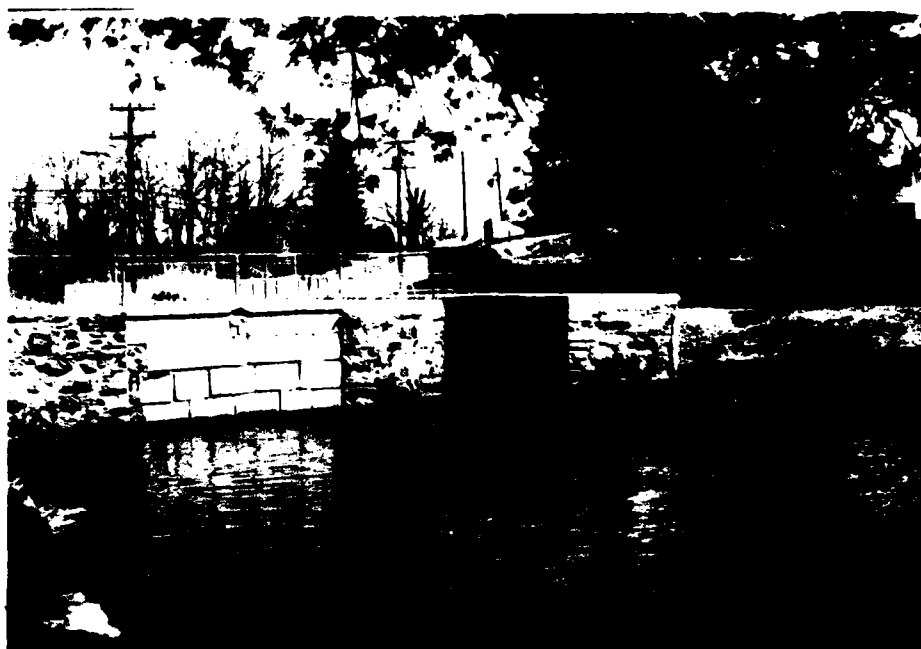
C-7 UPSTREAM FACE OF DAM AT LEFT ABUTMENT; BLOCKED  
PENSTOCK OPENING AT LEFT - APPROACH TO CONTROL GATES -  
MIDDLE - SPILLWAY AT RIGHT

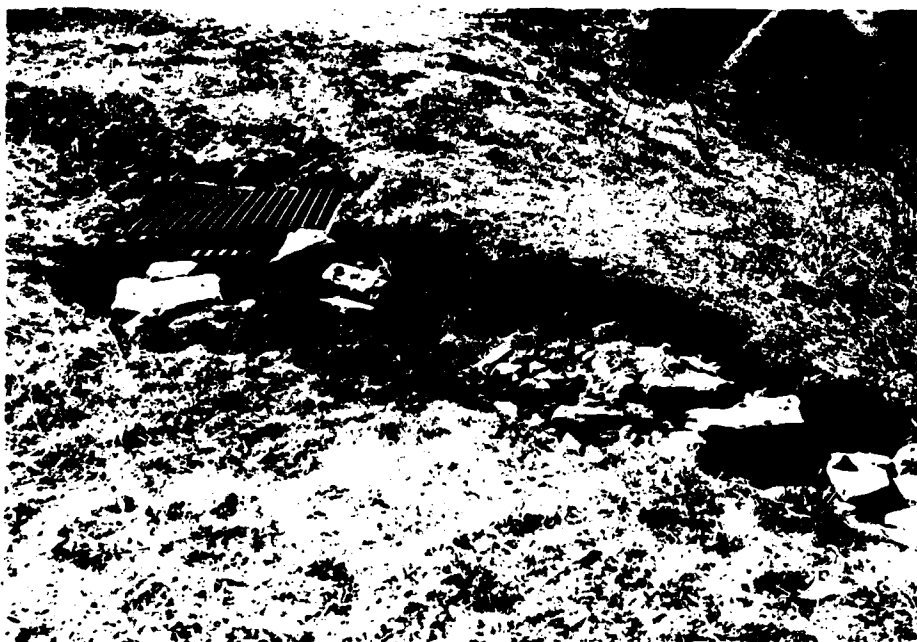
Extensive erosion has occurred on the earth slope above the right wall of the spillway channel, as illustrated in Photos C-11 and C-12. Erosion gullies up to 6-ft.-wide and 2-ft.-deep (Photos C-11 and C-12) and erosion holes up to about 5 ft. in diameter (Photo C-11) were observed. Erosion has occurred along the contact between the spillway and right abutment, as shown in Photo C-1.

C-12 SURFACE EROSION FROM IMPROPER DRAINAGE FACILITY  
ADJACENT TO SPILLWAY

3. Evaluate the cause of the cracking and seepage through the walls of the outlet works discharge channel and implement a program of rehabilitation.
4. Develop a suitable erosion protection system to protect the earth slope above the right wall of the spillway and discharge channel.

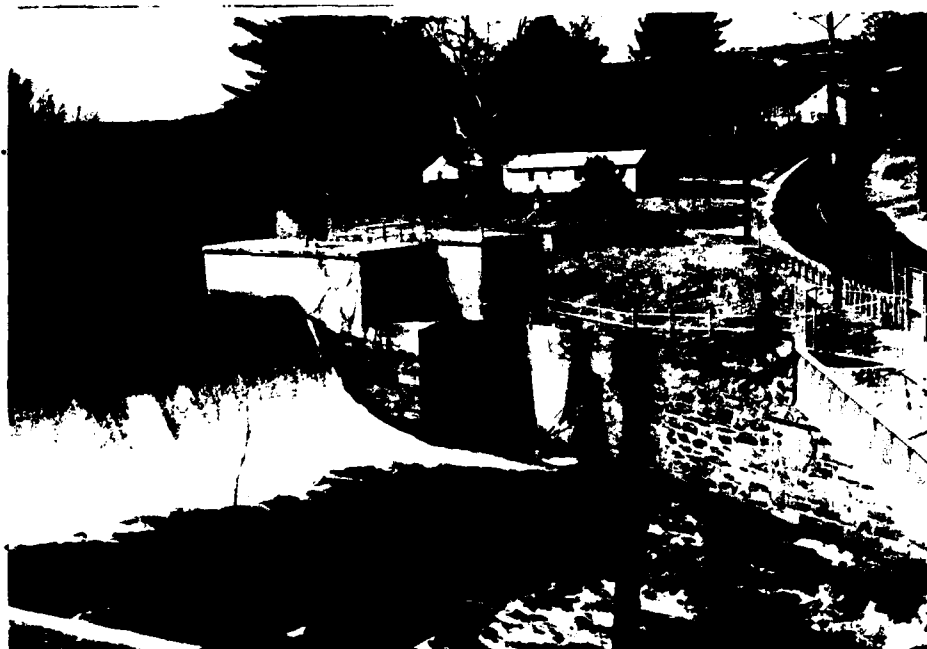
C-13 LEFT ABUTMENT OF DAM AND OUTLET WORKS (HIGHWAY  
BRIDGE - RIGHT FOREGROUND)
