# JENNINGS POND DAM CT 00396

## PHASE I INSPECTION REPORT NATIONAL DAM INSPECTION PROGRAM

FEBRUARY, 1981

CT 00396

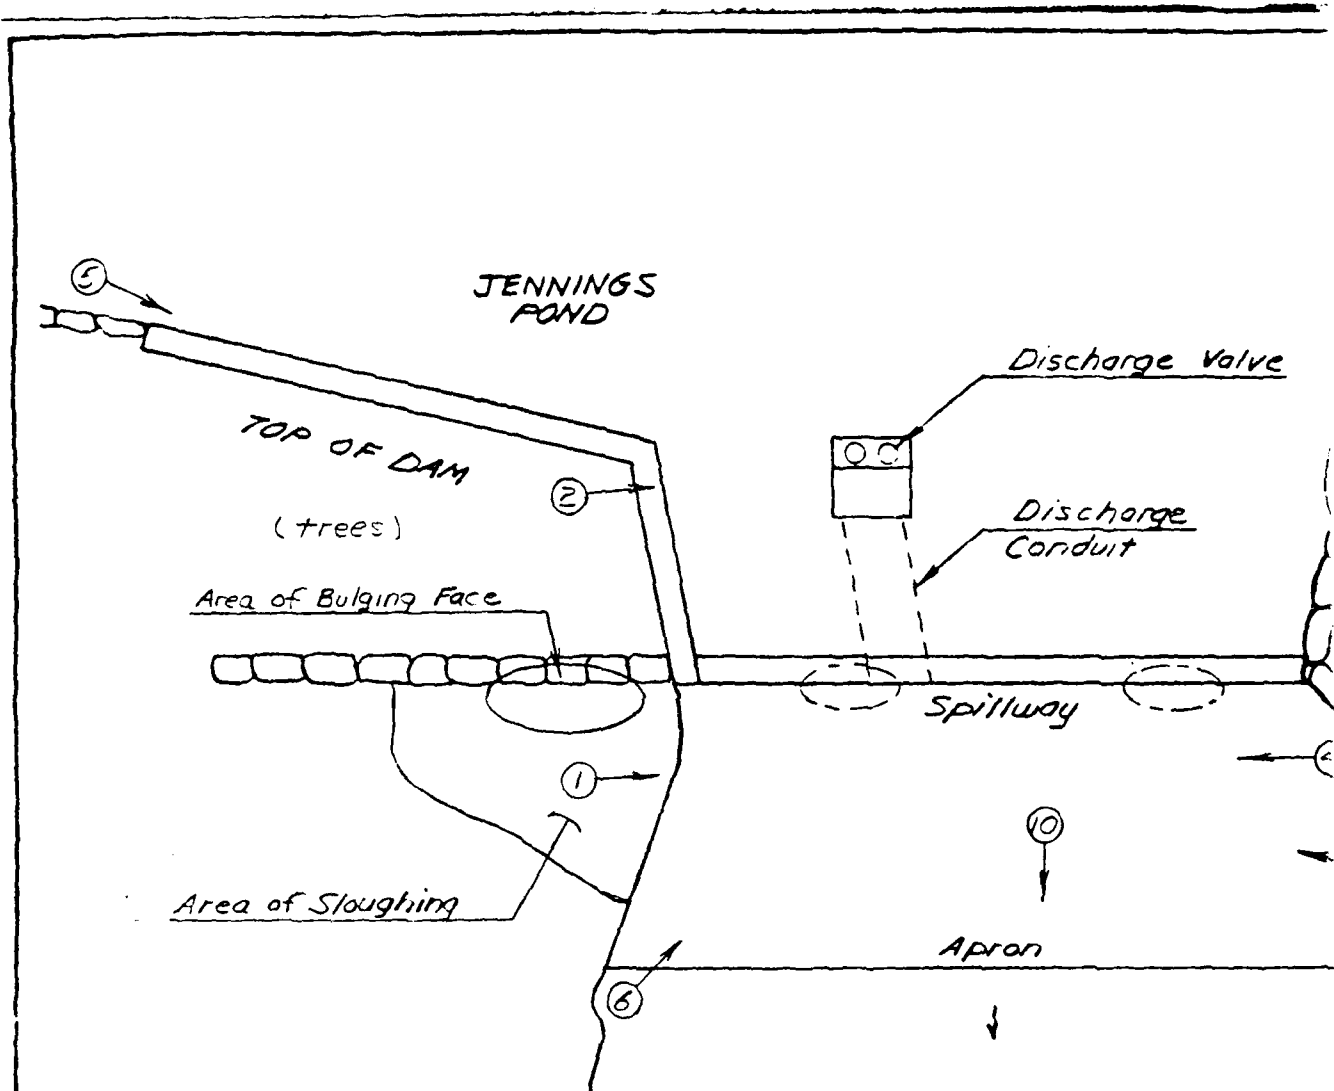
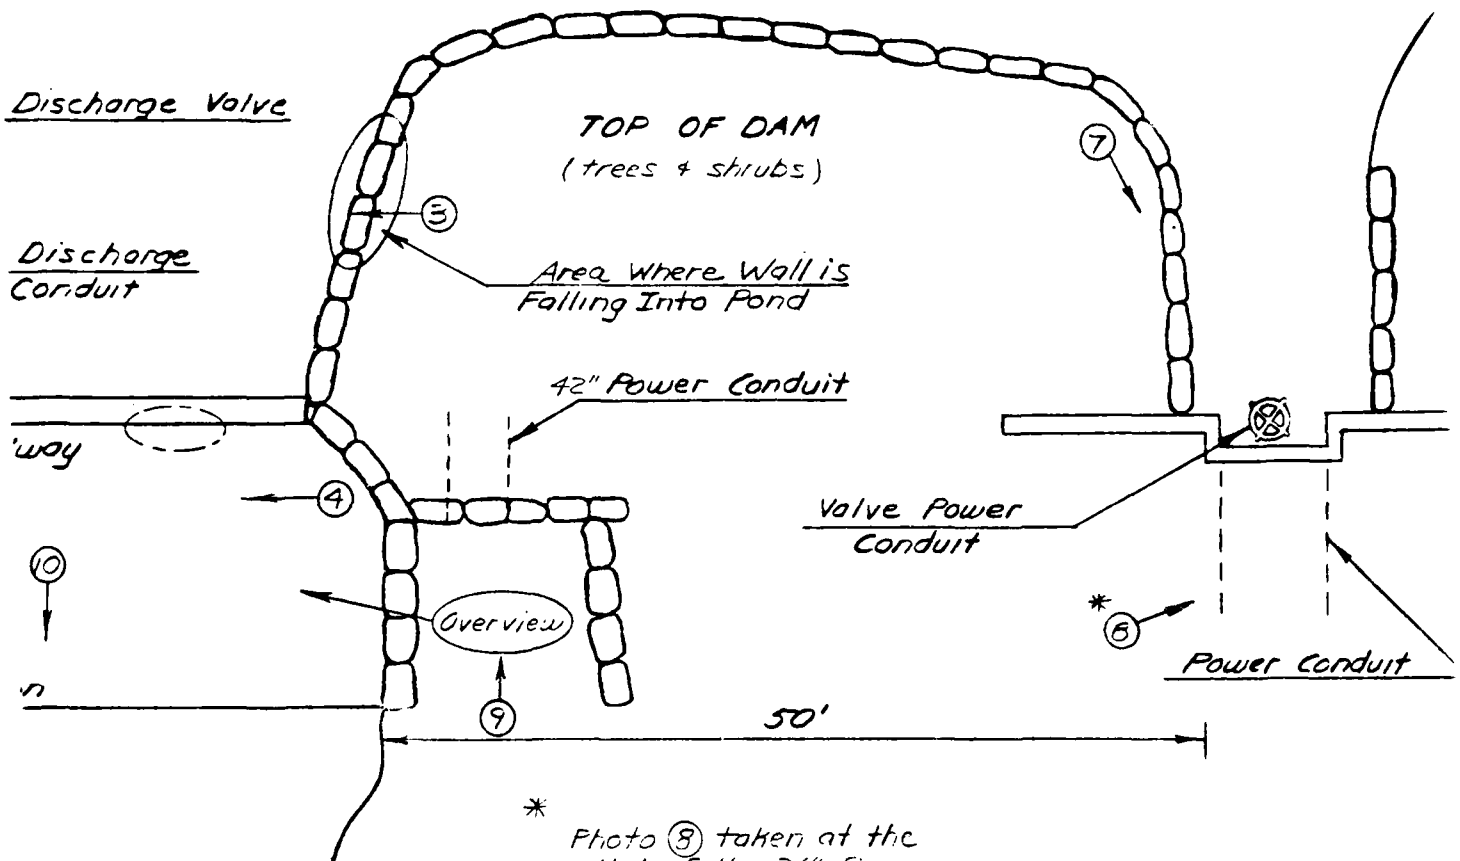
The upstream face of the dam has a stone masonry retaining wall that is generally in fair condition (Photos 2 and 3) and one location the wall is falling into the pond (See Photo Location Plan - Plate 3). The channel embankment adjacent to the dam is eroding and sloughing into the channel (Photo 4). Also at this location, the downstream face of the dam is bulging.
