CONNECTICUT CENTRAL COASTAL AREA
GUILFORD , CONNECTICUT

**MENUCKATUCK RESERVOIR DAM
CT-00408**

**PHASE I INSPECTION REPORT
NATIONAL DAM INSPECTION PROGRAM**

FEBRUARY 1980

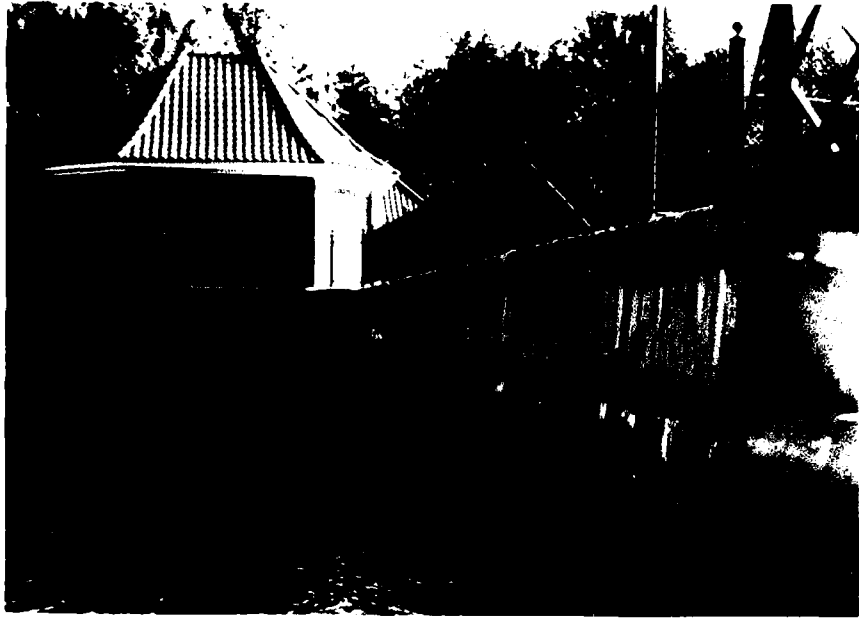
1) Upstream Face - The concrete face is in good condition as indicated in Photo No. 1 and Photo No. 2. Some spalling horizontally along the face at about the spillway elevation was noted (see Photo No. 3). Some efflorescence and discoloration of the concrete surface has occurred as indicated in Photo No. 3 and Photo No. 9 (apparently rust stains and high water marks). Generally the condition of the upstream face is good with no evidence of structural cracking or severe deterioration.

PHOTO #3: Upstream face of dam looking towards left (east) abutment.

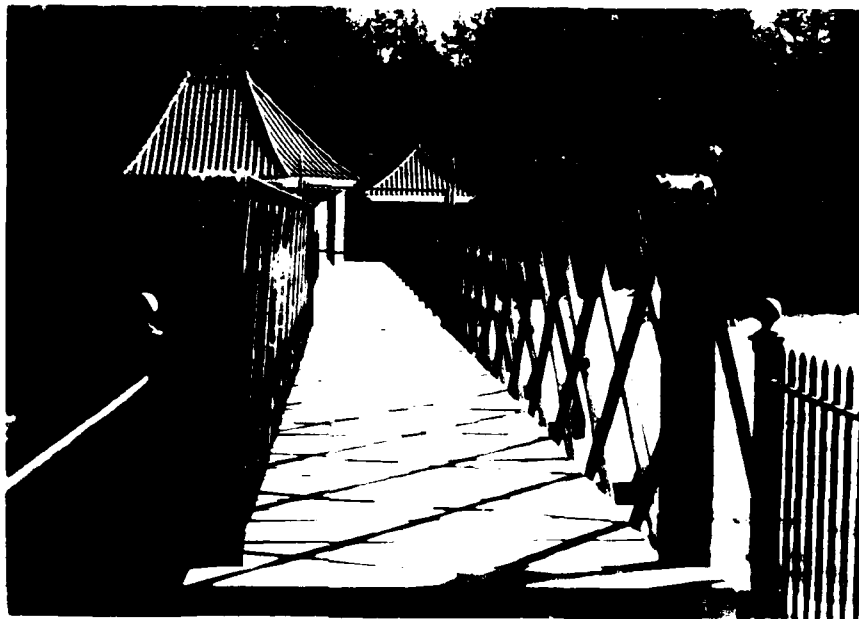
2) Crest - The crest is level and the concrete is in good condition. The vertical and horizontal alignment is good (Photo No. 4).

f. Footbridge. The metal truss of the service bridge is in good condition. Only minor rusting has occurred. The wood planking on the bridge is in excellent condition (Photo No. 4 and Photo No. 11).

PHOTO #4: Crest of dam from right (west) abutment.
