NATIONAL PROGRAM FOR INSPECTION OF NON-FEDERAL DAMS  
UPPER SHEPAUG RESERVOIR (U) CORPS OF ENGINEERS WALTHAM  
MA NEW ENGLAND DIV MAY 79

| REPORT DOCUMENTATION PAGE | | READ INSTRUCTIONS<br>BEFORE COMPLETING FORM |
|---|---|---|
| 4. TITLE (and Subtitle)<br>Upper Shepaug Reservoir Dam | | 5. TYPE OF REPORT & PERIOD COVERED<br>INSPECTION REPORT |

NATIONAL DAM INSPECTION PROGRAM  
PHASE I INSPECTION REPORT

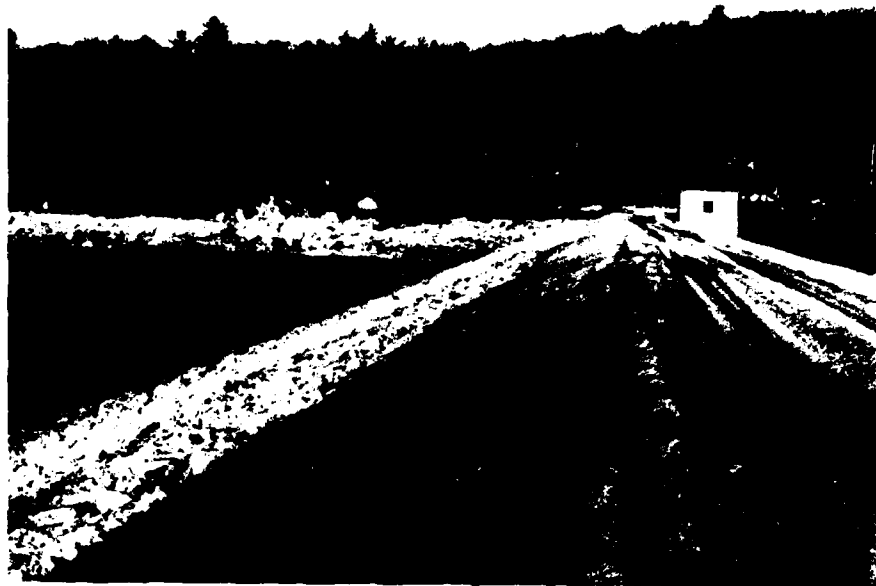
PHOTO NO. 1 - Looking along upstream face toward east abutment, 150' left (east) of spillway channel.

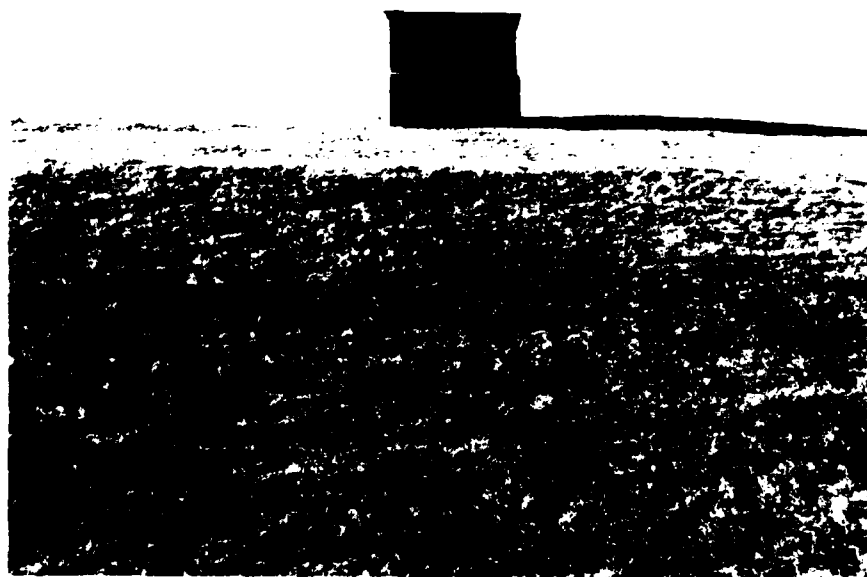
PHOTO NO. 13 - Looking upstream at downstream slope  
from right (west) edge of outlet training  
wall.
