PAPERMILL POND DAM

CT. 00471

PHASE I INSPECTION REPORT  
NATIONAL DAM INSPECTION PROGRAM

DECEMBER 1979

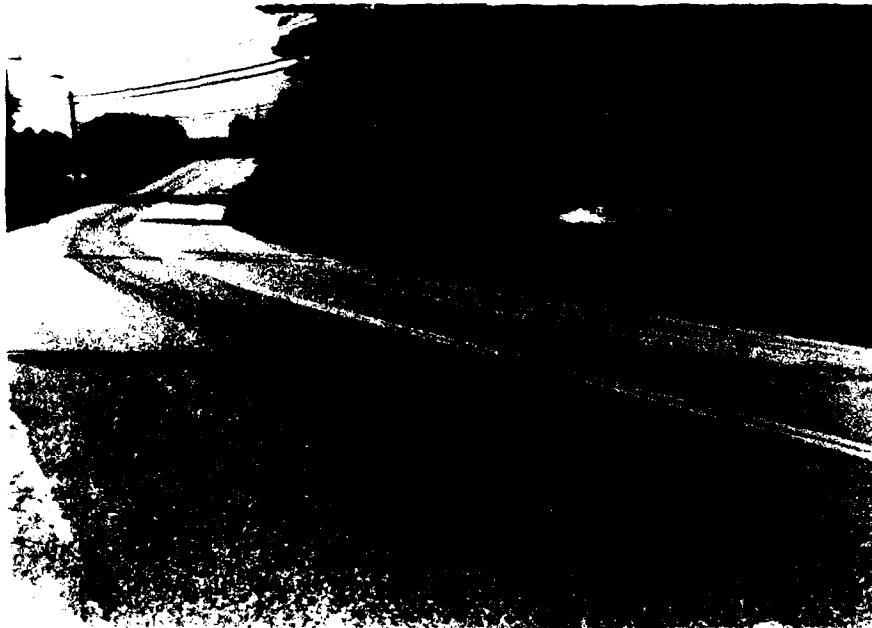
16. Bushnell Hill Road Bridge over the Little River
