**CONNECTICUT RIVER BASIN  
WESTBROOK, CONNECTICUT**

**WRIGHTS POND DAM**

**CT 00393**

**PHASE 1 INSPECTION REPORT  
NATIONAL DAM INSPECTION PROGRAM**

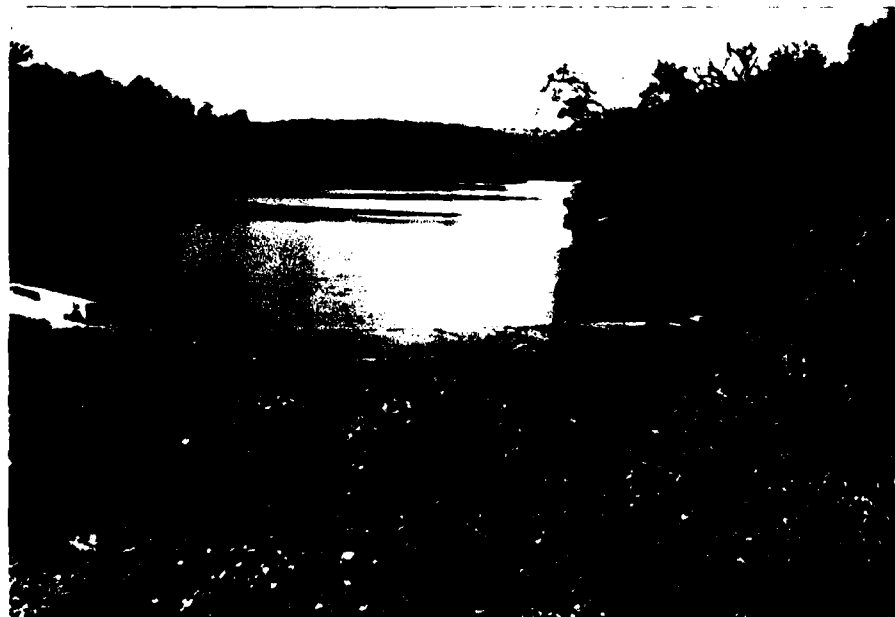
1. Spillway: The spillway is a 100 foot long by 11 foot wide stone masonry and concrete structure near the western end of the dam. (Photos C-1, C-2). The eastern half of the spillway is the original spillway for the dam. It is constructed of stone masonry with a concrete covering (Photos C-4, C-8). This covering is spalled but still adequate and there are many missing and loose stones, seepage and brush along the downstream face (Photos C-8, C-9). Because of flow over the spillway, the rate of seepage between the stones in the downstream face could not be determined. No evidence of fines was noted in the seepage. The outlet of the 18 inch pipe is at the base of this spillway section (Photo C-11). A concrete wingwall was added in 1972 and is in good condition (Photo C-4). There is a void under the

C-2 SPILLWAY LOOKING NORTH
