**THAMES RIVER BASIN  
GRISWOLD, CONNECTICUT**

**PACHAUG POND DAM  
CT 00663**

**PHASE 1 INSPECTION REPORT  
NATIONAL DAM INSPECTION PROGRAM**

**SEPTEMBER 1978**

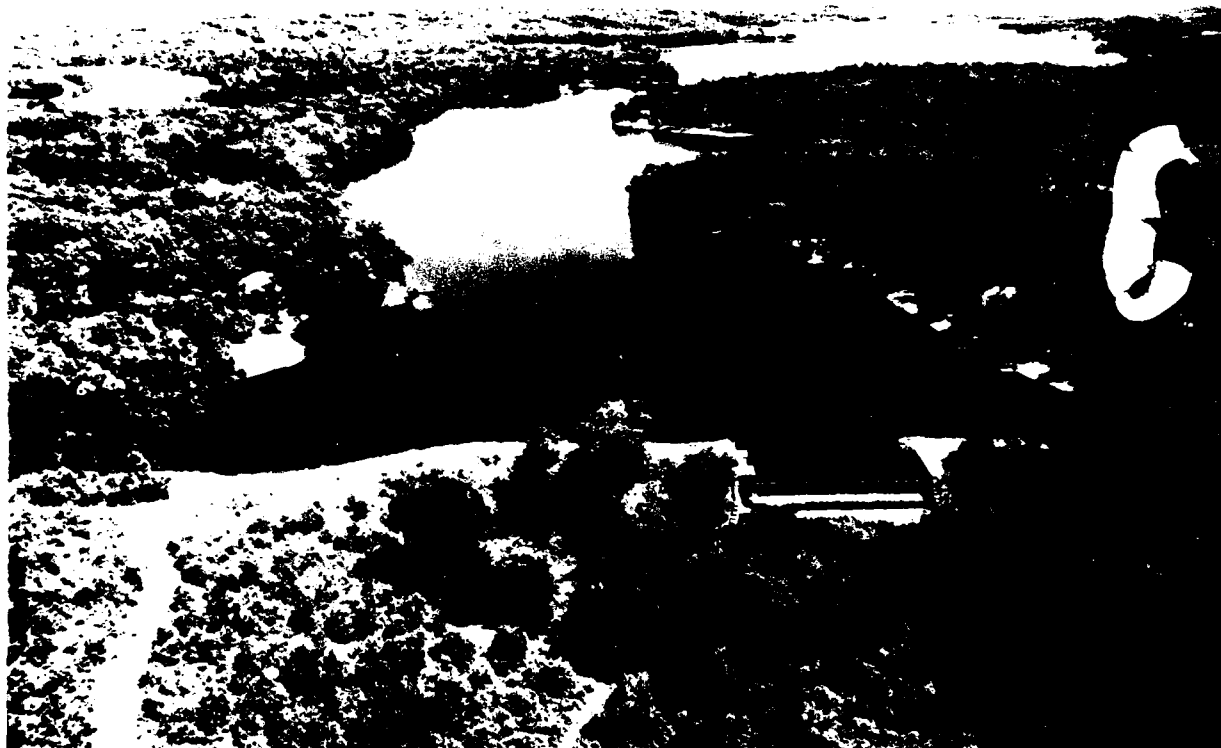
C-1 PACHAUG POND & DAM - LOOKING UPSTREAM

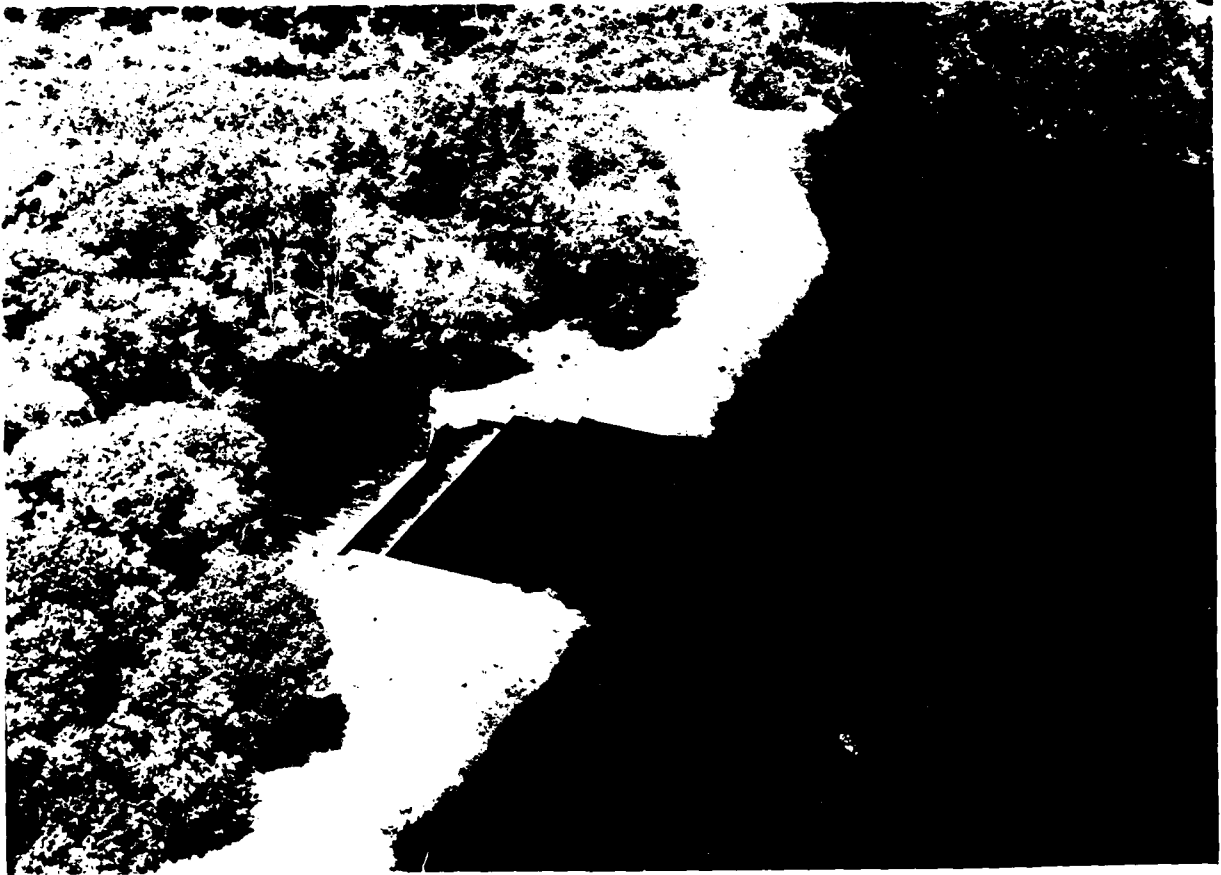
C-2 PACHAUG POND DAM - LOOKING NORTH

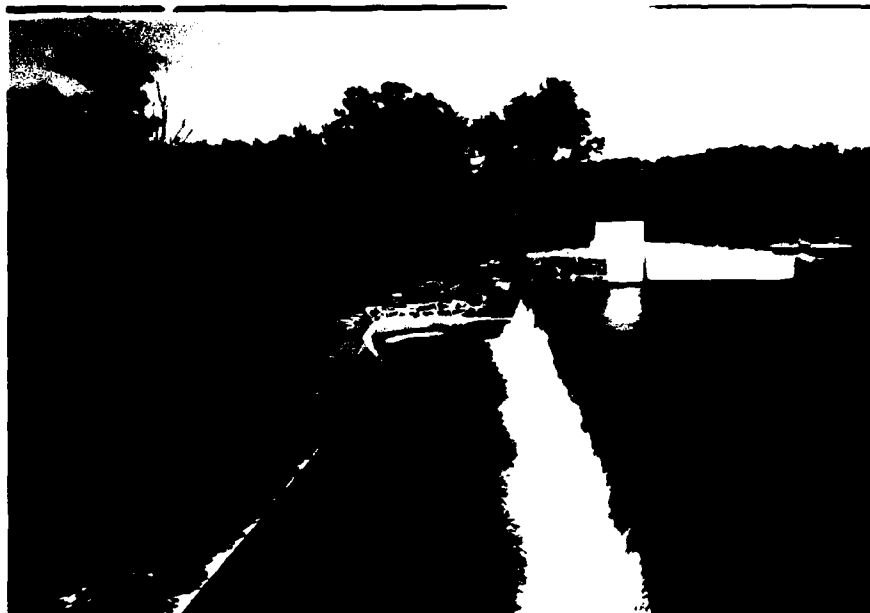
C-3 SPILLWAY CREST, RIGHT TRAINING WALL, GATEHOUSE  
AND DOWNSTREAM STILLING BASIN

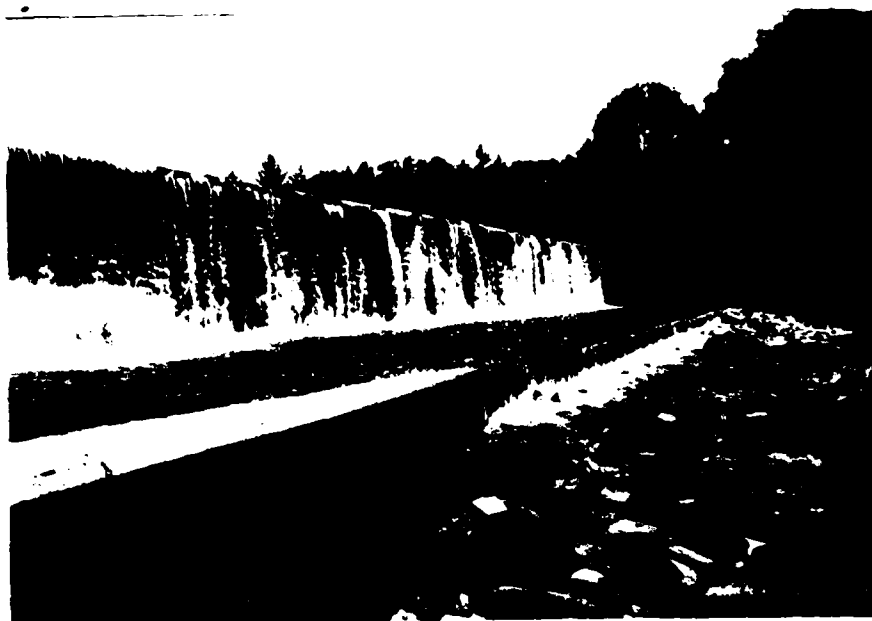
| AREA EVALUATED | CONDITION |
|---|---|
| General Condition | Grouted stone masonry surface good, some settlement of stones on right training wall observed, none dislodged. |

C-4 SPILLWAY CREST, DOWNSTREAM CHANNEL BED AND  
LEFT TRAINING WALL

1. Consideration should be given to the placement of downstream stone protection at the spillway as an effective energy dissipator.
2. Repair to both training walls is needed and should include backfilling, grouting and re-pointing.
3. It is essential to control trespass on the dam embankment and eliminate excessive wear and erosion.
4. Freeboard allowance is lacking for the spillway design flood as well as lesser storm events. Storm surge and wave ride-up causing

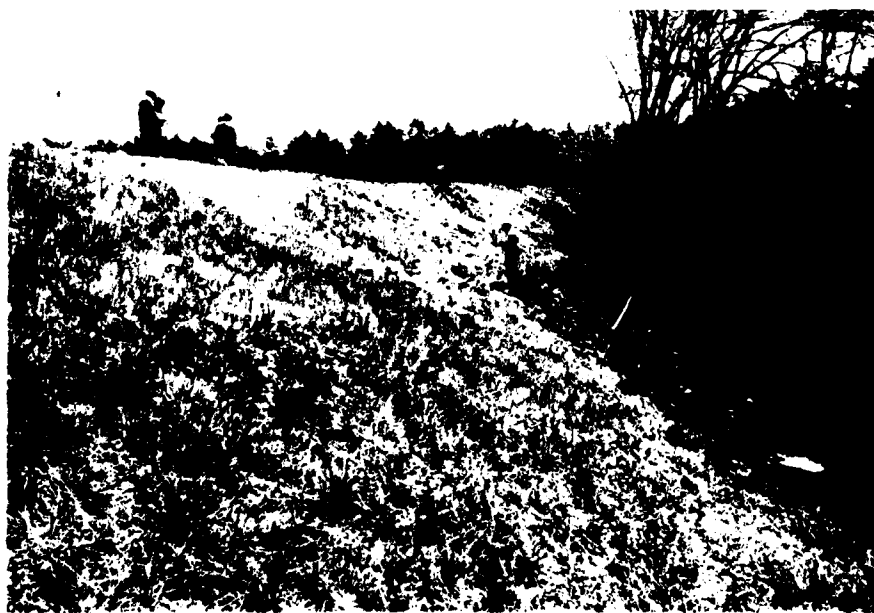
Based on the approximate observed cross section, the seepage appears to exit on the downstream side of the right embankment at a level higher than would be expected if this dam were homogeneous in cross section and permeability. The exit point at one location is shown on a cross-section sketch in Appendix B, and the seepage pond it creates may be seen in Photo C-11. The person standing on the downstream slope (See Photo C-12) is approximately at the top exit point of the seepage.

1. Seepage was observed emerging from the downstream slope of the dam embankment at levels higher than usual for a dam of this type. High water levels in the pond could lead to internal erosion and eventual failure, because the seepage is not controlled. The presence of decaying roots on both the upstream and downstream sides increases the probability of failure by internal erosion. There is no evidence of any wing wall or cutoff from the spillway walls into the embankment. Internal erosion could occur at this location, although no leakage was observed at the time of inspection.

C-12 DOWNSTREAM FACE OF EARTH EMBANKMENT. (note: seepage area to right below level of inspector standing on slope.)

It is recommended that the owner obtain the services of an engineer experienced in the design of earth dams to evaluate and design a seepage monitoring system to effectively collect and monitor these flows; develop a program for the procedure and timely removal of rotting tree stumps and roots along both upstream and downstream slopes of the dam; further, to analyze the embankments with regard to the spillway test flood for slope protection and freeboard allowances. A more detailed investigation should be made of the hydraulic and hydrologic aspects of the site to determine the impact of upstream dam failures and storage at Pachaug Pond because of the large contributing drainage area.
