HOCKANUM RIVER BASIN  
MANCHESTER, CONNECTICUT

CASE POND UPPER DAM  
CT 00560

PHASE I INSPECTION REPORT  
NATIONAL DAM INSPECTION PROGRAM

MAY 1980

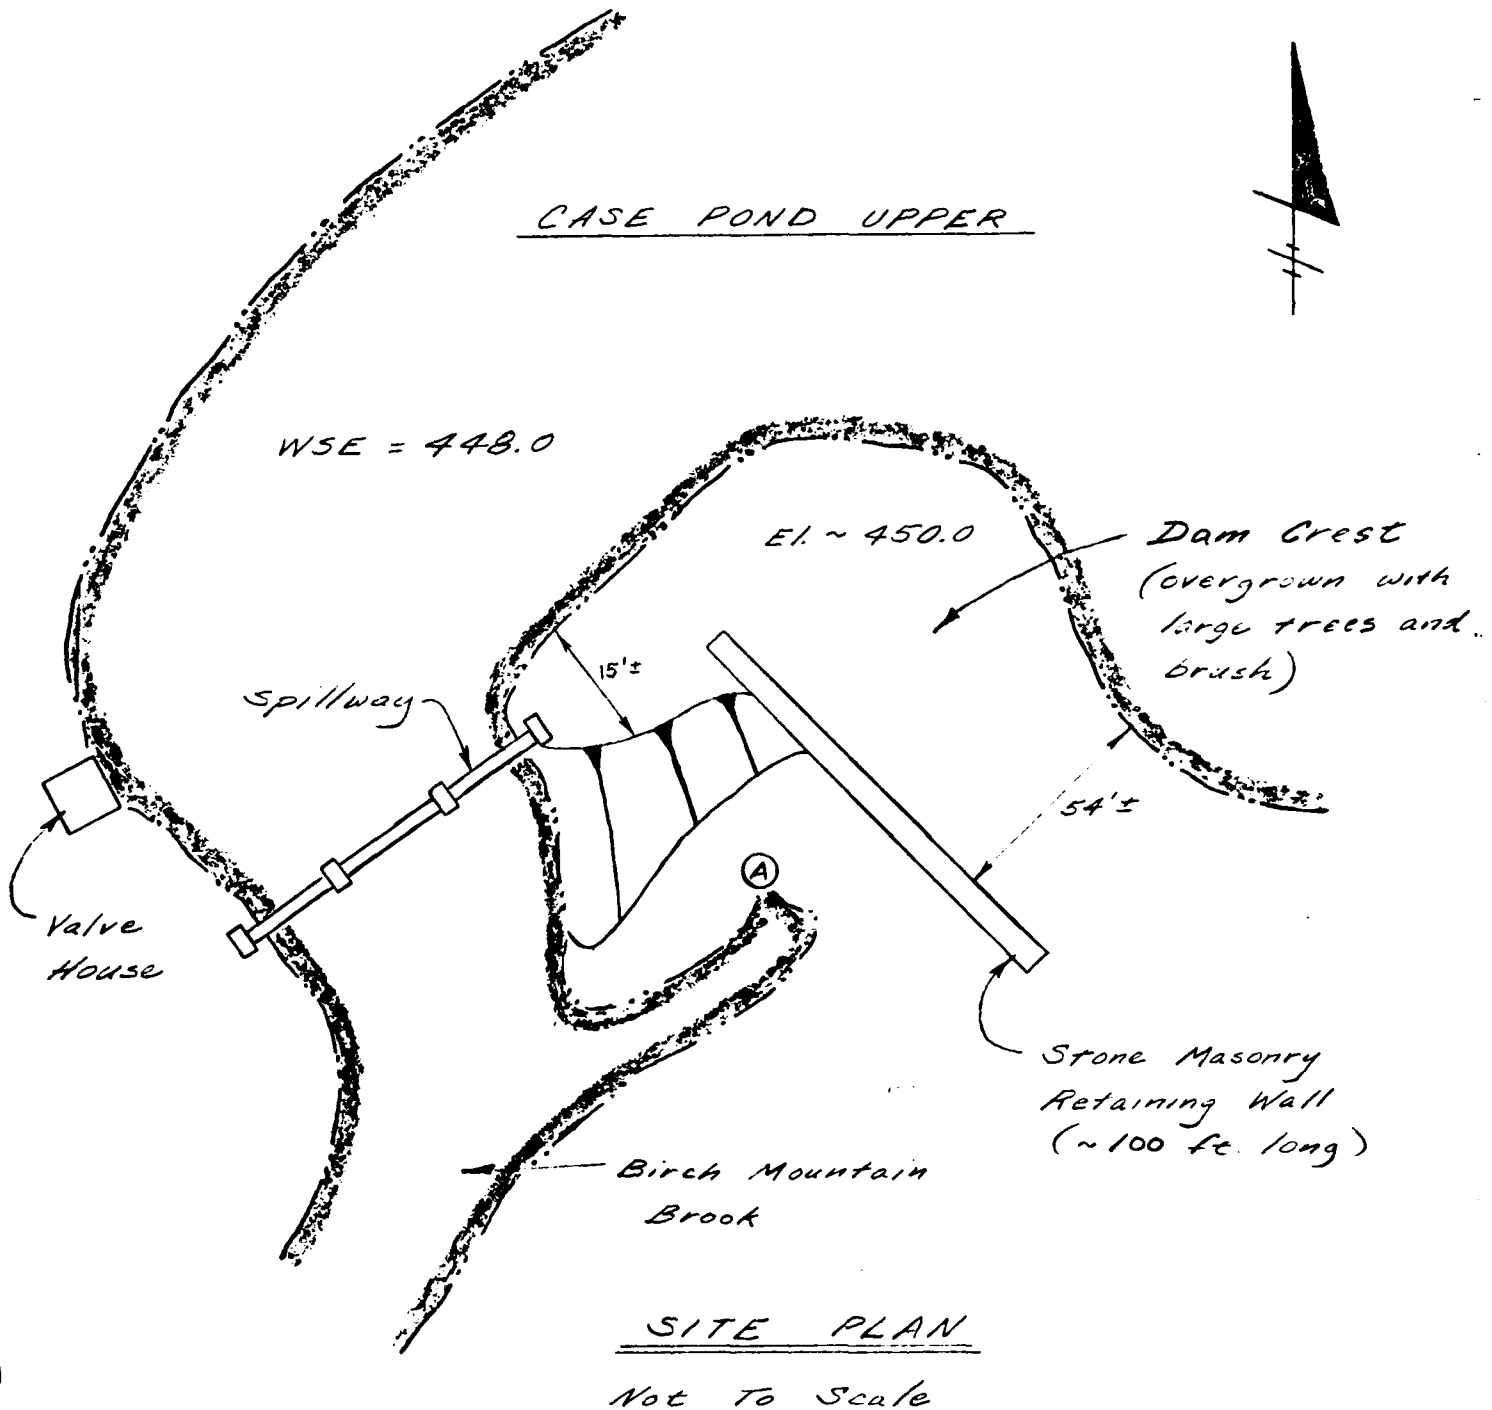
| Case Pond Upper Dam | B-1 | A. H. | 3/80 | 2060-001 |

1. A significant amount of seepage (about 2 gpm) was observed in the vicinity of the downstream toe of the embankment about 10 feet from the downstream embankment retaining wall.

(A) Approximate location of "boiling" seepage.

1. Investigate the causes of the seepage located in the vicinity of the downstream toe of the embankment (about 10 feet downstream of the retaining wall) and at the base of the spillway wall and assess the need for remedial action at each location.

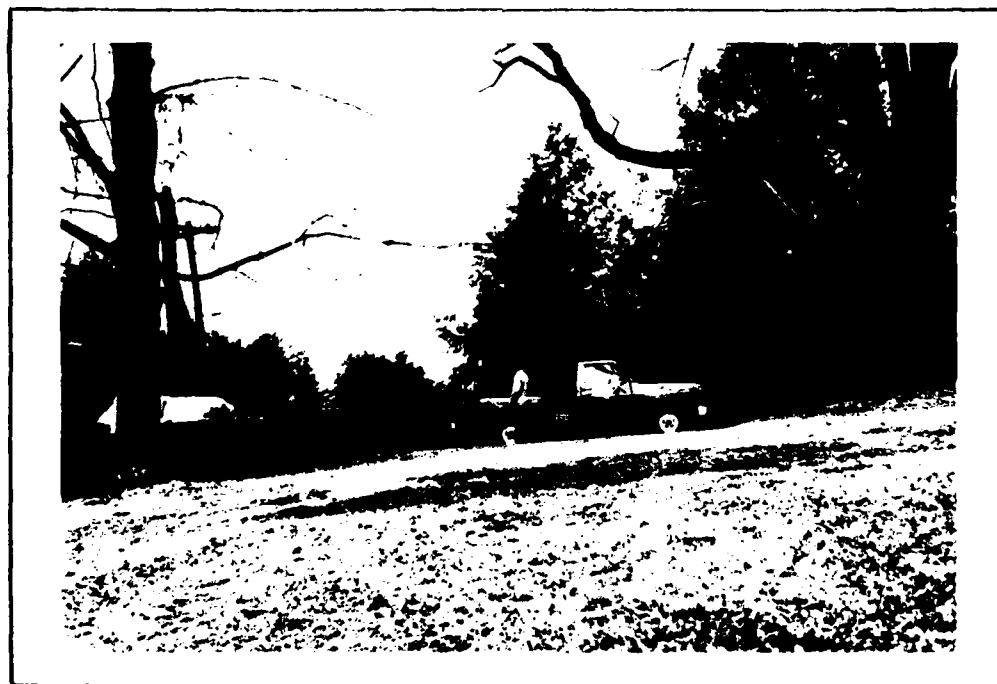
12. REGION TO THE RIGHT OF THE CASE POND LOWER DAM WHERE DISCHARGE WOULD BE CONCENTRATED DURING PERIODS OF EXCESSIVE FLOW. (11/14/79)

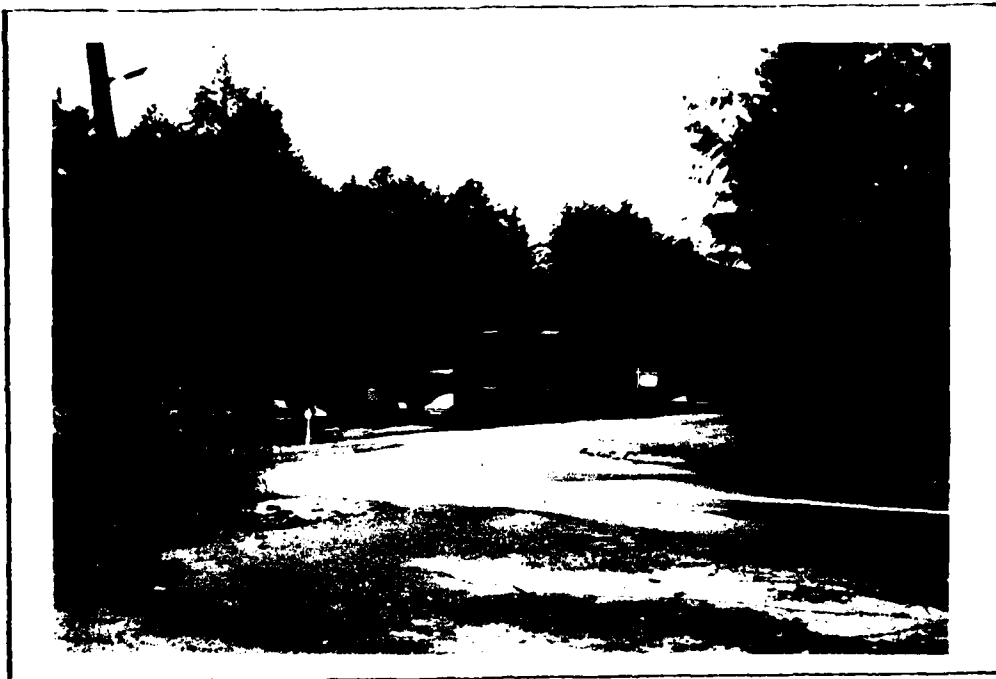
13. FACTORY COMPLEX ABOUT 900 FEET DOWNSTREAM OF CASE POND  
UPPER DAM. (11/14/79)

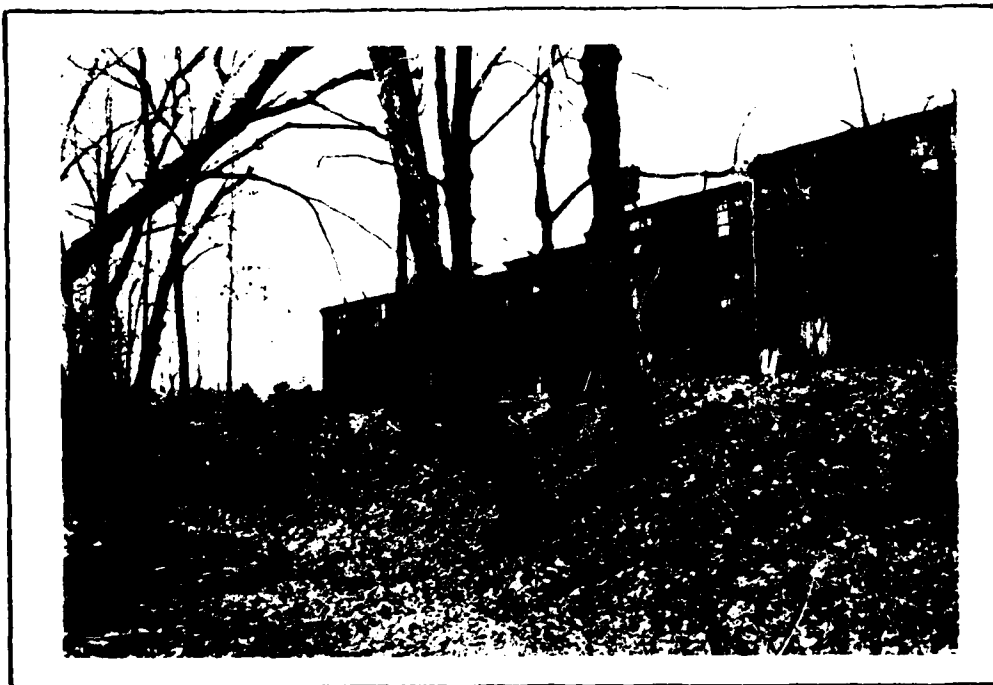
14. APARTMENT COMPLEX ABOUT ONE MILE DOWNSTREAM OF CASE POND  
UPPER DAM. (11/14/79)
