BLACKSTONE RIVER BASIN  
WORCESTER, MASSACHUSETTS

GOES RESERVOIR DAM  
MA 00120

**PHASE I INSPECTION REPORT  
NATIONAL DAM INSPECTION PROGRAM**

AUGUST, 1978

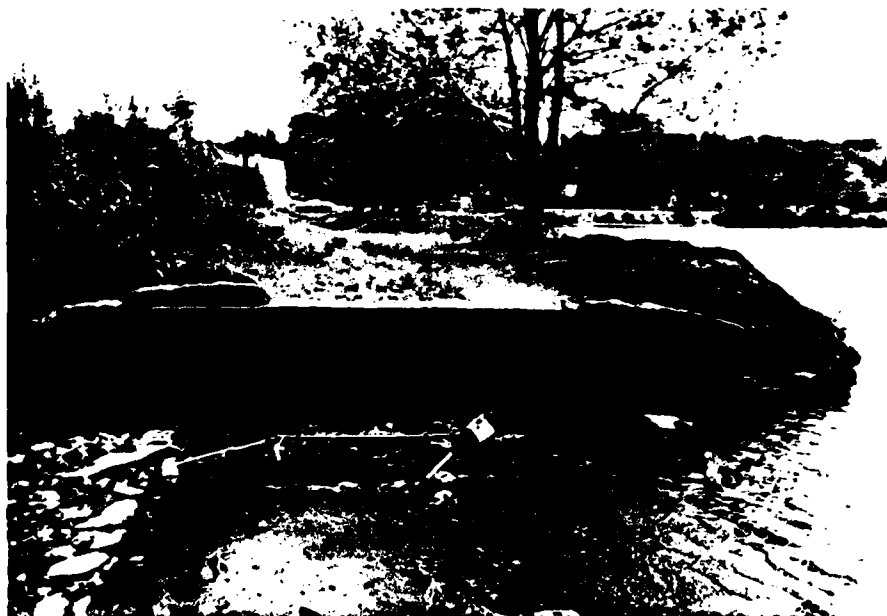
NO. 2 VIEW OF SPILLWAY CREST AND DAM EMBANKMENT

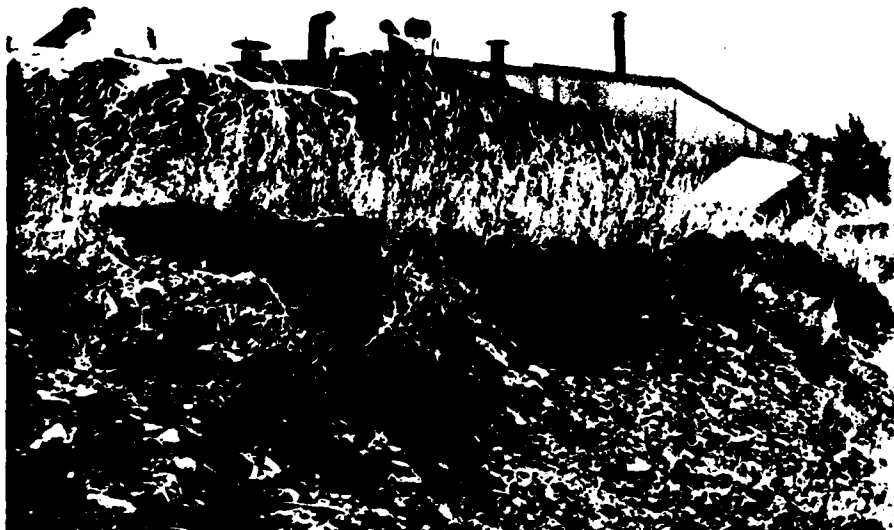
Several signs of distress were observed, the most significant being erosion of the upstream face of the dam which is generally a 1:1 slope without riprap. In several places on the upstream face, the grinding grit is being undermined by wave erosion, causing local sloughing of the slope. The dam section just north of the spillway consists of sand which has been eroded. In this area, undercutting of the bank along the upstream edge of the crest has caused portions of a chain-link fence to fall.

NO. 4 VIEW OF UPSTREAM FACE OF DAM
