STEVENS PAPER COMPANY (UPPER) DAM
MA-00075

NATIONAL DAM INSPECTION PROGRAM
CORPS OF ENGINEERS

4. TITLE (and Subtitle) Stevens Paper Company (Upper) Dam NATIONAL PROGRAM FOR INSPECTION OF NON-FEDERAL DAMS	5. TYPE OF REPORT & PERIOD COVERED INSPECTION REPORT

June 21, 1979

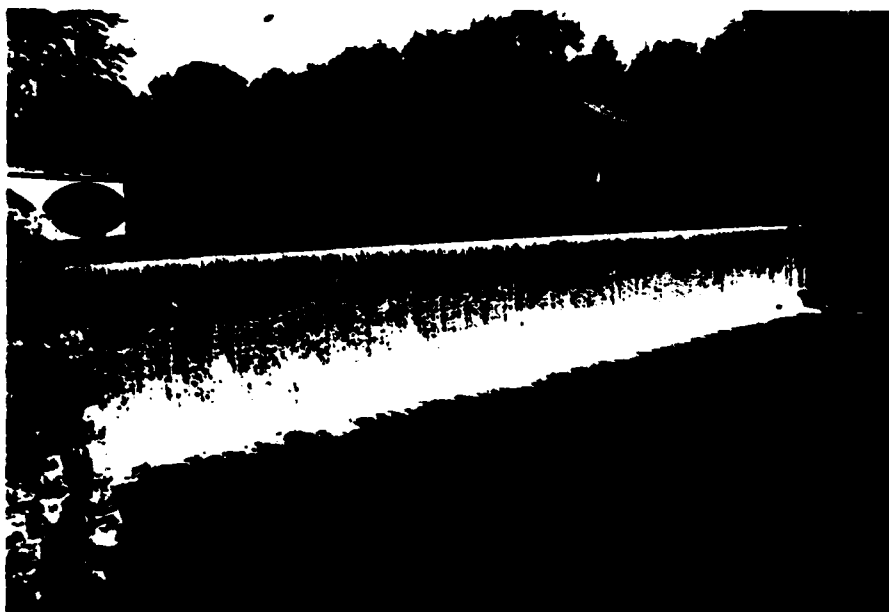
1. Overview of dam from downstream right abutment. Portion of Hortons Bridge located upstream of dam is shown in background.

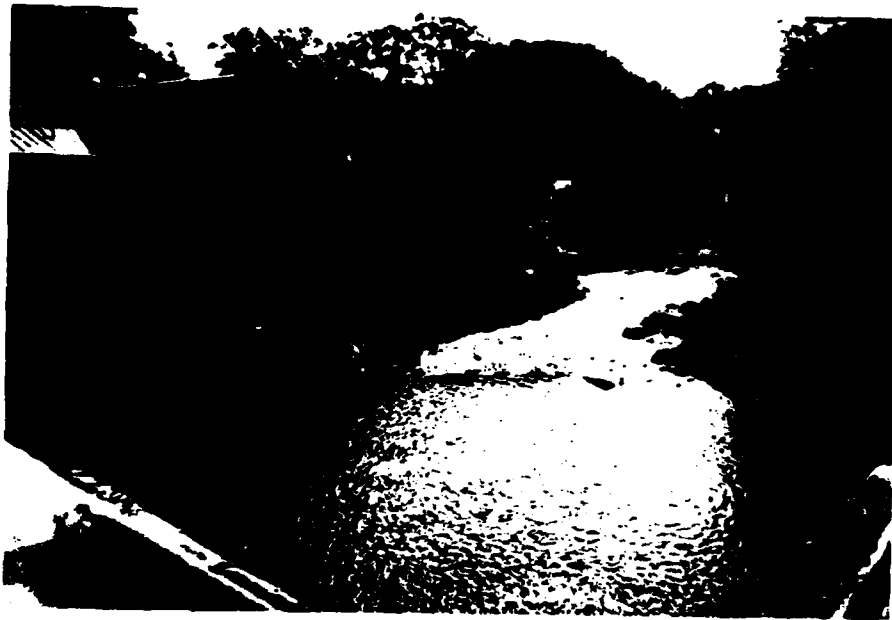
3. Downstream channel from right abutment.

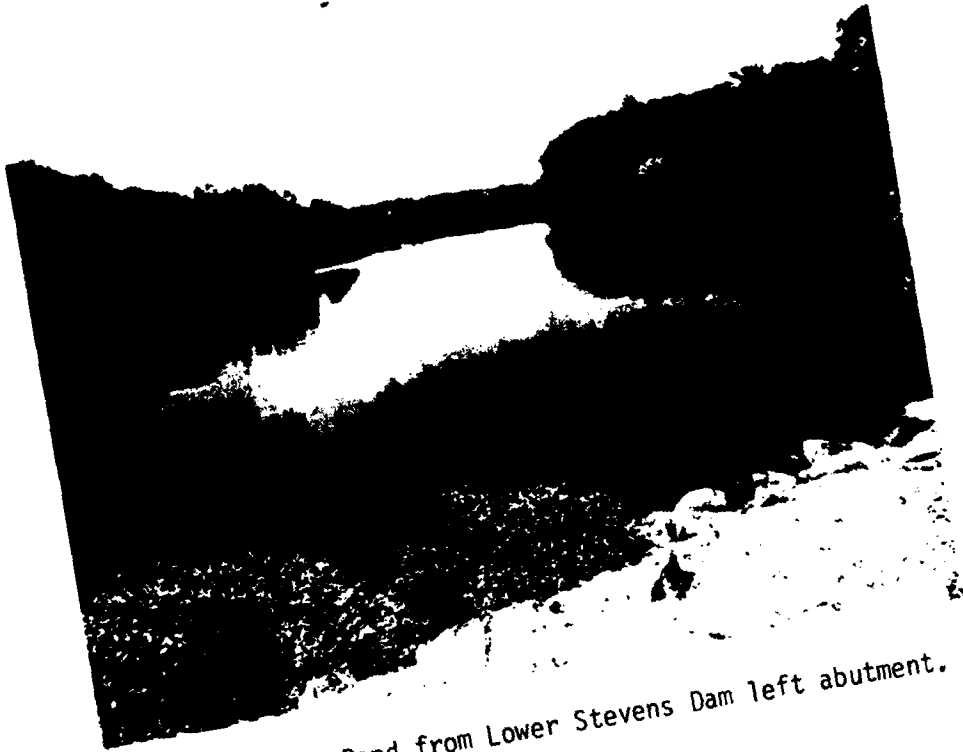
7. View of Crane Pond from Lower Stevens Dam left abutment.

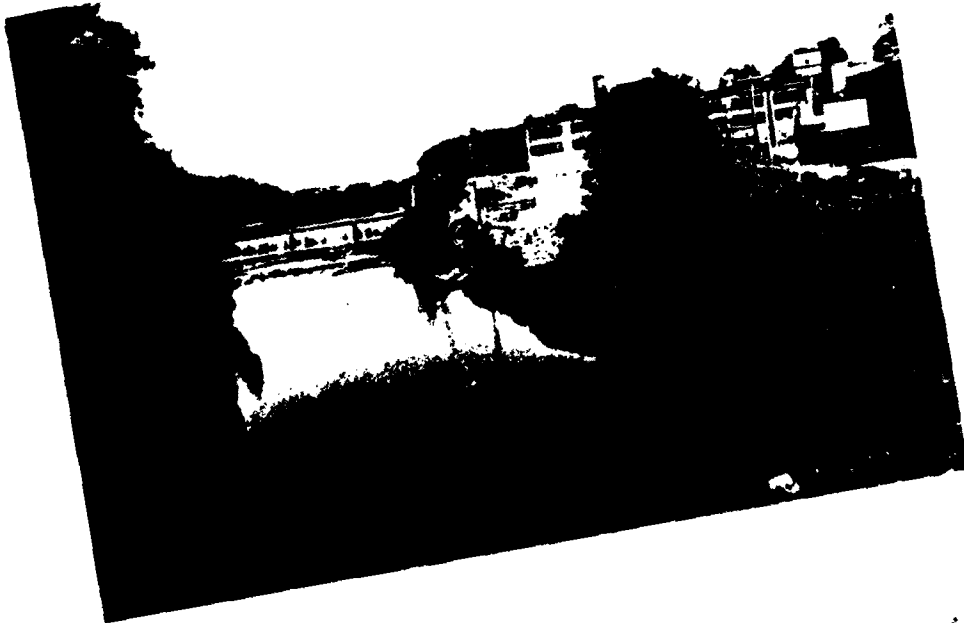
8. View of Lower Stevens Dam and adjacent mill from Southwick Road Bridge.

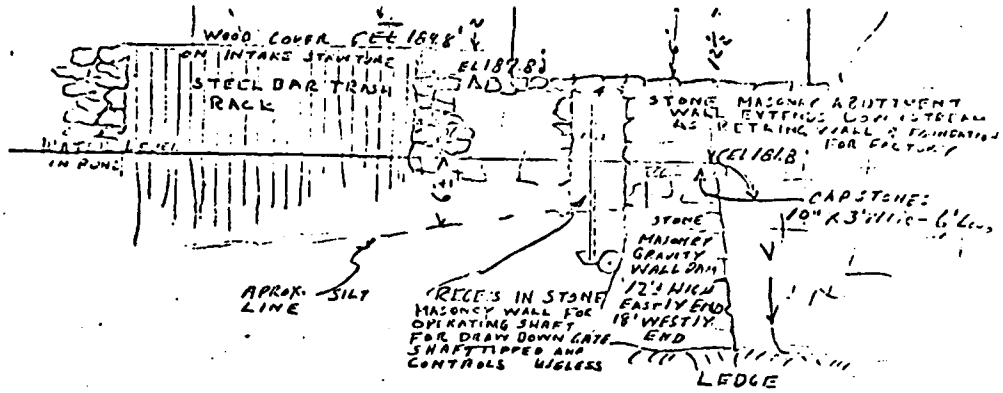
X SECTION A A - SHOWING EAST ABUTMENT & INTAKE FOR MILL

According to the Mill Maintenance Supervisor the control at the penstock inlet has not been operated for some time but control valves and gates inside the Mill are operating. The penstock entry chamber is covered with a plank deck with the hand wheel controlling the intake gate projecting above it. Close inspection of the intake was not practical. There is a steel bar trash rack on the river side of the entry chamber.

In 1957 a concrete flood training wall was built on top of the old stone abutment wall on the northeasterly end of the dam with a leg extending into the slope to present flooding of the Mill and Mill Yard. At this time the shaft for the remote control for the drawdown gate in a recess in the abutment wall was forced outward making it inoperative. The concrete wall and stone masonry abutment are in good condition.

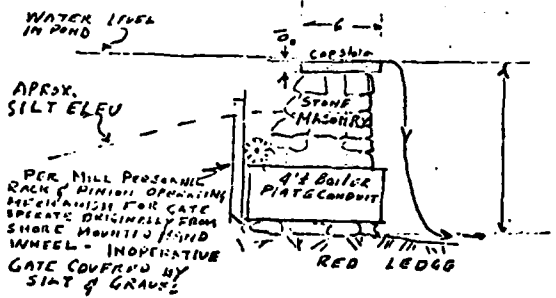
X SECTION BB-THRU 4 1/2 DRAW DOWN CONDUIT - 10' FROM EAST END DAM

Gate covered with silt, etc. by floods. Stem of remote operating
Comments: mechanism bent out - bearing removed - inoperative.

The old four foot diameter drawdown conduit through the base of the stone masonry spillway wall about ten feet from the east end was visible on the downstream face. Silt and other debris covered the upstream end and the gate. The Plant Maintenance Supervisor said that the gate was originally operated by a rack and pinion arrangement located under the water at the gate. The pinion was turned by means of a hand wheel located on the abutment through a system of gears. This drawdown has not been opened for years and the operating mechanism is inoperative.

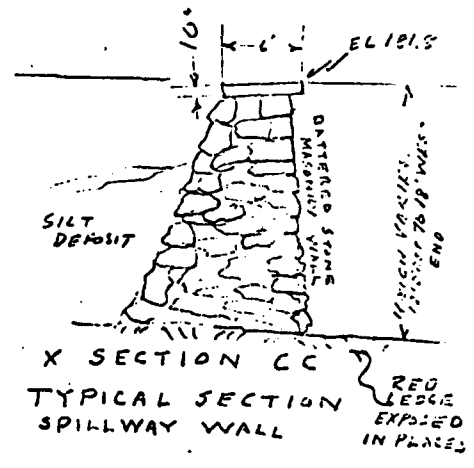
X SECTION CC TYPICAL SECTION SPILLWAY WALL

Comments: Unable to inspect spillway wall and toe due to 4 to 6 inches of water flowing
over wall. Wall apparently founded on red ledge. Noted three small boils
100' downstream.

The alignment and grade of spillway structure and the abutments were true with no visible sags or bulges and no loose or missing stones noted. It appears to be built on red sand stone ledge.
