CONNECTICUT RIVER BASIN
WESTFIELD, MASSACHUSETTS

STEVENS PAPER COMPANY
(LOWER DAM)
MA 00074

PHASE I INSPECTION REPORT
NATIONAL DAM INSPECTION PROGRAM

MARCH 1979
84 09 05 114

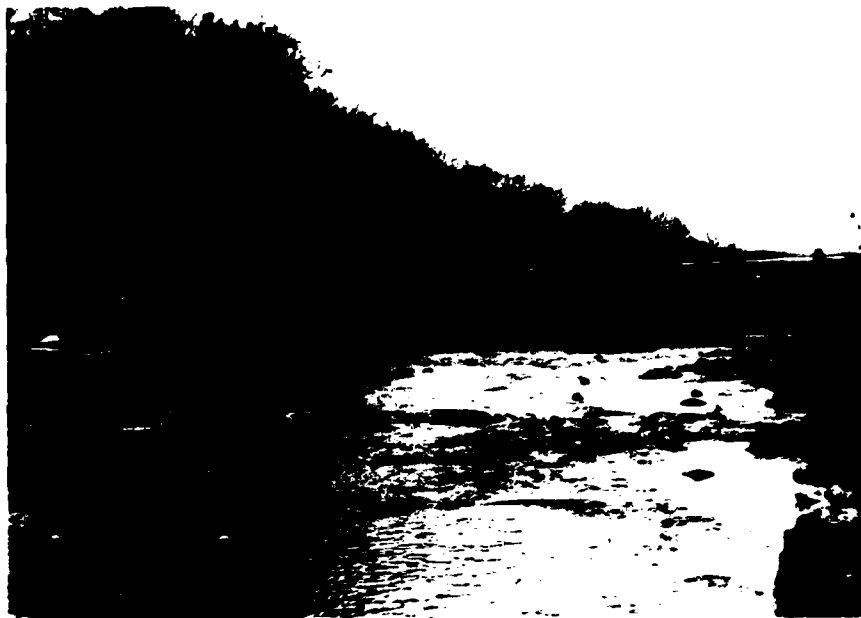
PHOTO NO. 1 - Downstream face of spillway section.

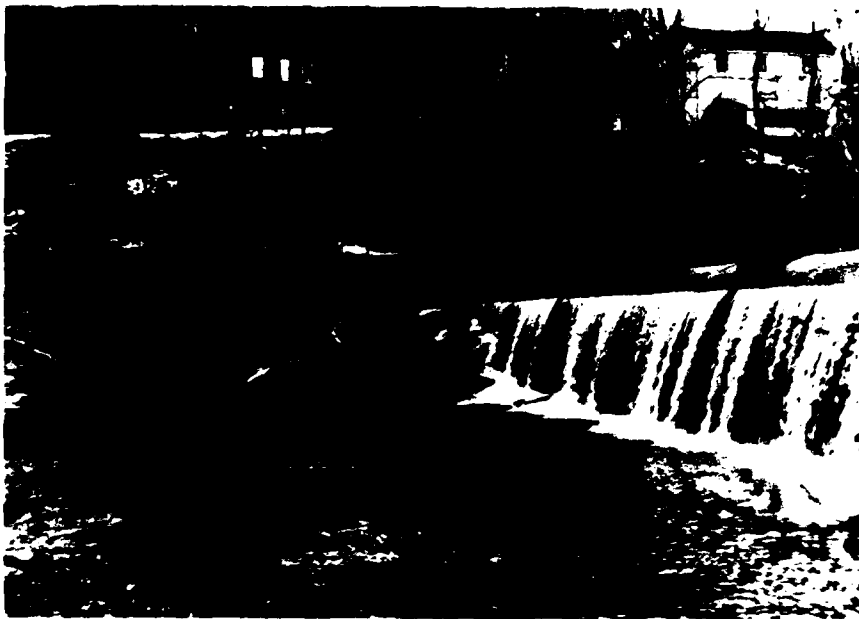
PHOTO NO. 8 - Downstream face of spillway section and right training wall of spillway. Note bedrock outcrop at right end of spillway.

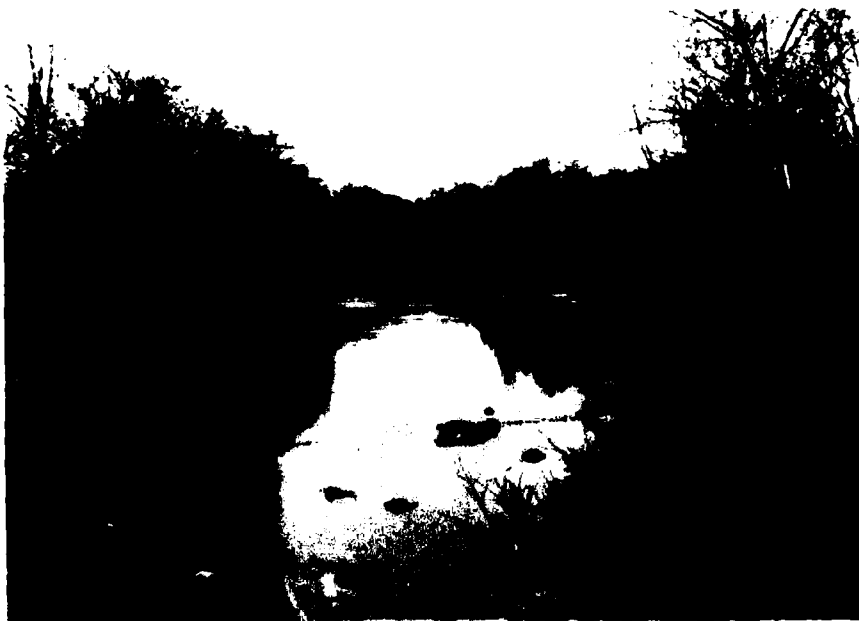
PHOTO NO. 12 - Downstream channel from bridge shown in photo no. 10.

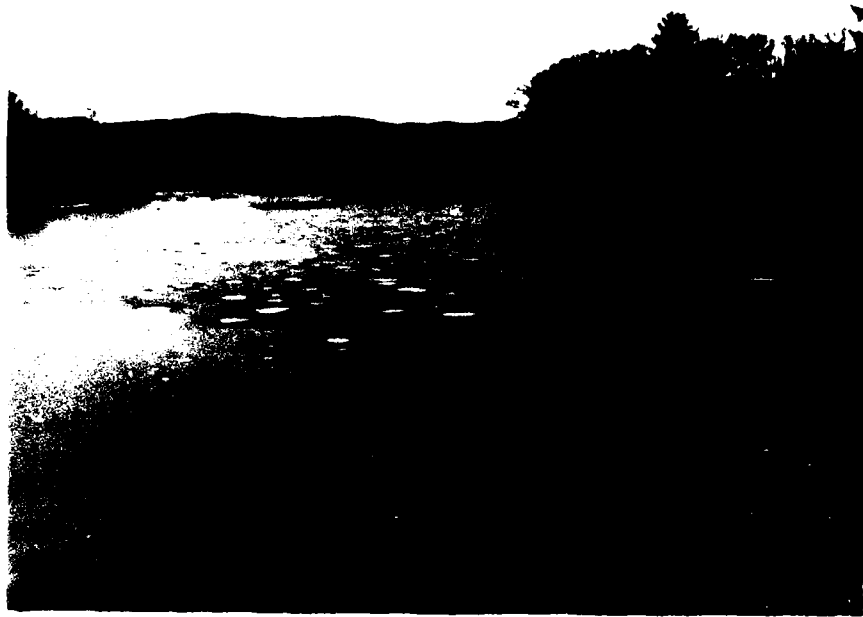
PHOTO NO. 13 - Upstream channel.
