CONNECTICUT RIVER BASIN
SOUTH BARRE, MASSACHUSETTS

SOUTH BARRE MILL POND DAM
MA 00091

PHASE I INSPECTION REPORT
NATIONAL DAM INSPECTION PROGRAM

AUGUST 1978

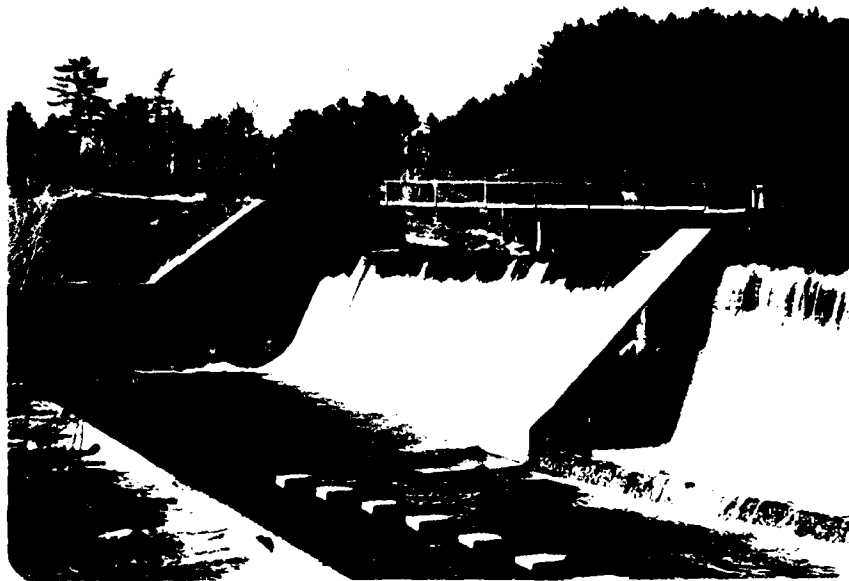
1. Overview of Spillway and Right Embankment

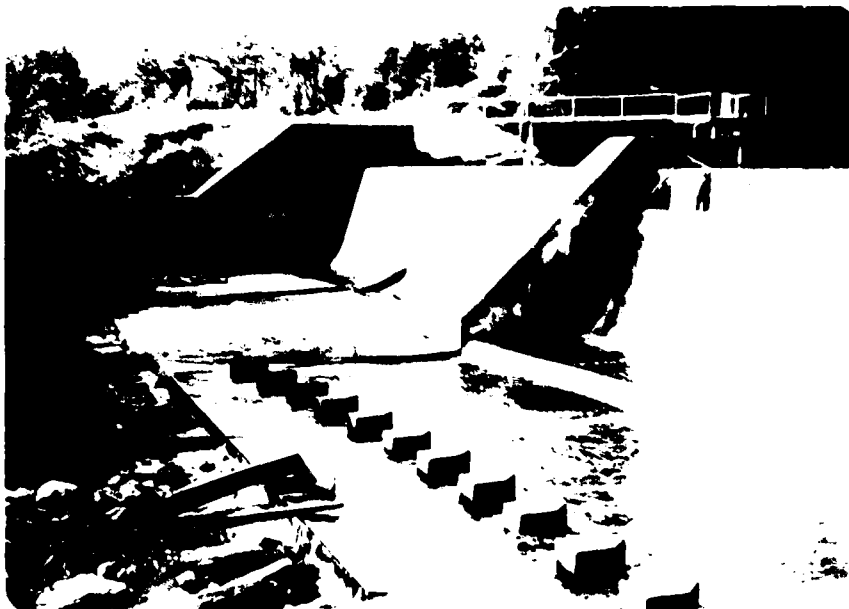
A supplemental inspection was made in June at that time no water was flowing over the right weir, Photo No. 5. The parge coat was found to be in fair condition in the lower region adjacent to the weir and apron. One section approximately 4 ft. long has spalled off exposing the reinforcing mesh. The entire length of the parge coat at the junction of the apron has been undercut. Three drains outlet at the base of the right wall, Photo No. 7. The upstream drain has a small flow of water, the center one was dry and the downstream drain has two plugged pipes just beneath it. Rusty water is seeping from the plugged pipes, Photo No. 8.

The right weir exhibited considerable surface deterioration in the lower region. Several spalled areas are present and the general area appeared to be loose when sounded with a hammer. Two vertical cracks are present. One rises from the main reservoir drain outlet to approximately mid-height of the weir, Photo No. 6. The second is several feet to the left of the first and starts approximately at the elevation of the crown of the outlet pipe and rises vertically to the top of the weir.

5. Right and Left Spillway Weirs Showing Center Pier

1. Repair concrete surfaces on the left spillway training wall and the downstream face of the right spillway weir, to prevent continued deterioration of these structures in the future. Loose weak concrete should be removed and the surface restored by application of concrete mortar, shotcrete or by other methods.
2. Maintain both the gates to the outlet works and the gate which controls flow to the reservoir drain through the right spillway, and operate these gates at least once a year, to provide a means for lowering the pond level in the event of an emergency.

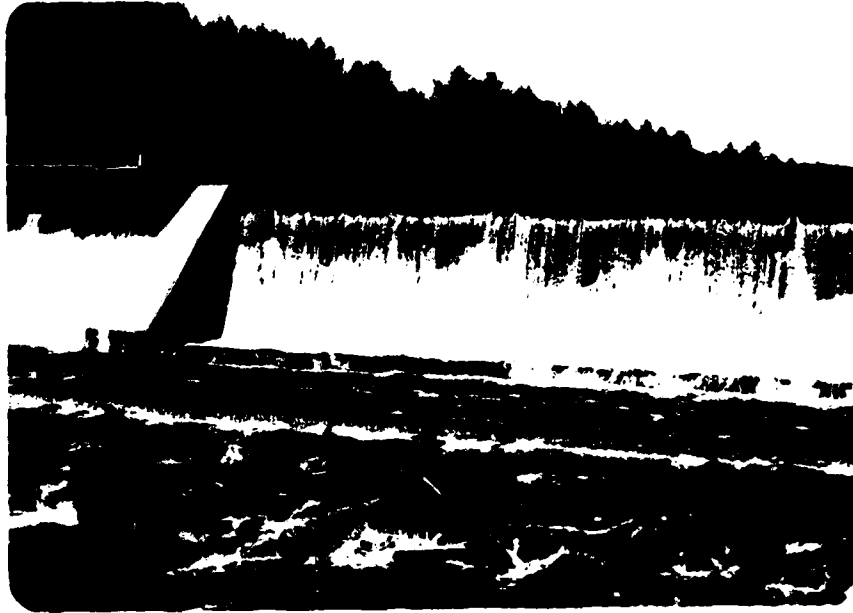
E. Downstream Channel. The channel immediately downstream of the spillways is in satisfactory condition. The floor of the channel is generally covered with cobbles, boulders and broken concrete and the side slopes are paved with large boulders. Islands in the channel floor and side slopes are lightly wooded. These conditions are shown in Photos No. 2, 3 and 9.

9. Left Spillway Weir
