HOUSATONIC RIVER BASIN
PITTSFIELD, MASSACHUSETTS

ONOTA LAKE DAM
MA 00016

PHASE 1 INSPECTION REPORT
NATIONAL DAM INSPECTION PROGRAM

NOVEMBER 1978

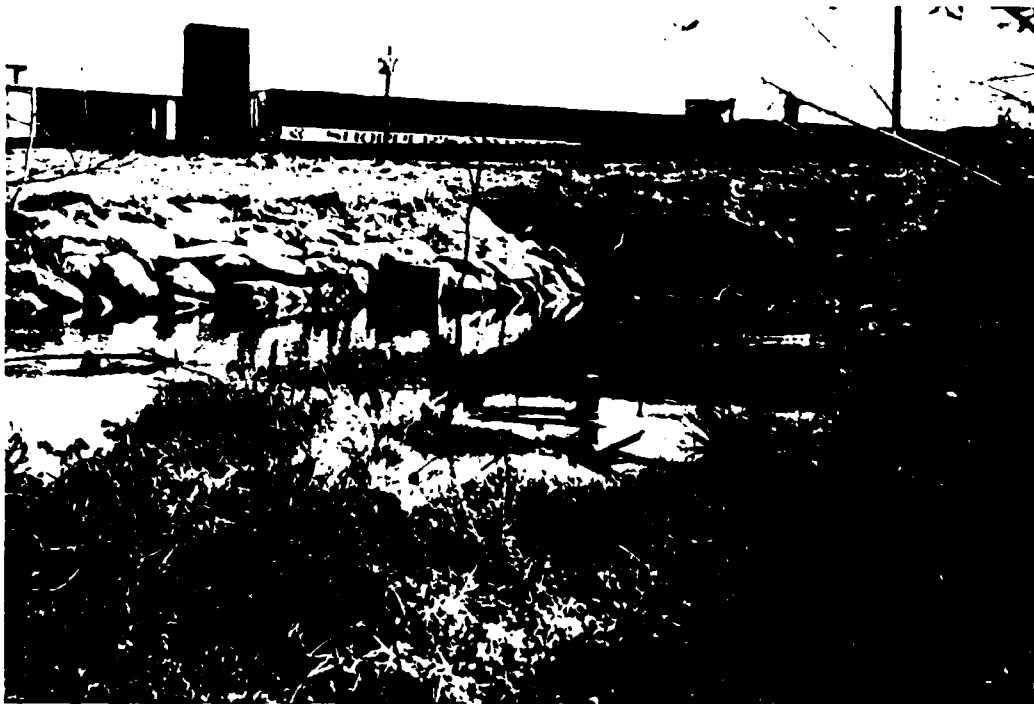
9a. AT INLET. NOTE RIPRAP SLOPE.

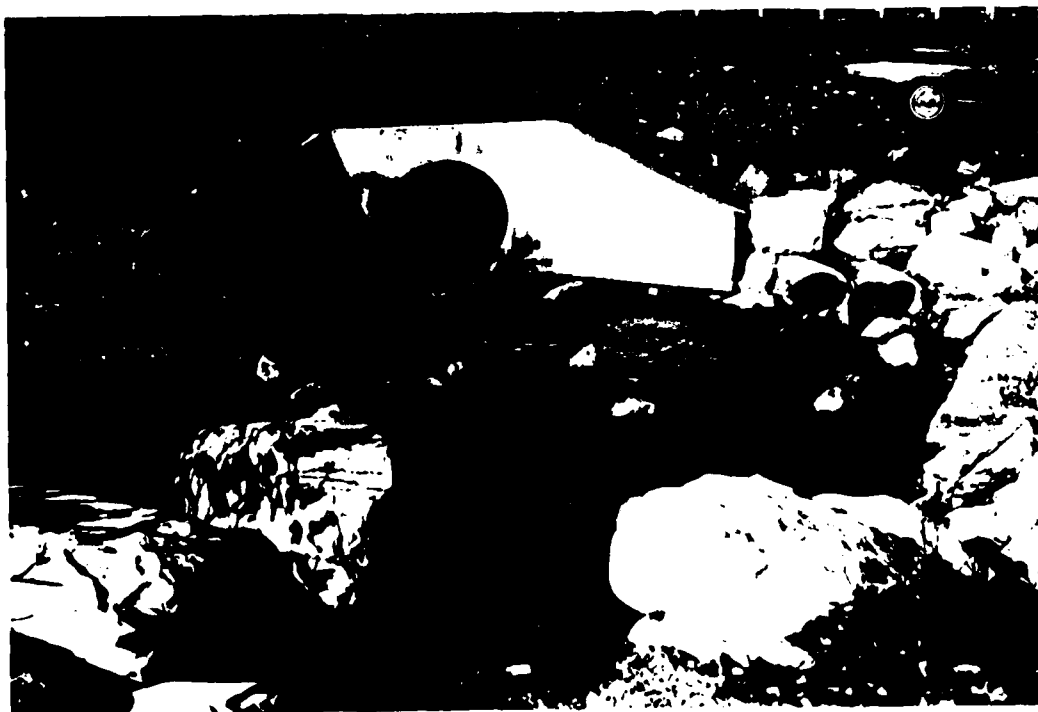
9c. AT OUTLET. NOTE INTAKE STEEL PIPE CONTINUATION OF

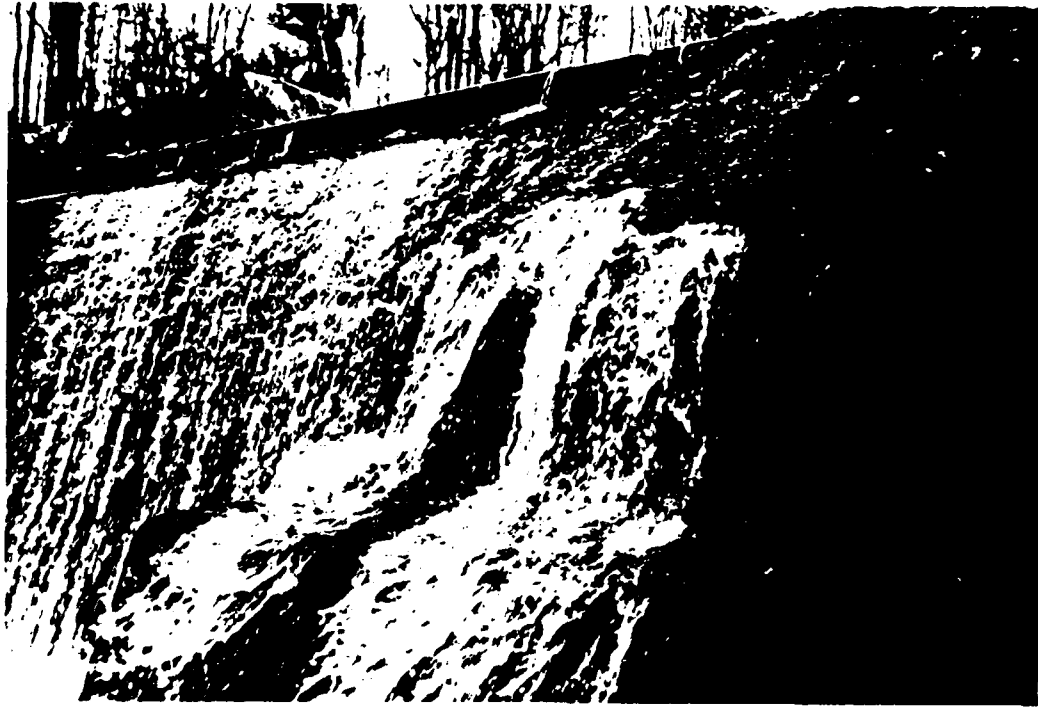
3) The grout on the face of the buttress is spalled and the grout and concrete at the base of the buttress is eroded exposing the underlying stone masonry.

16. VIEW OF SPALLED CONCRETE ON MAIN DAM BUTTRESS.

5. Repair all gunited and concrete surfaces.
6. Keep vegetation in a close cut condition on the crest and slopes of the earthfill portion of the Canal Dam and the area adjacent to the downstream toe.
