**CONNECTICUT RIVER BASIN  
CHICOPEE, MASSACHUSETTS**

**UPPER BEMIS POND DAM  
MA00069**

**LOWER BEMIS POND DAM  
MA 00531**

**PHASE I INSPECTION REPORT  
NATIONAL DAM INSPECTION PROGRAM**

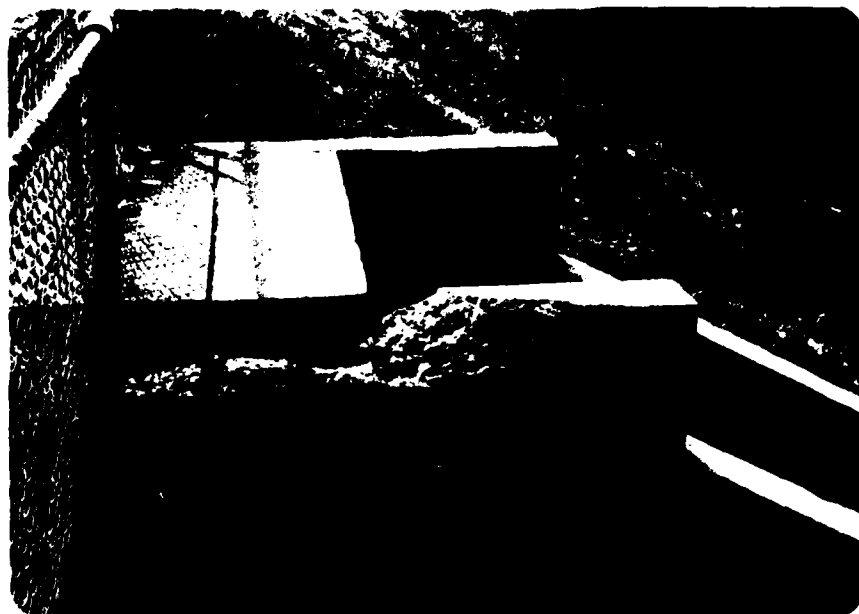
NO. 4 SPALLING OF FLUME WALL UPPER BEMIS POND DAM

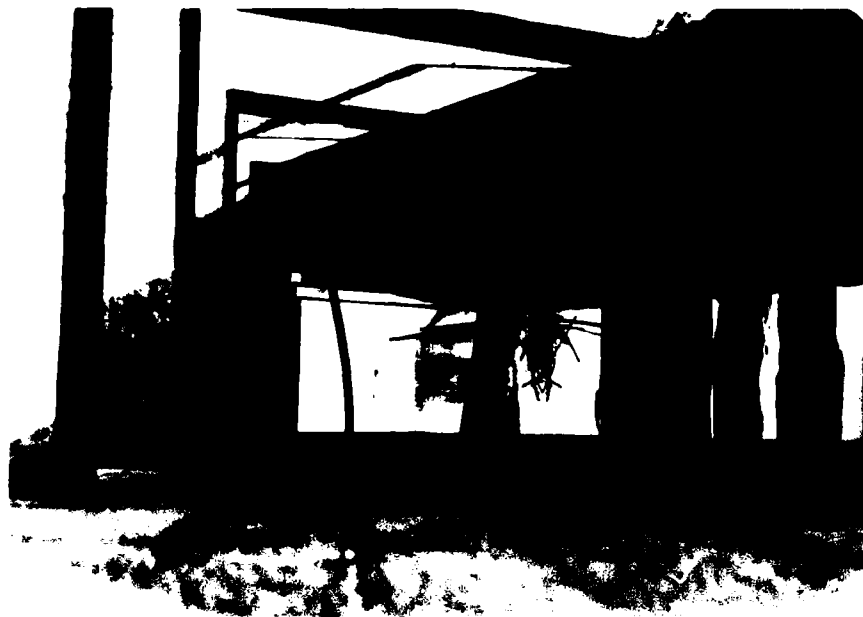
There are nine 12-inch square concrete struts bracing the walls and they were all in good condition (see Photographs No. 5 and 6).

NO. 6 INTERIOR OF FLUME UPPER BEMIS  
POND DAM

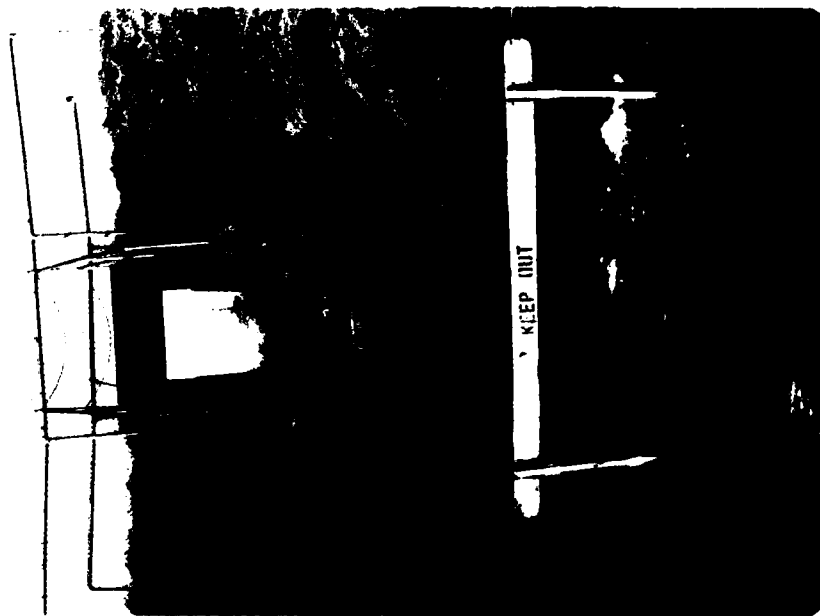
The flume (main spillway) is a flat-bottomed concrete channel with stop logs (see Photograph No. 5). At the time of the inspection, water was discharging through the flume, so the floor, stop logs, and downstream toe could not be examined (see Photograph No. 6). The concrete on the walls of the flume was in poor condition in localized areas. The top of the east wall has deteriorated to expose the reinforcing steel (see Photograph No. 4). There was a 1-1/2-inch deep casting void on the west wall that covered a 2-foot square area. The walkway over the flume is made of concrete slabs that are in fair condition with moderate spalling of the edges.

NO. 5 UPSTREAM END OF FLUME UPPER BEMIS  
POND DAM
