CONNECTICUT RIVER BASIN
COLRAIN, MASSACHUSETTS

KENDALL CO. NO. I DAM
MA 00047

PHASE I INSPECTION REPORT
NATIONAL DAM INSPECTION PROGRAM

JANUARY 1981

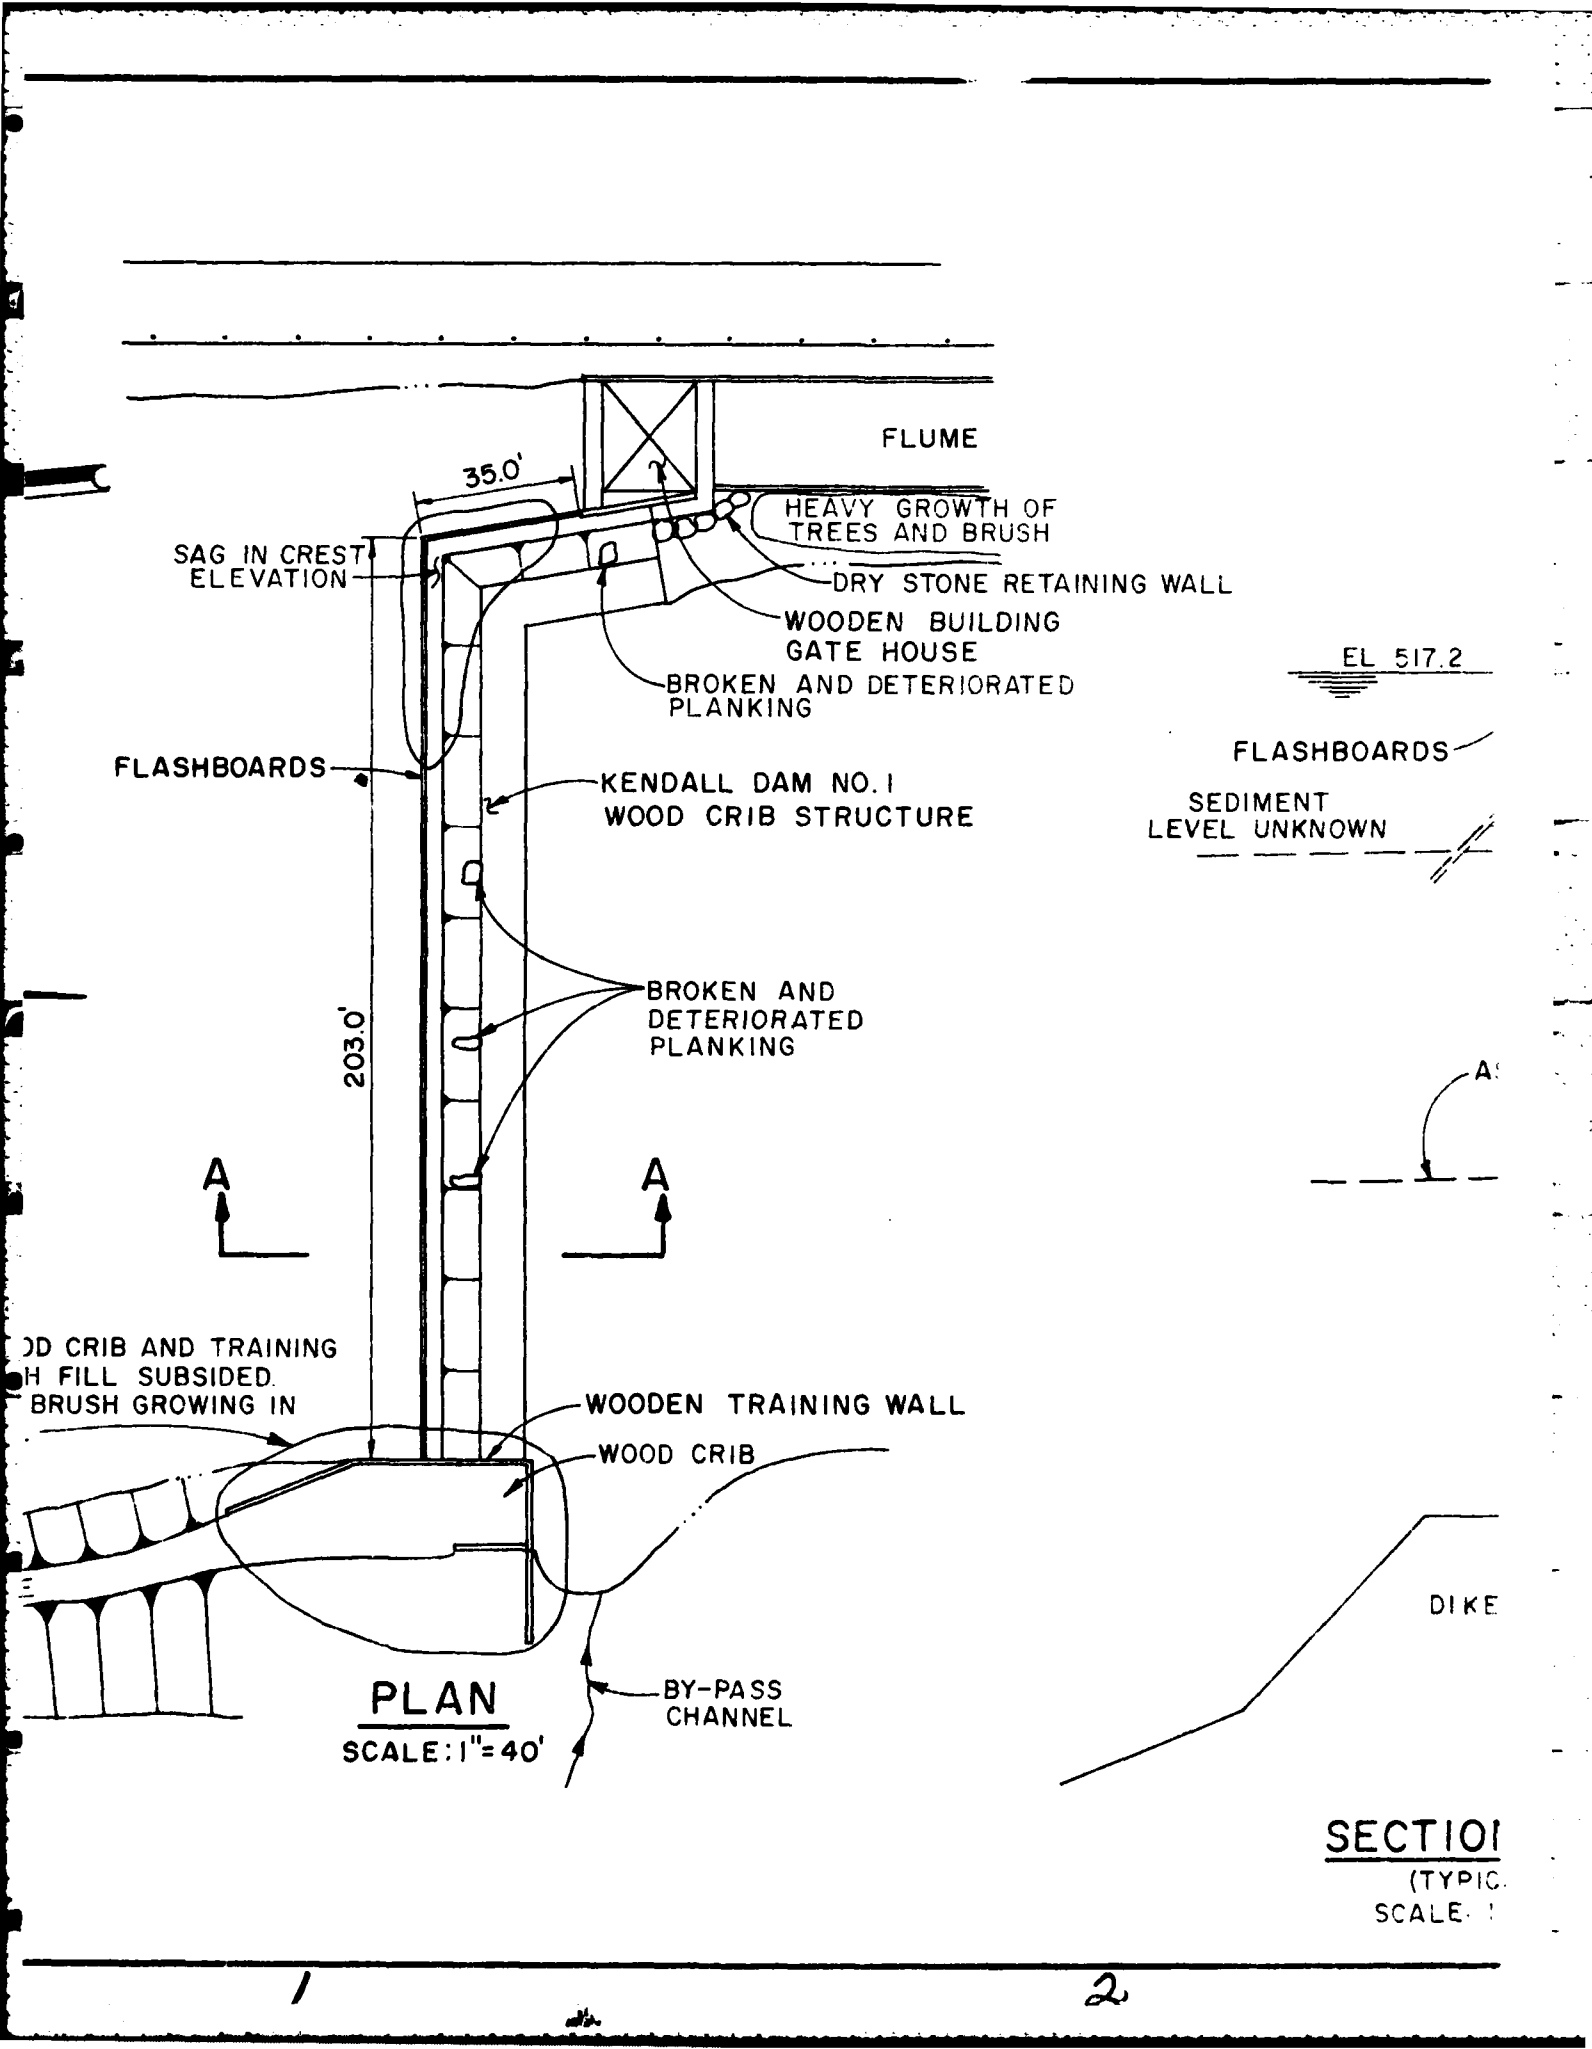
SAG IN CREST ELEVATION

BROKEN AND DETERIORATED PLANKING
