CONNECTICUT RIVER BASIN  
GARDNER , MASSACHUSETTS

PERLEY BROOK RESERVOIR DAM  
MA 00119

PHASE I INSPECTION REPORT  
NATIONAL DAM INSPECTION PROGRAM

JUNE 1980

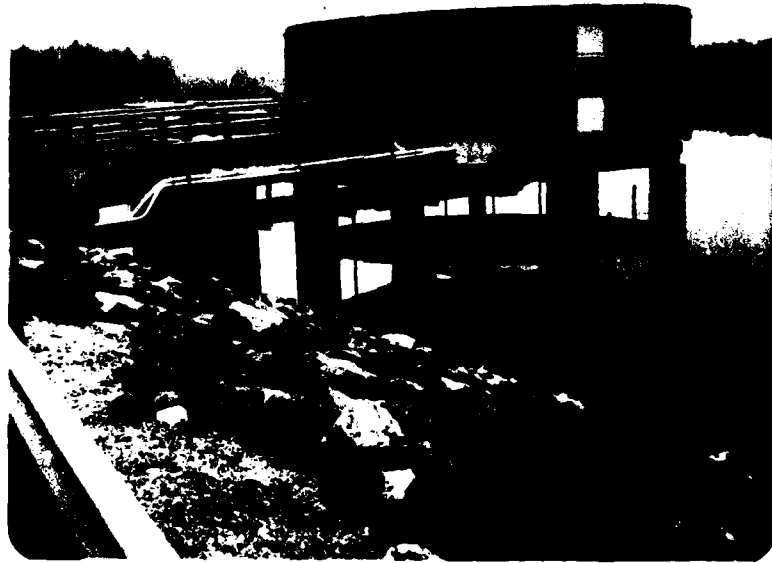
**NO. 1 VIEW OF PUMP STATION AND SPILLWAY**
