FRENCH RIVER BASIN
CHARLTON, MASSACHUSETTS

LITTLE NUGGET LAKE DAM
MA 00103

**PHASE I INSPECTION REPORT
NATIONAL DAM INSPECTION PROGRAM**

OCTOBER 1978

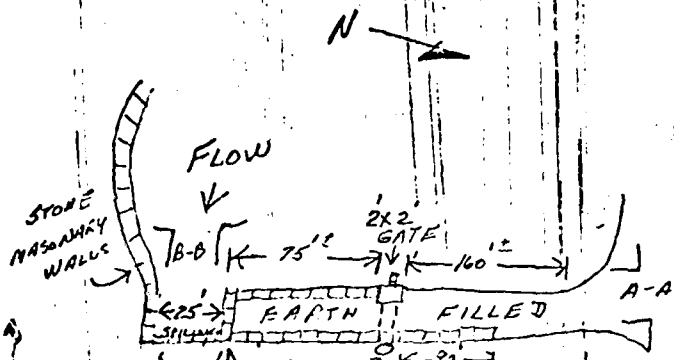
A-A - DAM SIDE VIEW -

LEAKS BETWEEN LOGS + MORTAR CO STONE WALL - 6/26/72 ART
