NATIONAL PROGRAM FOR INSPECTION OF NON-FEDERAL DAMS  
SOUTH VILLAGE DAM (MA.) (U) CORPS OF ENGINEERS WALTHAM  
MA NEW ENGLAND DIV NOV 79

SOUTH VILLAGE DAM  
MA 00107

PHASE I INSPECTION REPORT  
NATIONAL DAM INSPECTION PROGRAM

NOVEMBER 1979

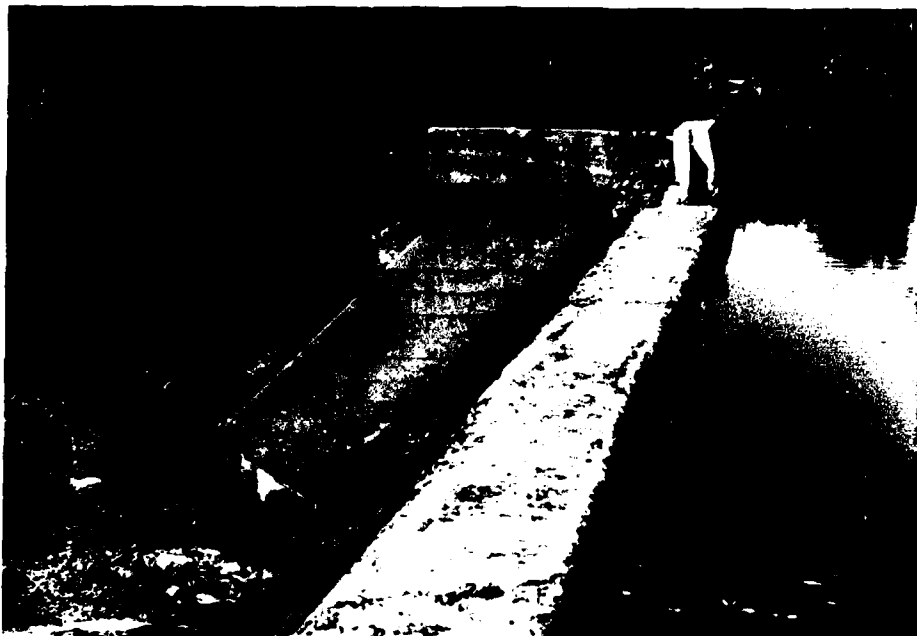
- (7) The stone masonry wall on the shore side of the canal has some stones missing and vegetation growing in the joints.
- (8) The concrete canal wall and overflow spillway have minor spalls along its length and a major face spall on the right side wall of the overflow spillway. A diagonal crack was

noted near the base of the overflow spillway right side wall. Vertical joints in these walls have started to deteriorate and some vegetation is present.

8. RIGHT SIDEWALL OF CANAL SPILLWAY.

- (1) Remove the remaining flashboard pins from the overflow section of the dam.
- (2) Perform maintenance work on the concrete at the dam and canal. This should include the removal of vegetation from expansion joints, the sealing of expansion joints, the patching of spalls and cracks, and the resurfacing of the eroded concrete areas.
