CONNECTICUT RIVER BASIN  
LEYDEN, MASSACHUSETTS

LOWER GLEN (GREENFIELD) RESERVOIR DAM  
MA 00048

PHASE I INSPECTION REPORT  
NATIONAL DAM INSPECTION PROGRAM

MARCH 1981

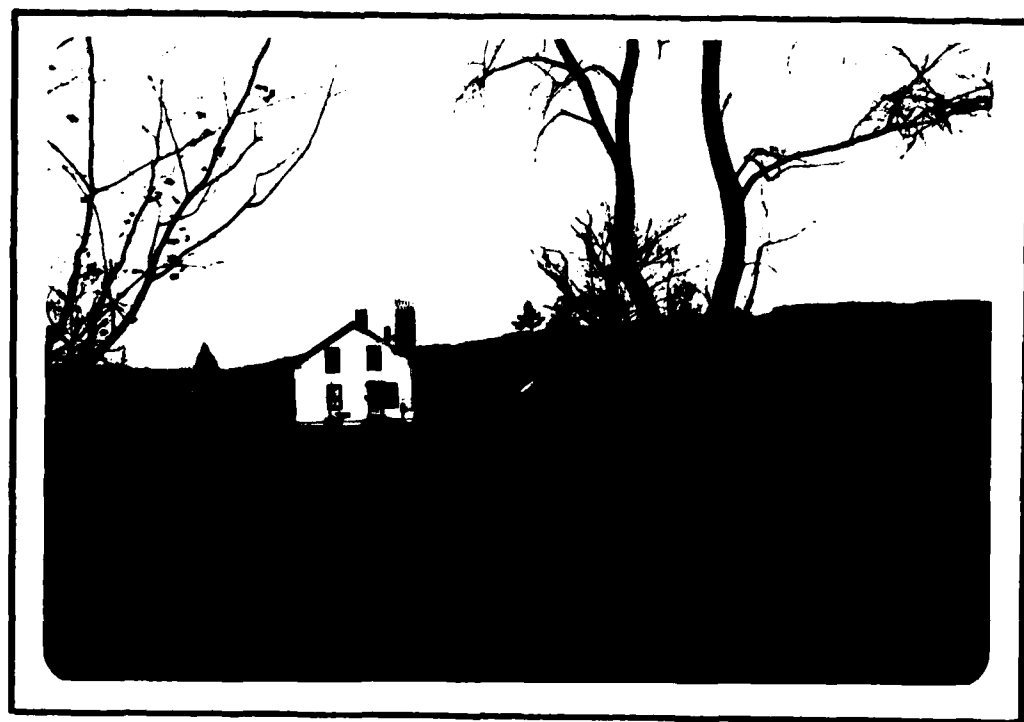
8. POTENTIAL DAMAGE AREA APPROXIMATELY 1.6 MILES DOWNSTREAM OF THE DAM. (12/3/80)
