FRENCH RIVER BASIN,  
DUDLEY, MASSACHUSETTS.

LARNER POND DAM  
(MA 00111)

**PHASE I INSPECTION REPORT  
NATIONAL DAM INSPECTION PROGRAM**

AUGUST, 1978

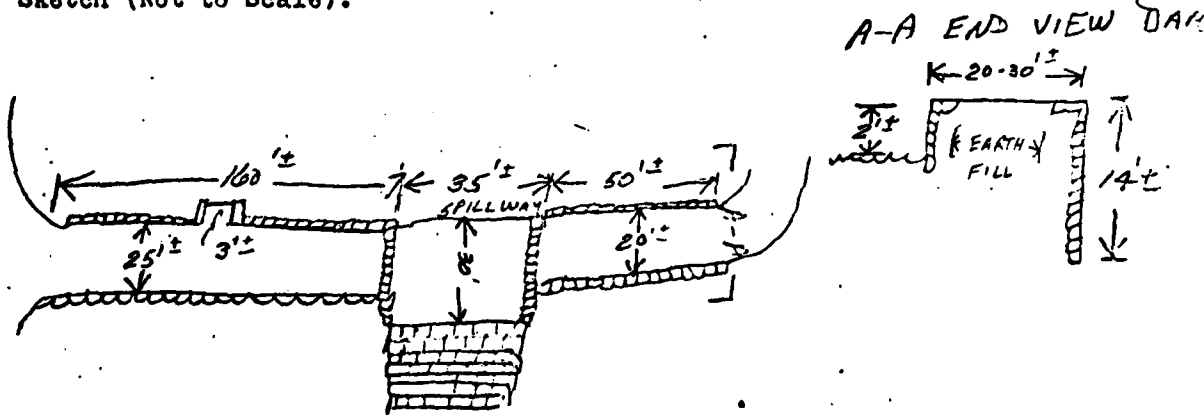
STONE MASONRY WALLS W/ EARTH FILL  
- 3 GATE OPEN CANNOT SEE ANY BOARDS, WATER 1'±  
- BELOW GOING OVER SPILLWAY. SPILLWAY WALLS 18" ABOVE SPILLWAY.  
Sketch (Not to Scale):

STONE MASONRY WALLS FACING THE WATER HAVE BEEN REMOVED IN NUMEROUS SPOTS CAUSING DEPRESSIONS IN DAM FACE FROM 1'-2'± IN SPOTS, NO APPARENT DANGER.
