CONNECTICUT RIVER BASIN  
RUSSELL, MASSACHUSETTS

COBBLE MOUNTAIN RESERVOIR DAM  
MA 00068

PHASE I INSPECTION REPORT  
NATIONAL DAM INSPECTION PROGRAM

MARCH 1980

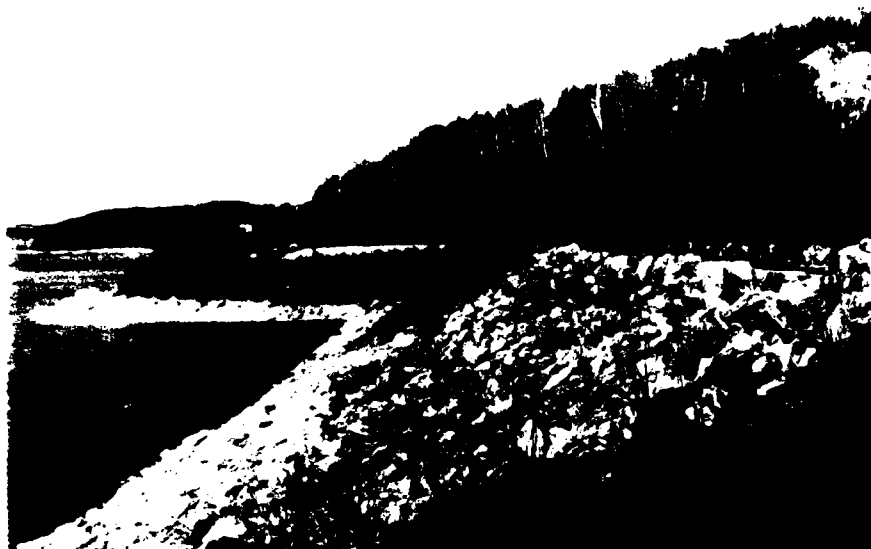
Photo 1

Upstream face of dam,  
looking north at left end
