CONNECTICUT RIVER BASIN  
LEYDEN , MASSACHUSETTS

UPPER GLEN (GREENFIELD) RESERVOIR DAM  
MA 00049

PHASE I INSPECTION REPORT  
NATIONAL DAM INSPECTION PROGRAM

MARCH 1981

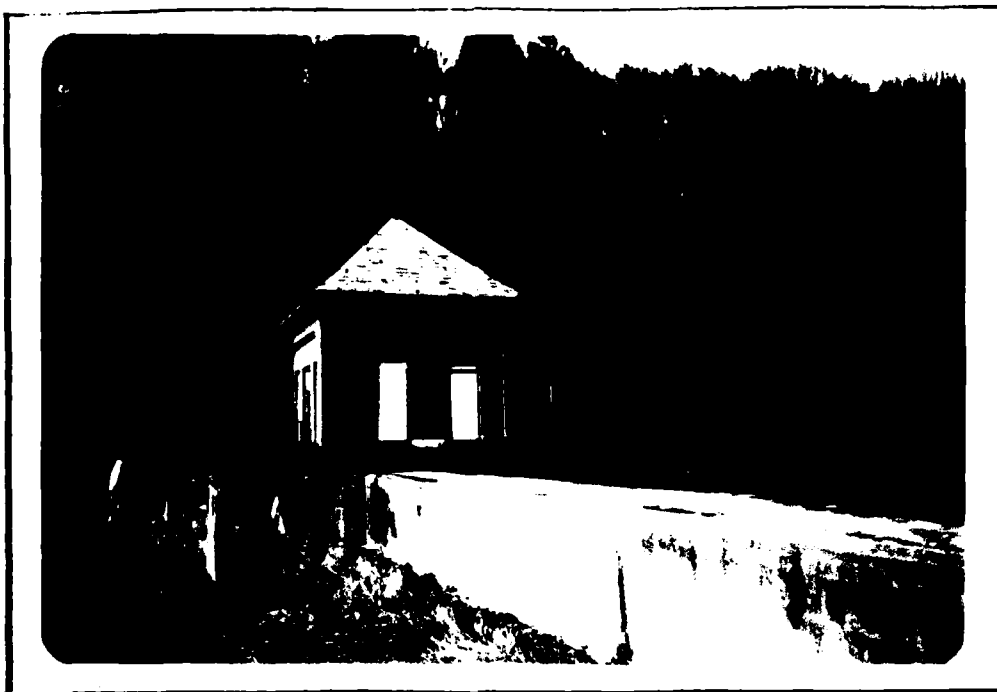
1. CREST OF DAM SHOWING GATE HOUSE, HOIST PLATFORM AND  
HOIST, AND CONCRETE WALL. (12/3/80)

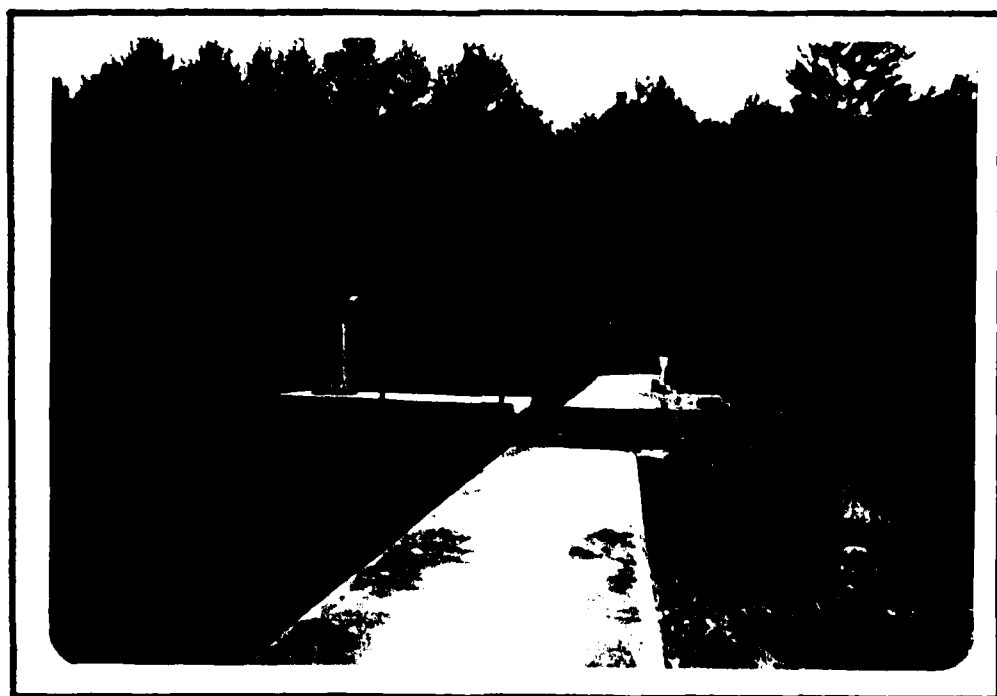
The access bridge to the operator for the 24-inch diameter low-level outlet appears to be in good condition. As shown in photo number 2, it appears to have been recently painted. According to Mr. Richard Michand, Water Foreman, the crank and the worm gear for the operator have been removed to prevent unauthorized operation. For a more detailed description of the outlet works, refer to Section 1.2b.

2. CLOSE-UP OF HOIST PLATFORM AND HOIST. (12/3/80)

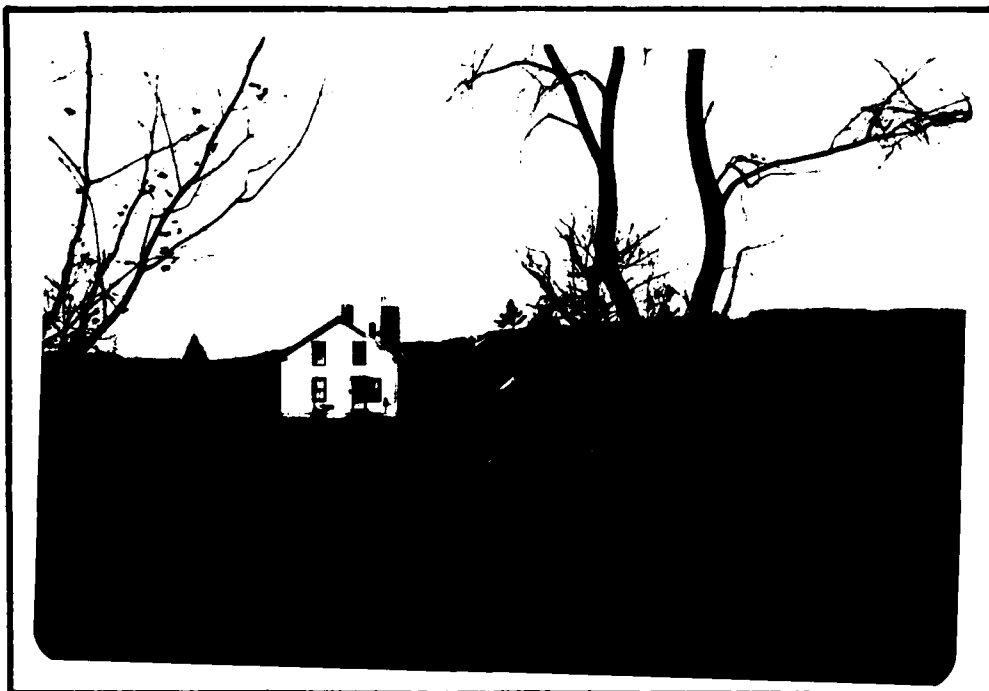
12. POSSIBLE DAMAGE AREA APPROXIMATELY 2 MILES DOWNSTREAM  
OF THE DAM. (12/3/80)
