BLACKSTONE RIVER BASIN  
MILLBURY, MASSACHUSETTS

BRIERLY POND DAM  
MA 00143

**PHASE I INSPECTION REPORT  
NATIONAL DAM INSPECTION PROGRAM**

OCTOBER 1978

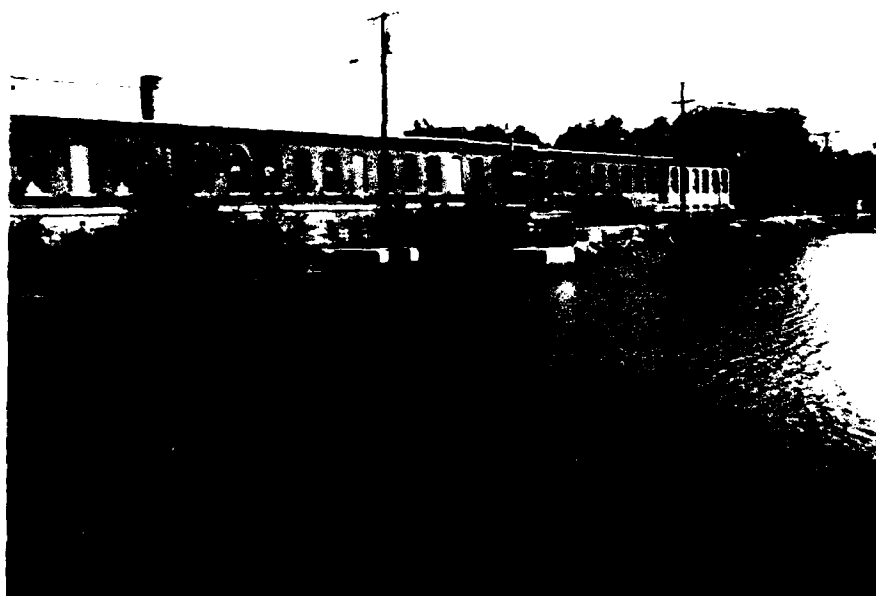
**UPSTREAM VIEW OF MAIN DAM**

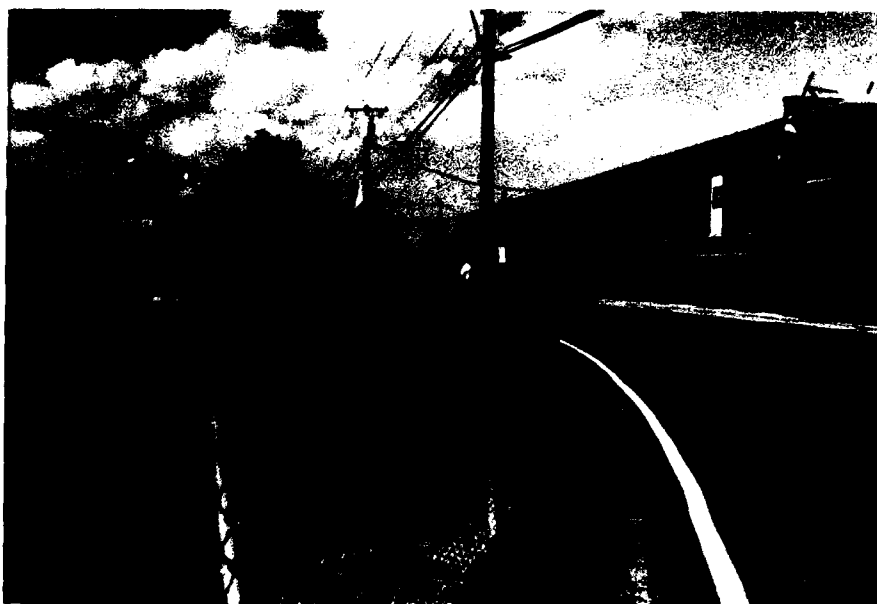
- b. Dam. The earthfill dam, which forms part of West Main Street, is in generally good condition. The paved crest is level with no cracks or depressions on the surface. The upstream slope is covered with weeds and only partially protected by scattered riprap 1.5 to 2.5 feet in size. Apparently there was once a short vertical stone wall at the top of the slope but the wall has deteriorated in places to a pile of rubble at the toe. The three-story brick building situated on the downstream slope of the dam is separated from the road by a 4-foot-wide, 10-foot-deep concrete channel. This channel is partially filled with water.

**NO. 1 CREST OF DAM**
