BLACKSTONE RIVER BASIN
WORCESTER, MASSACHUSETTS

CURTIS PONDS DAM
MA 00140

PHASE I INSPECTION REPORT
NATIONAL DAM INSPECTION PROGRAM

OCTOBER 1978

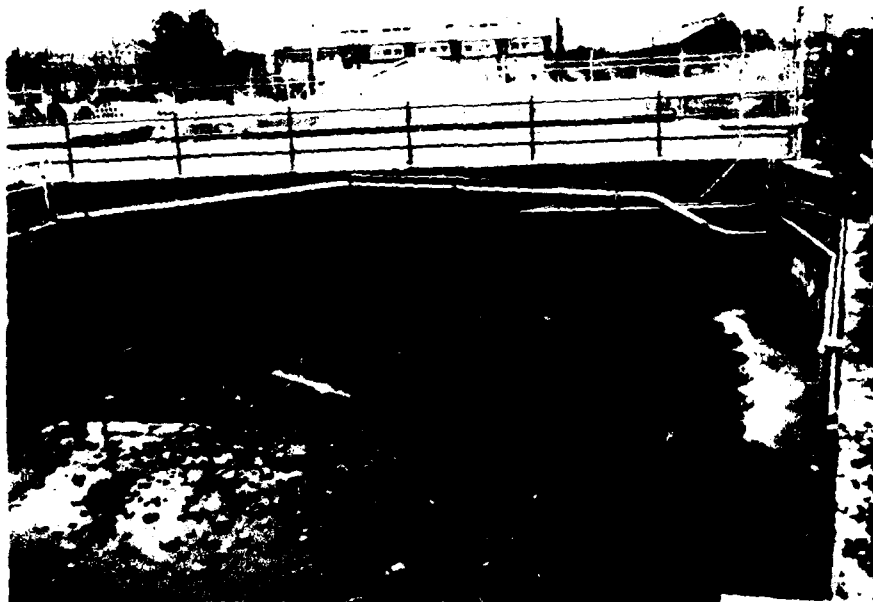
**NO. 6 VIEW OF WEBSTER STREET BRIDGE
OVER MIDDLE RIVER**
