BLACKSTONE RIVER BASIN  
MILLBURY, MASSACHUSETTS

RAMSHORN POND DAM  
MA 00145

**PHASE I INSPECTION REPORT  
NATIONAL DAM INSPECTION PROGRAM**

JULY 1978

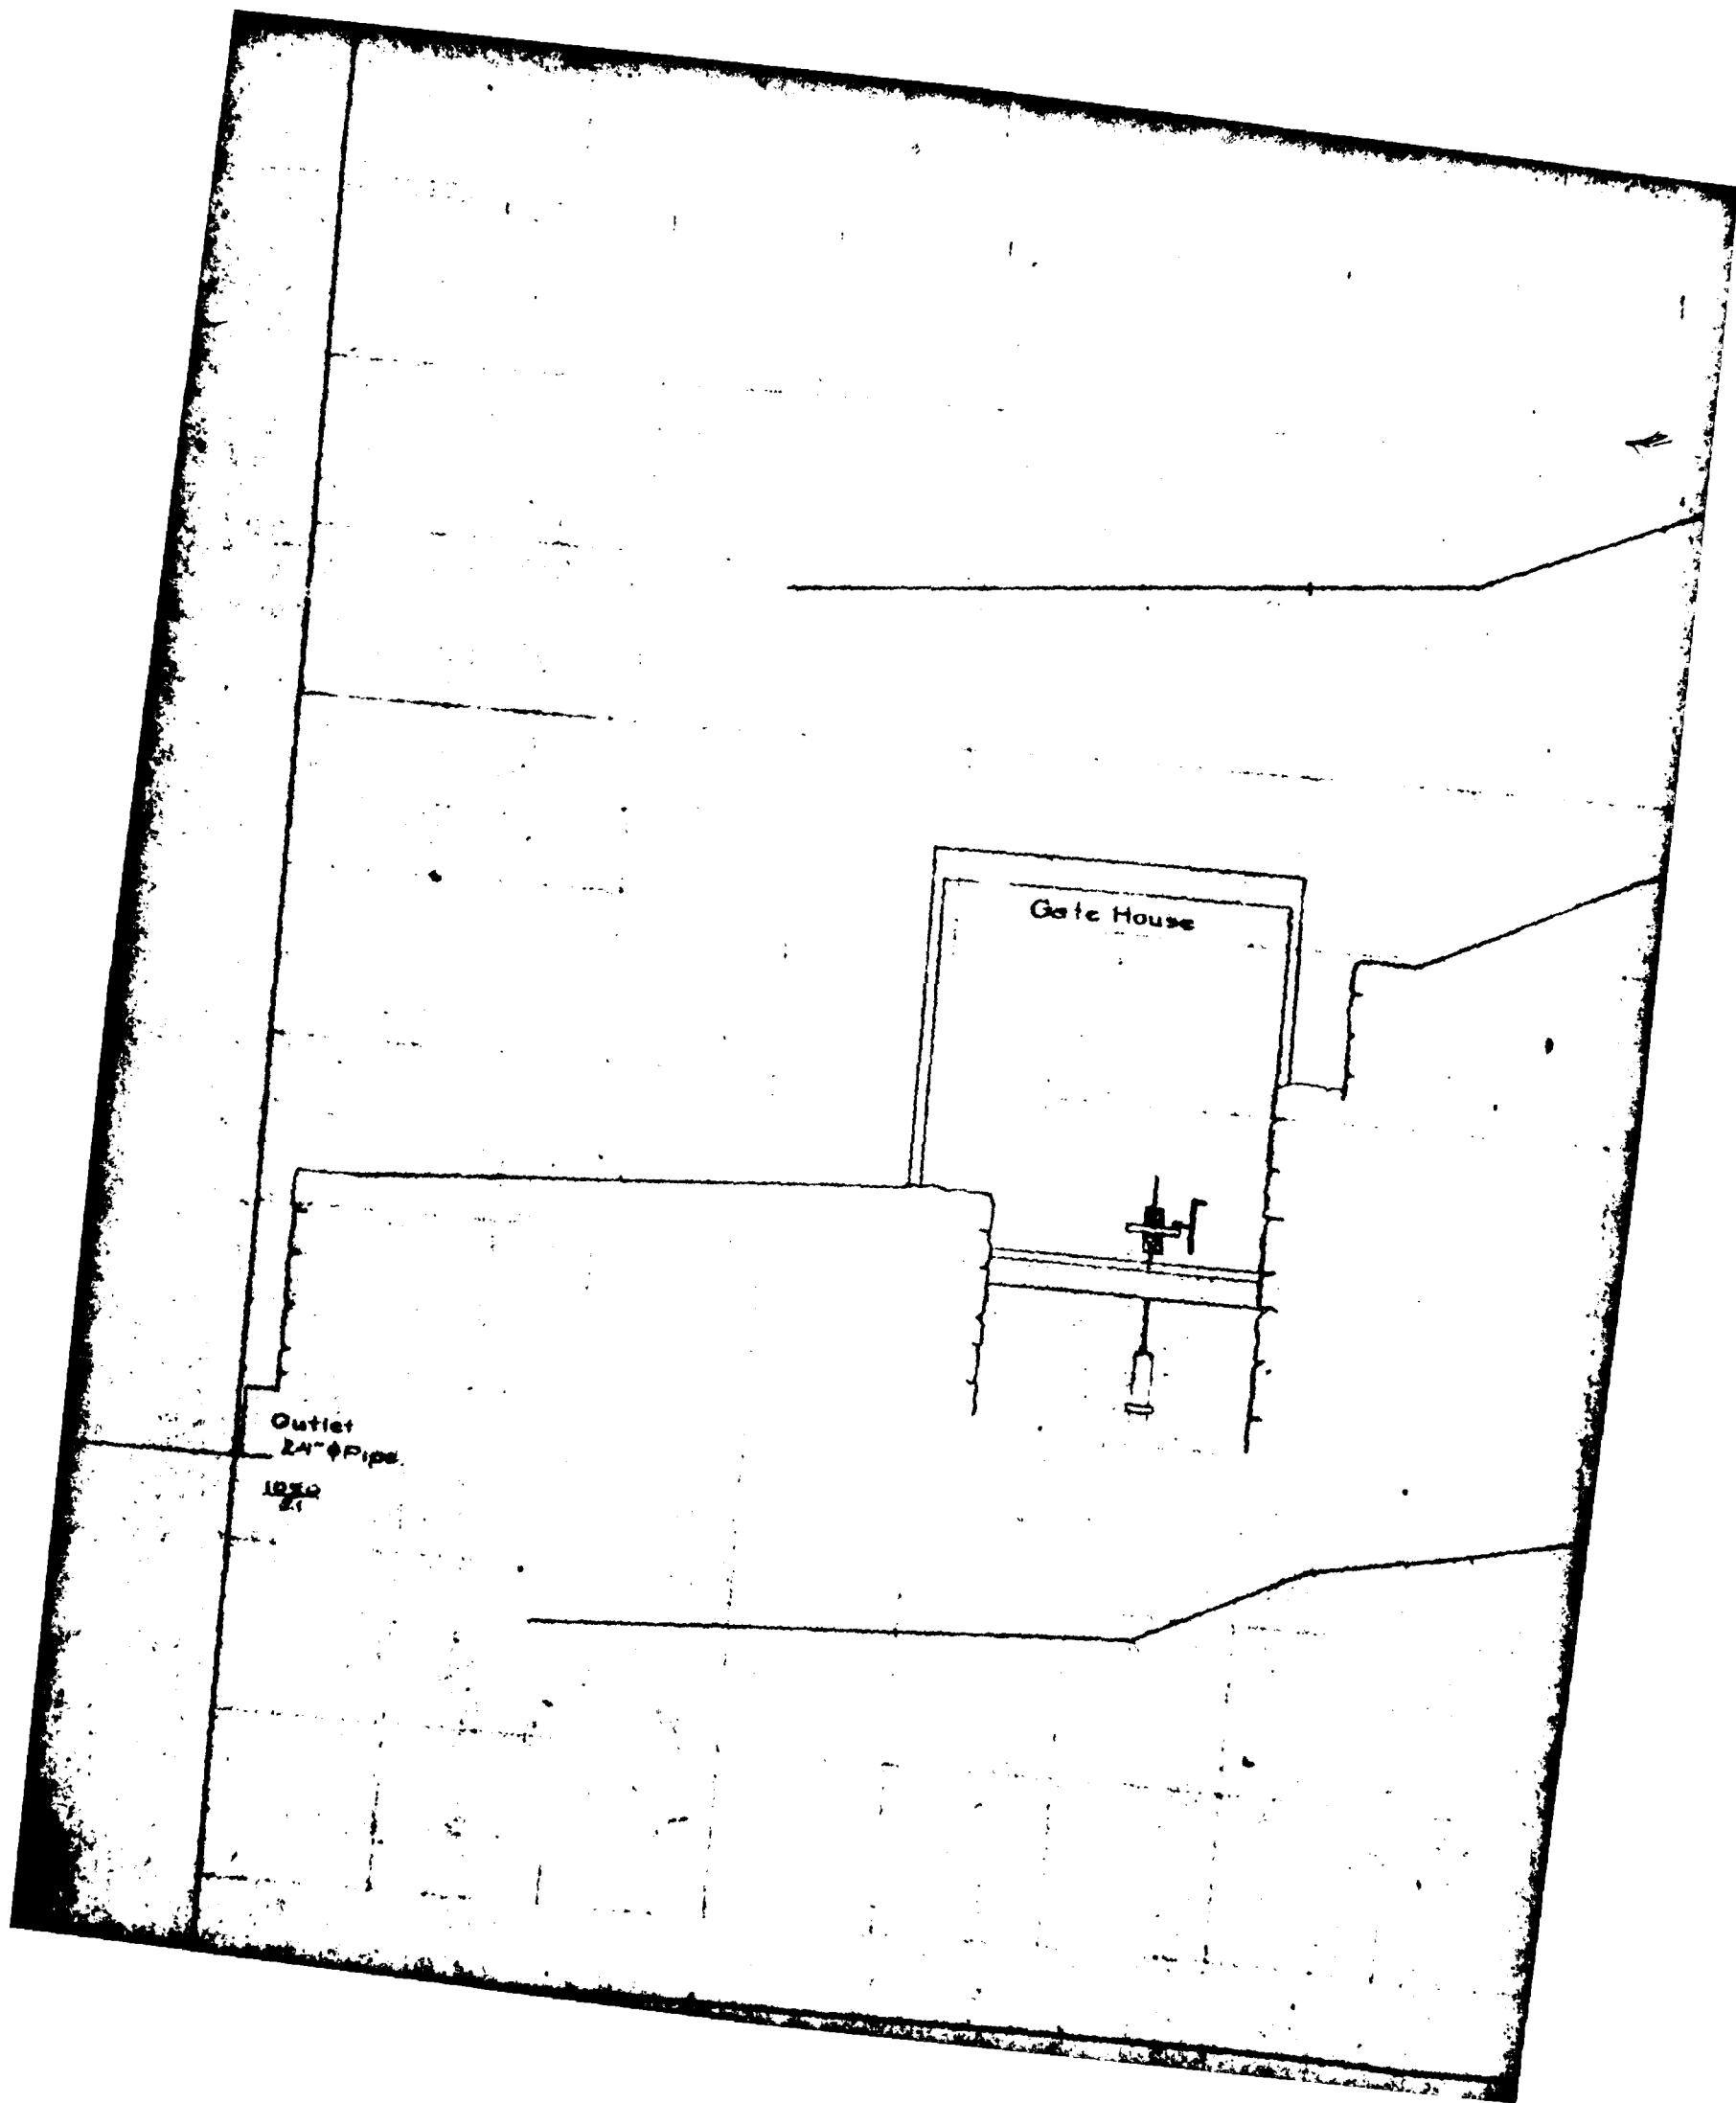
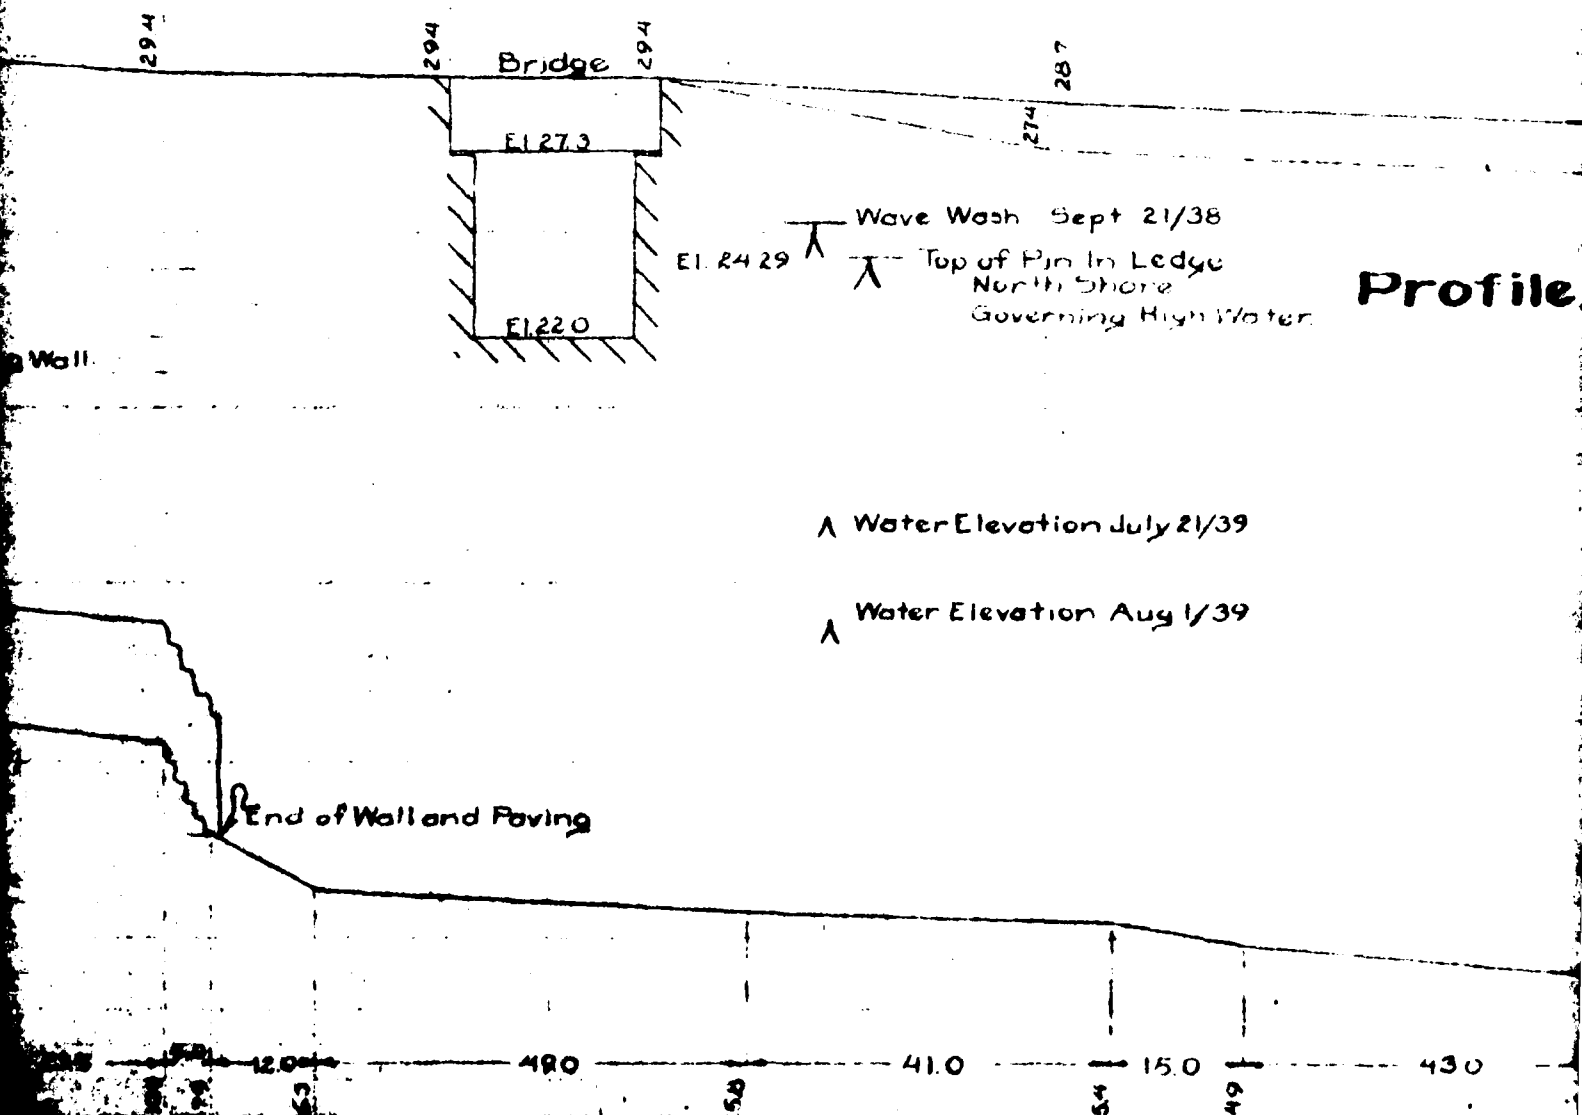
FIGURE B-3

- d. Overtopping Potential. Overtopping of the dam is expected under an outflow test flood of 2,670 cfs; as noted previously, however, the records on overtopping indicate that the dam was overtopped during the 1938 flood but was not overtopped in 1955. Figures B-2 and B-3 in Appendix B show the dam was raised about 2 feet in 1939.

It was learned that this dam was originally built in 1825, probably of local soil or rock materials. As discussed in Section 1, Paragraph 1.2.h, changes were made in the dam in 1873, 1915, and 1939. As noted in Figure B-2, the cutoff consists of chestnut planking driven along the centerline and for a distance of 10 feet either side. The fill was placed in layers and puddled.
