BLACKSTONE RIVER BASIN  
WORCESTER, MASSACHUSETTS

GREEN HILL POND DAM  
MA 00149

**PHASE I INSPECTION REPORT  
NATIONAL DAM INSPECTION PROGRAM**

AUGUST 1978

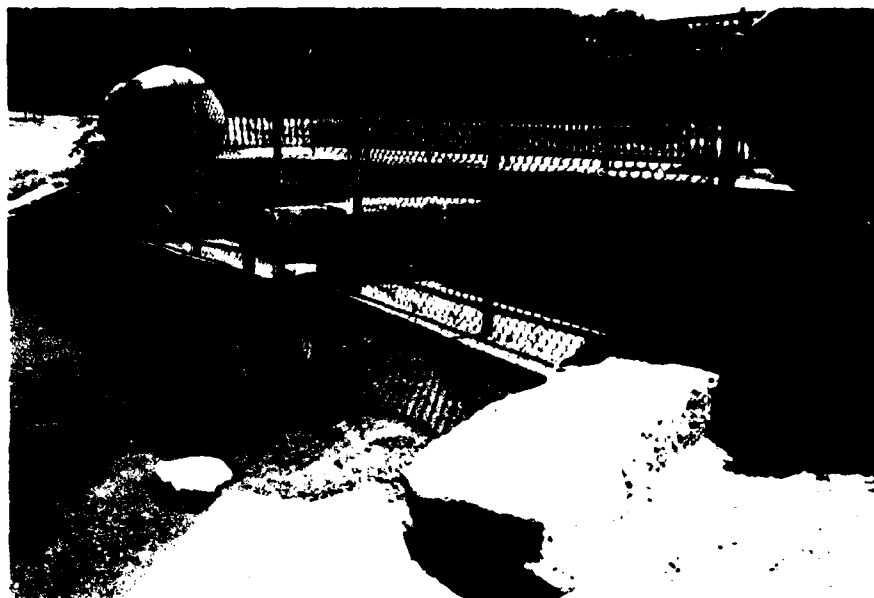
- c. Appurtenant Structures. The spillway is a vertical stone shaft with a granite overflow weir. The structure is in poor condition. Water is flowing under the granite weir and into the shaft. The piece of granite on the west half of the weir is misaligned. The shaft is filled with soil and debris to within 2 feet of the crest of the weir. This obstruction restricts all flows over the spillway. There is a fence located upstream of the crest of the spillway.

NO. 1 VIEW OF SPILLWAY

- (3) construct a gated outlet
- (4) repair the weir of the spillway where water is flowing beneath the granite slabs and realign the western weir stone.

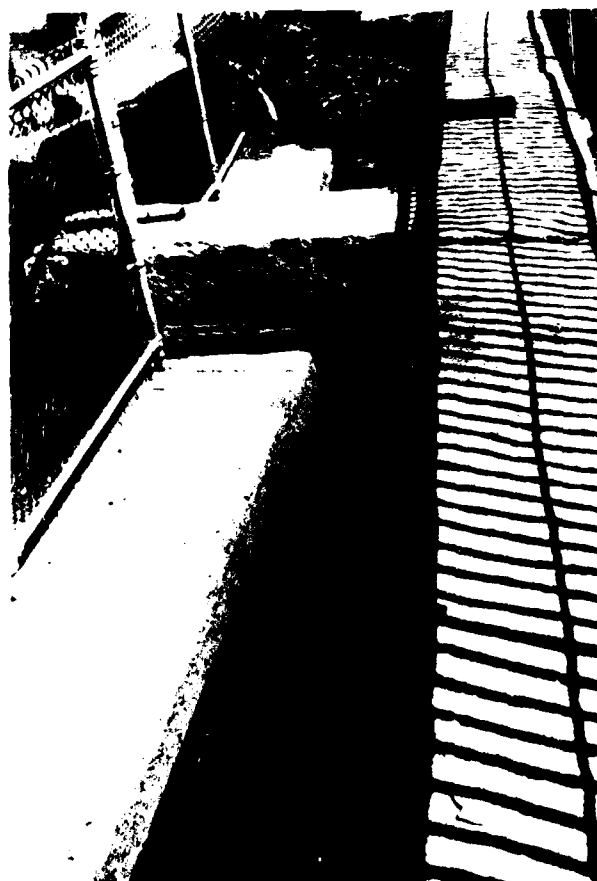
The overflow diversion structure is located at the northeast end of the pond and has a concrete box intake with a trash rack. The conduit is completely blocked with leaves, trash, and other debris. This material passed through the 6-inch openings of the trash rack and through an opening on the top of the intake box. The trash rack is severely corroded. Erosion of the concrete has also taken place on the upstream face of the intake box.

NO. 2 VIEW OF DEBRIS IN SPILLWAY

- (1) remove all debris from the shaft of the spillway and the overflow diversion facilities
- (2) install a trash rack on the spillway and repair the trash rack on the overflow diversion
