BLACKSTONE RIVER BASIN  
AUBURN, MASSACHUSETTS

STONEVILLE POND DAM  
MA 00126

PHASE I INSPECTION REPORT  
NATIONAL DAM INSPECTION PROGRAM

AUGUST 1978

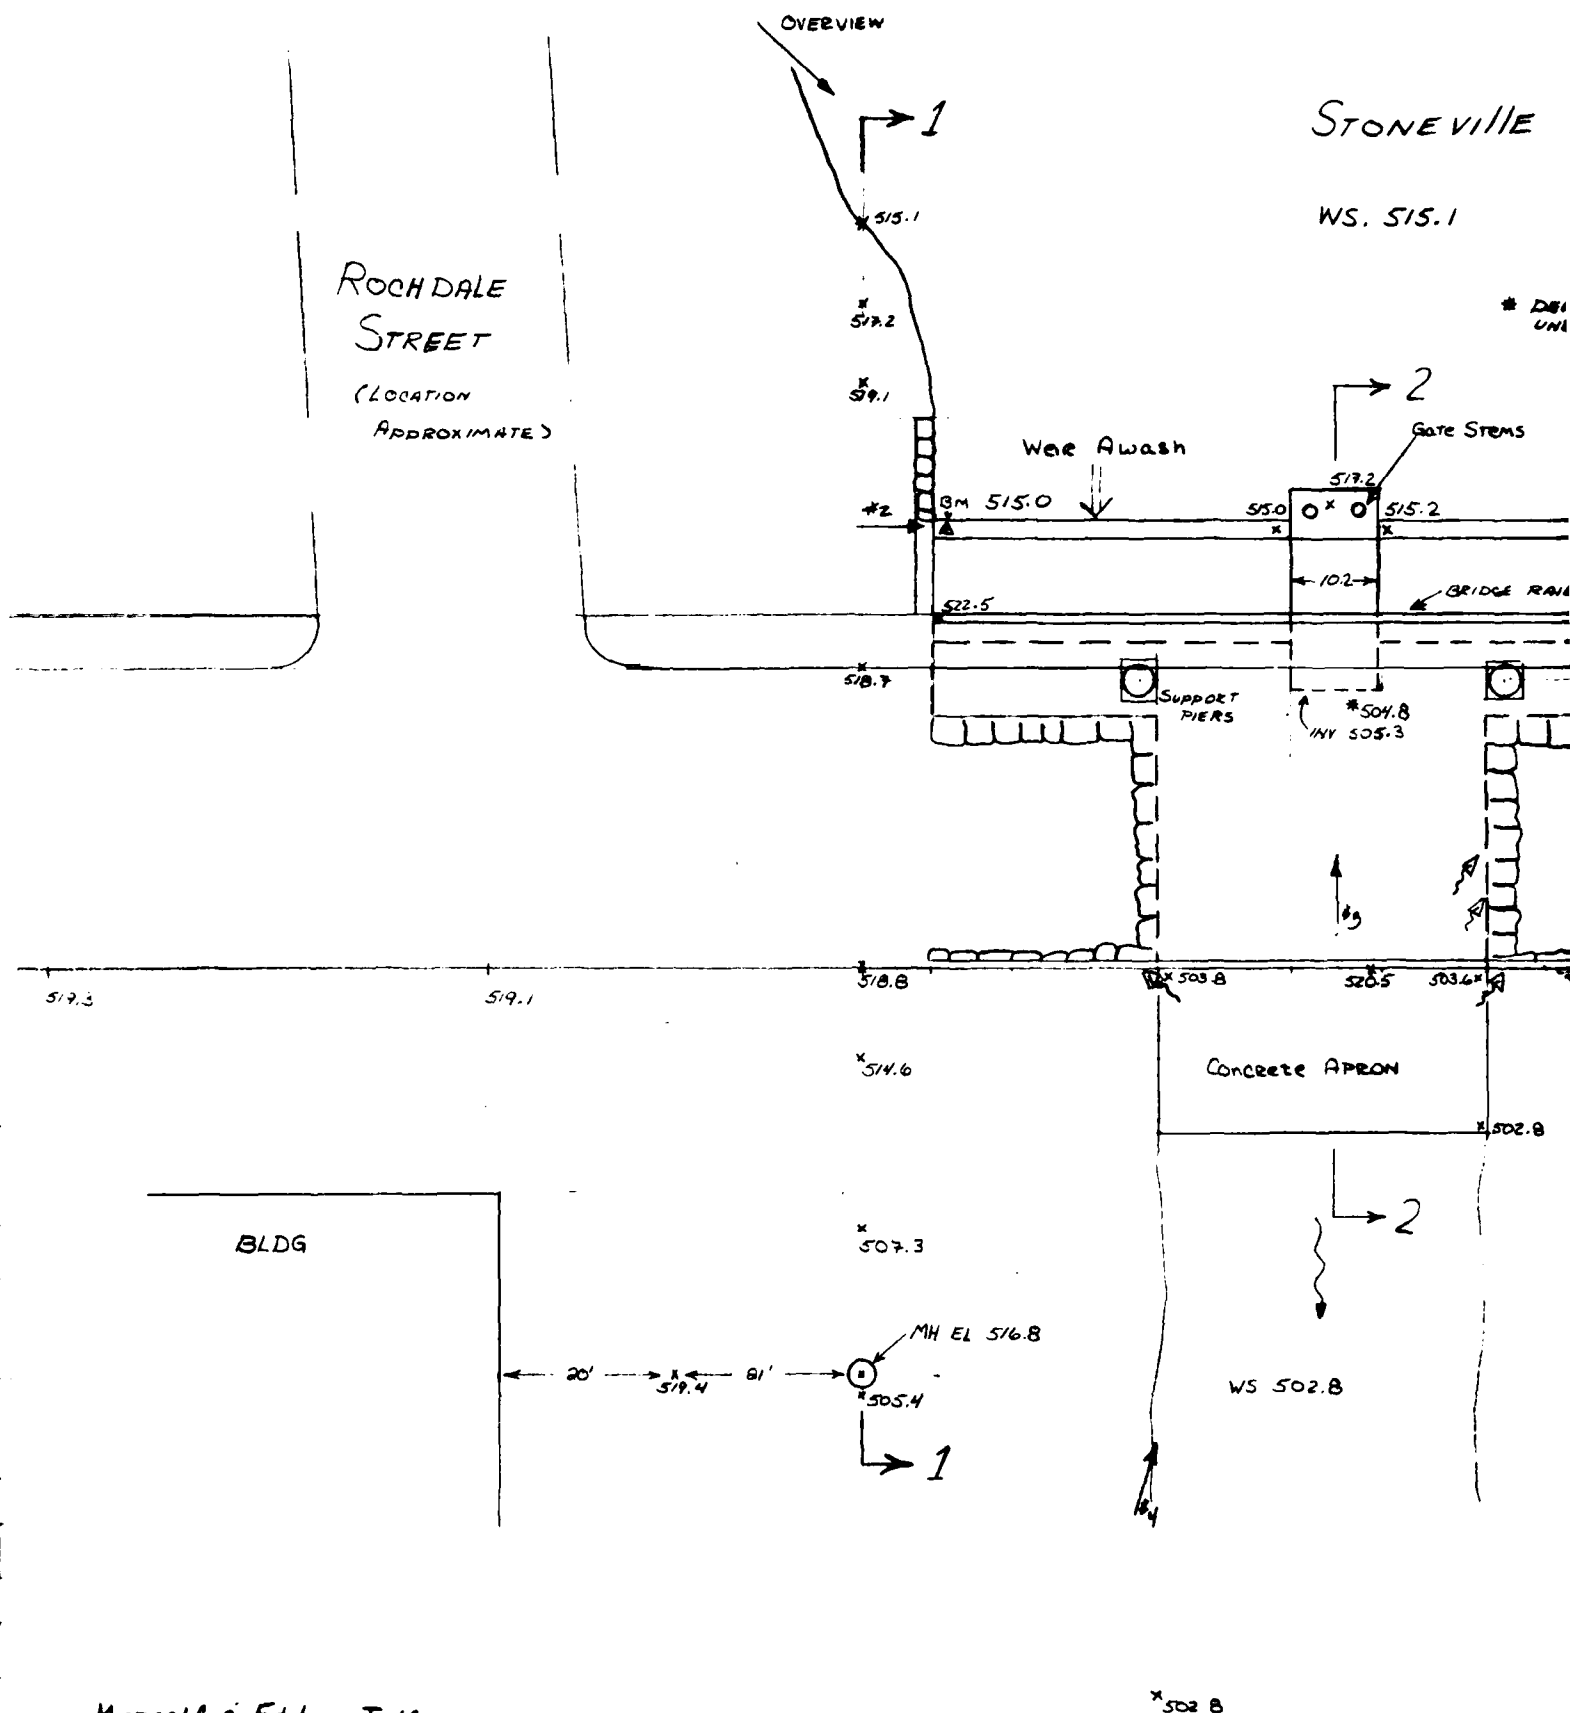
FIGURE B-1 PLAN OF DAM

- NOTES:
- 1. INFORMATION SHOWN BASED ON FIELD SURVEY OF JULY 31, 1978
  - 2. \* 515.9 REFERS TO ELEVATIONS LOCATED BENEATH BRIDGE
  - 3. Δ DENOTES SEEPAGE
  - 4. ELEVATIONS BASED ON ASSUMED BENCHMARK (515.0 MSL) ON SPILLWAY LIP
  - 5. \* → DENOTES DIRECTION OF VIEW OF PHOTOGRAPHS
  - 6. SEE FIGURE B-2 FOR SECTIONS
